## **Blacksmithing Works**

### **Introduction**

Blacksmithing activities at the Tell Mozan site are currently considered relatively challenging due to the lack of electricity at the site.

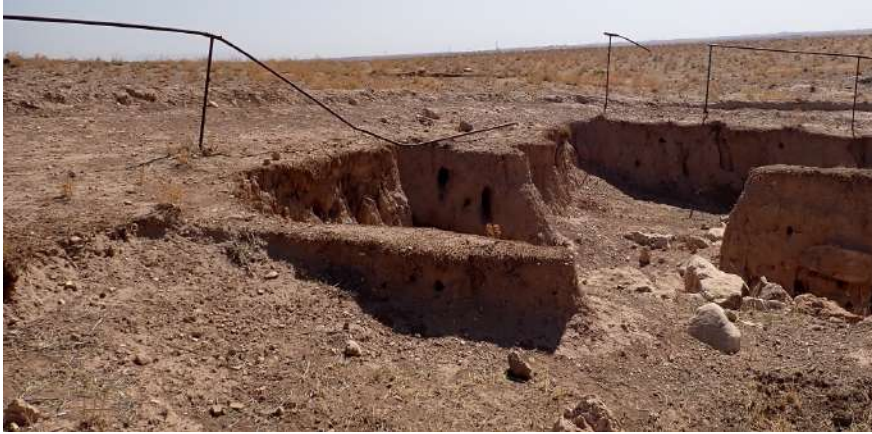
At the site, most sections of the iron fence were bent (Fig. 1), some were broken (Fig. 2), and other parts were entirely missing (Fig. 3). The objectives of the repair process were to:

*Figure 1: Image showing bent rods*

- Straighten the bent sections.
- Repair the broken parts.
- Replace the missing elements.

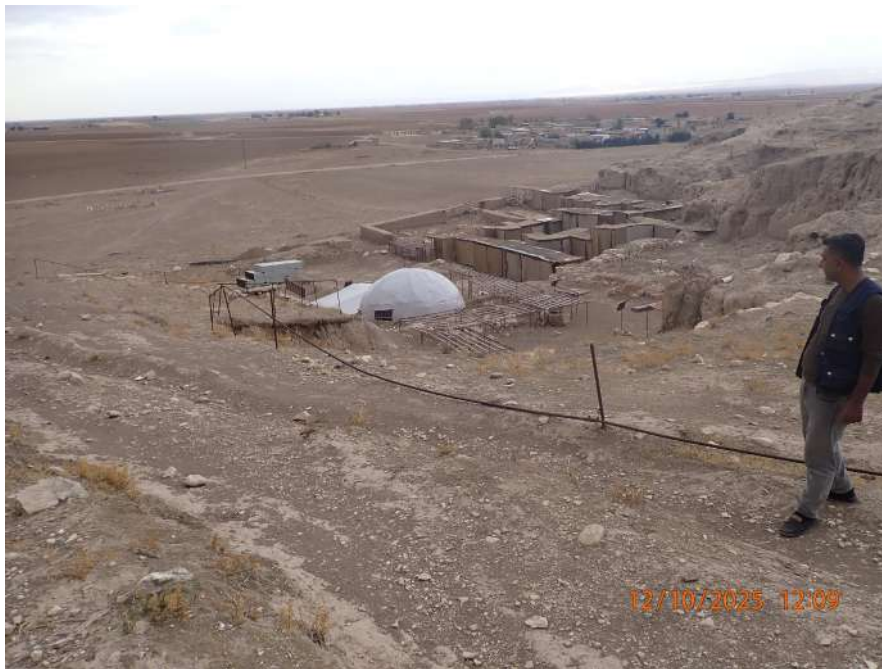
*Figure 2: Image showing broken rods*

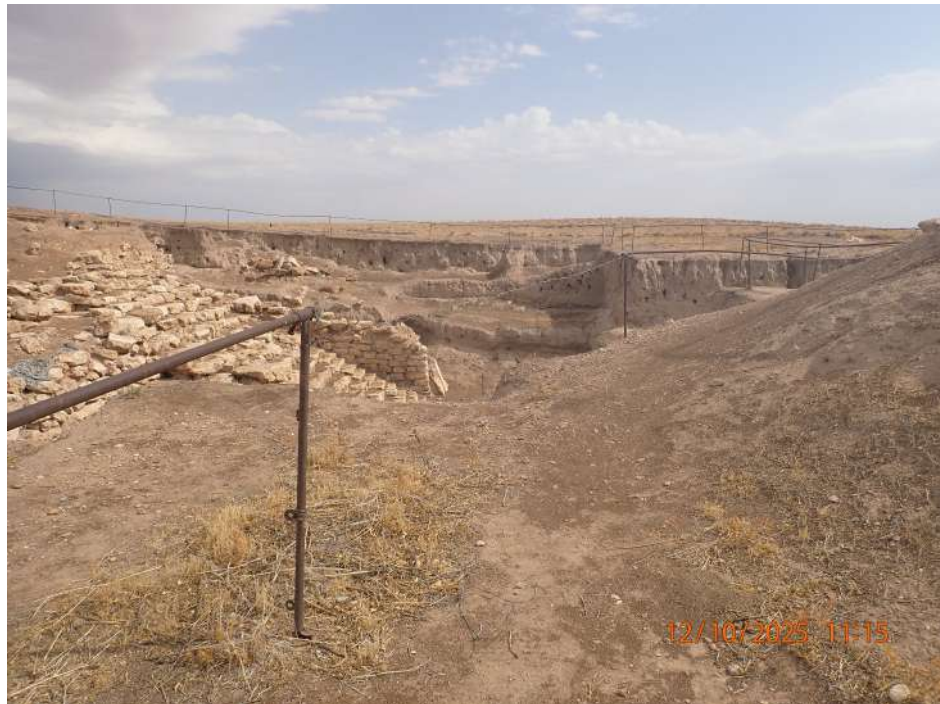
*Figure 3: Image showing missing rods*

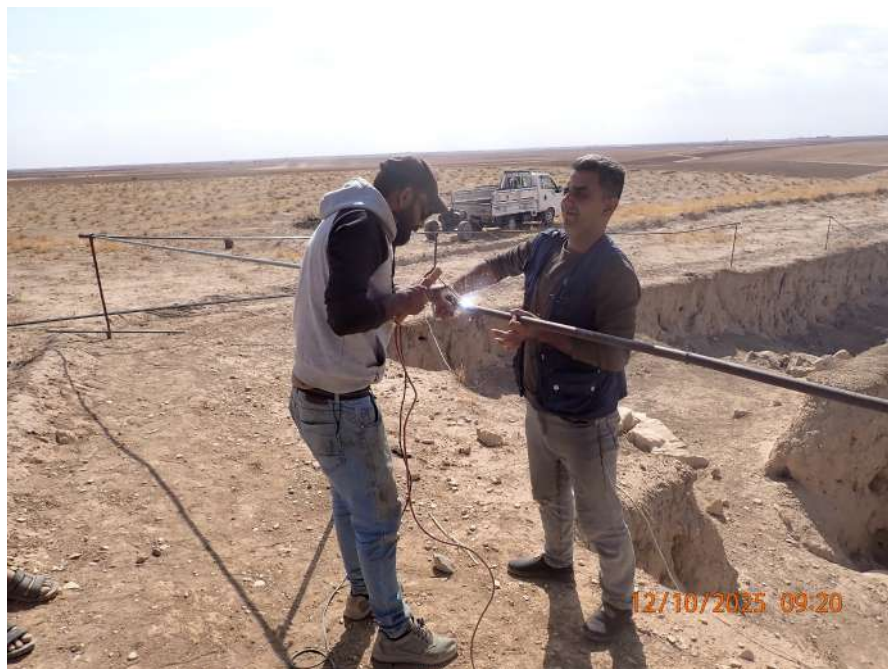
*Figure 4: Image showing welding of the rods*

The work on site continued for two days. On the first day, the iron fence was repaired by welding the broken sections (Fig. 4) and adding new rods to replace the missing parts in the temple area (Fig. 5). The blacksmith attempted to unscrew the bolts to reassemble the sections; however, the bolts were corroded and could not be removed.

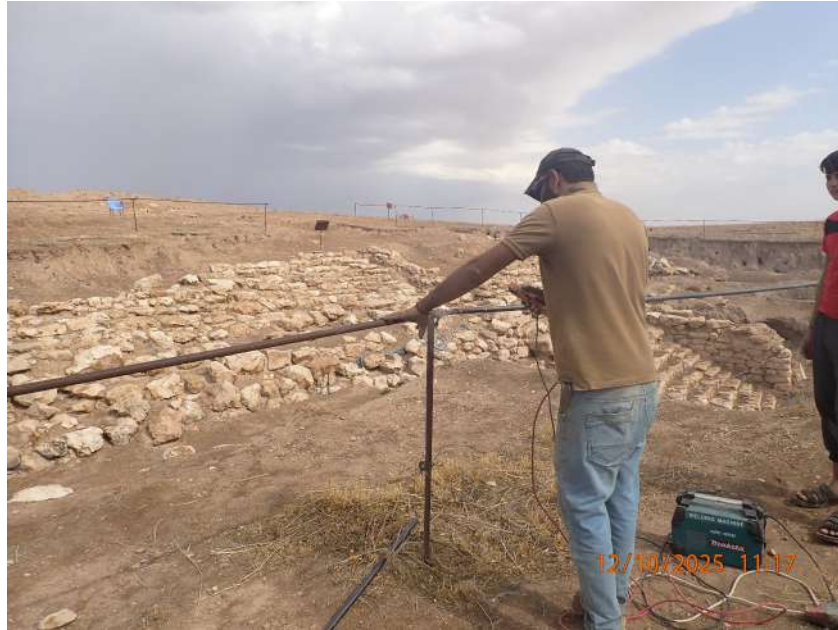
*Figure 5: Image showing the addition of new rods*

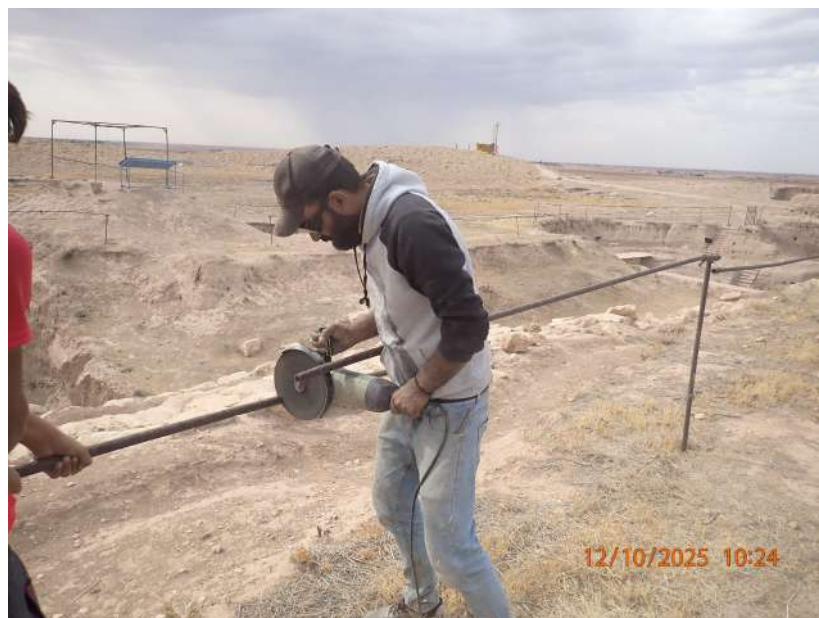
*Figure 6: Image showing cutting of parts of the rods*

Some parts had to be cut (Fig. 6) and rewelded (Fig. 7), and other parts straightened (Fig. 8) in both the temple and palace areas.

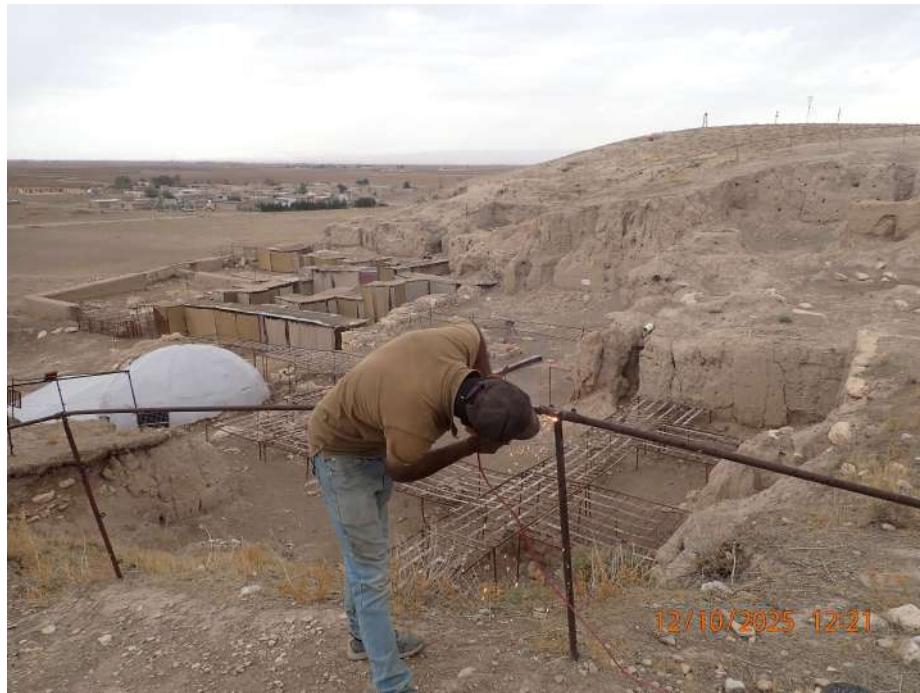
*Figure 7: Image showing welding of the rods*

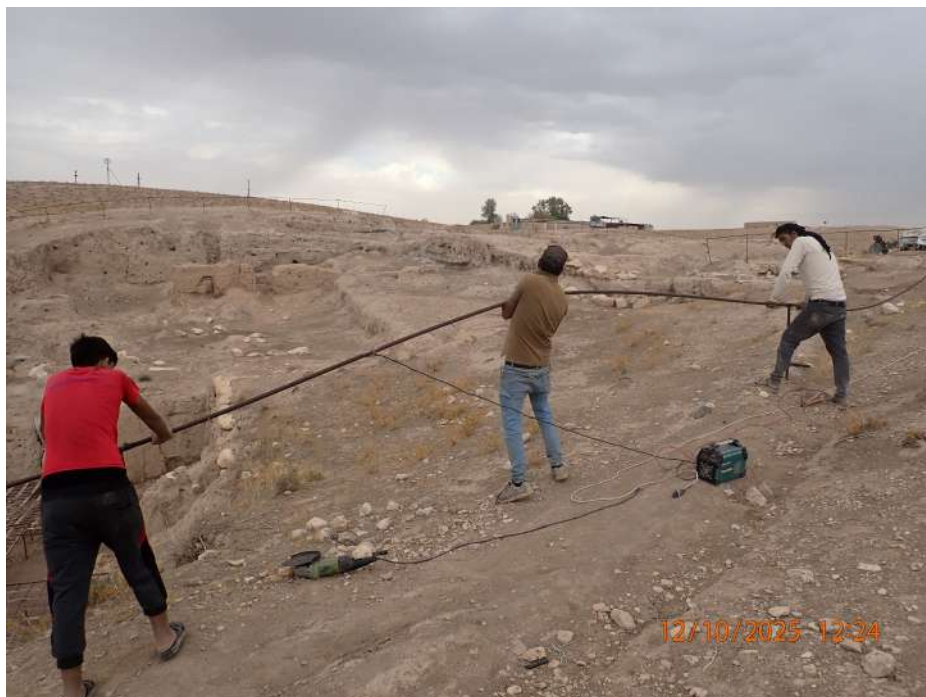
*Figure 8: Image showing the straightening of bent rods*

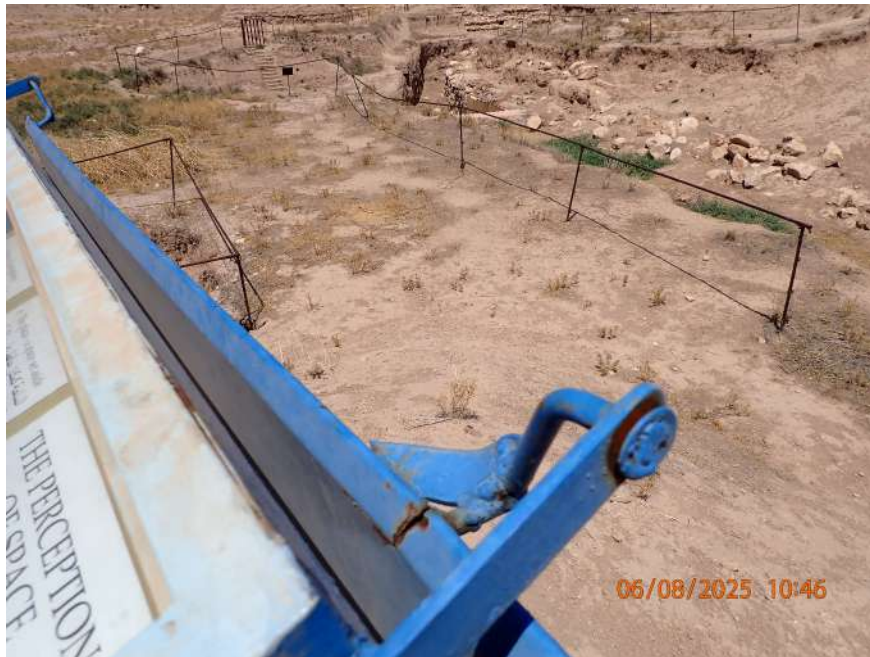
The temple panorama had a break in its right corner (Fig. 9), which made opening the cover difficult. Additionally, several minor cracks were observed on the cover. The blacksmith welded the broken corner (Fig. 10) and the minor cracks (Fig. 11).

*Figure 9: Image showing the broken corner of the panorama*

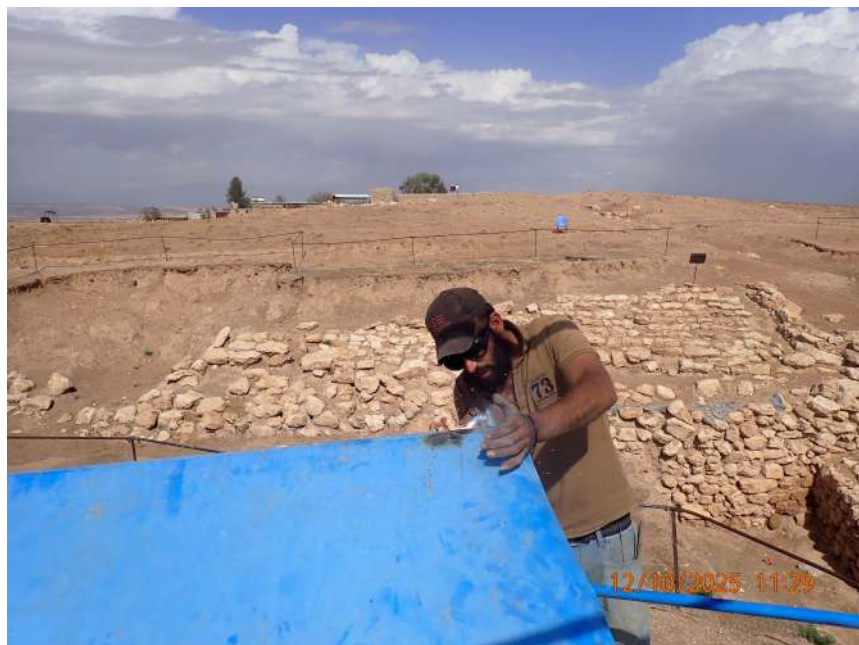
*Figure 10: Image showing welding of the panorama corner*

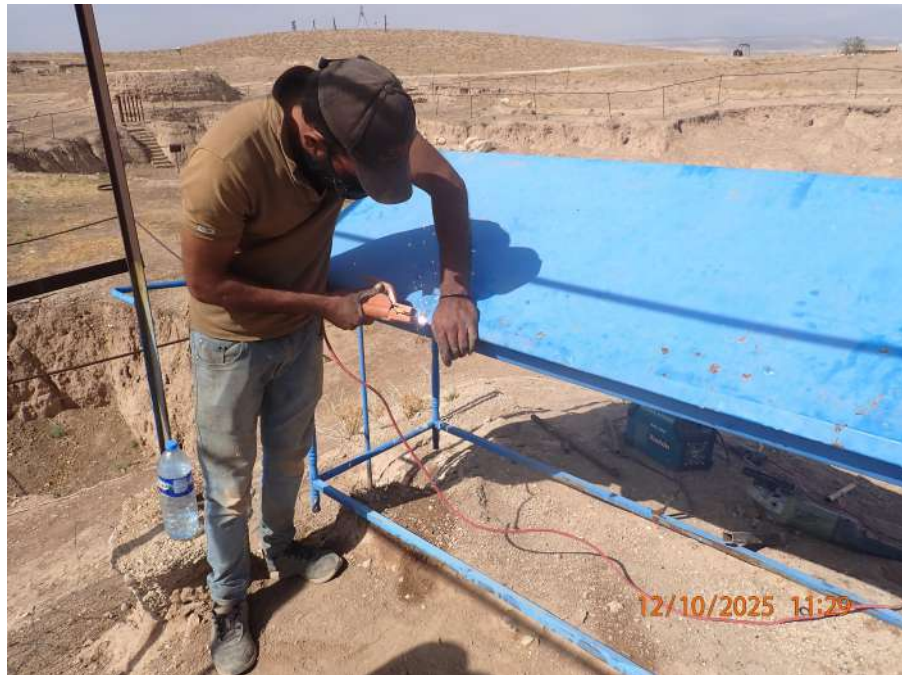
*Figure 11: Image showing welding of minor cracks in the temple panorama*

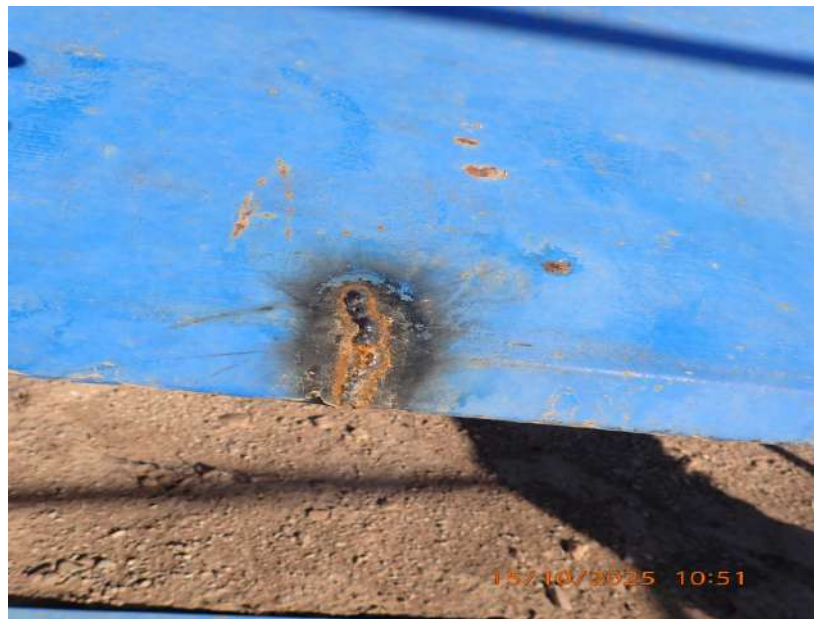
*Figure 12: Image showing the panorama after welding*

It is important to note that any repair work may affect other parts of the panorama. So, it will be necessary to repaint the entire panorama following the welding operations to ensure that its appearance and functionality are preserved (Fig. 12).

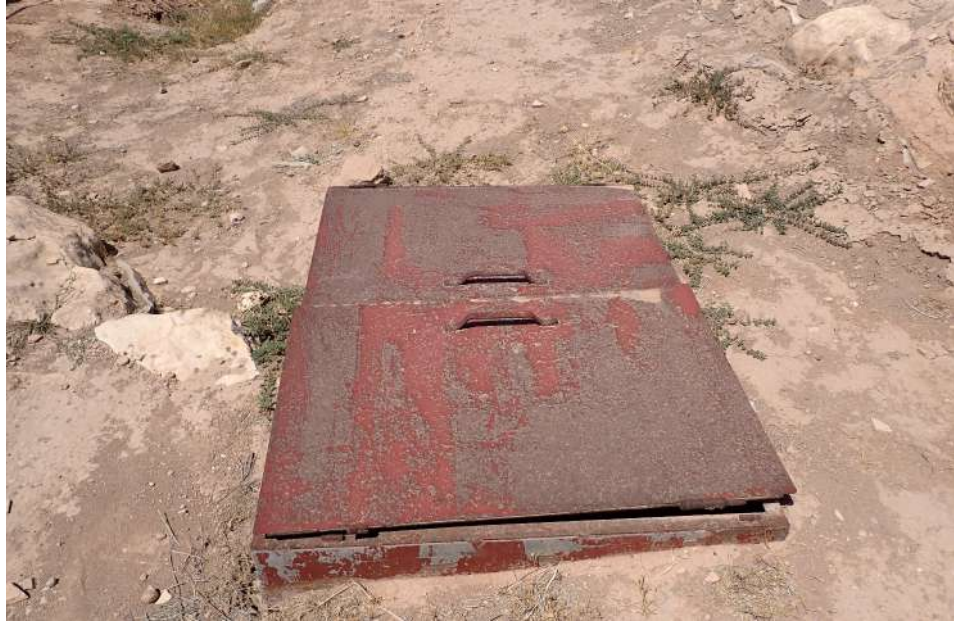
It was observed that two rings of the tannur cover were broken (Fig. 13), which hindered the proper closing of the cover and caused it to become dislodged from the surrounding tannur frame. Therefore, the damaged rings were replaced with new ones and welded in place (Fig. 14).

*Figure 13: Image showing the broken rings of the tannur cover*

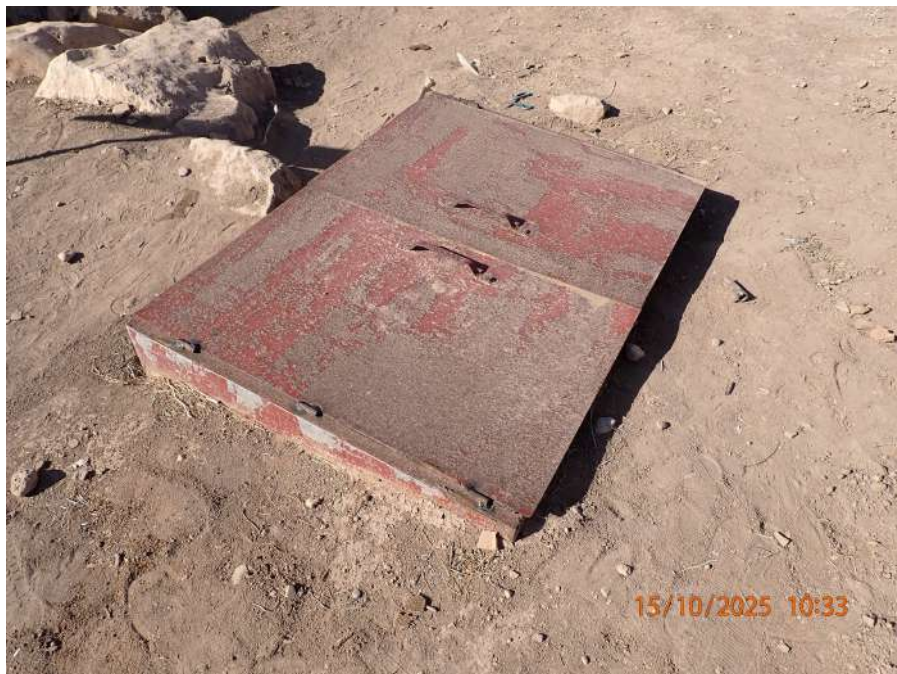
*Figure 14: Image showing the tannur cover after repair*

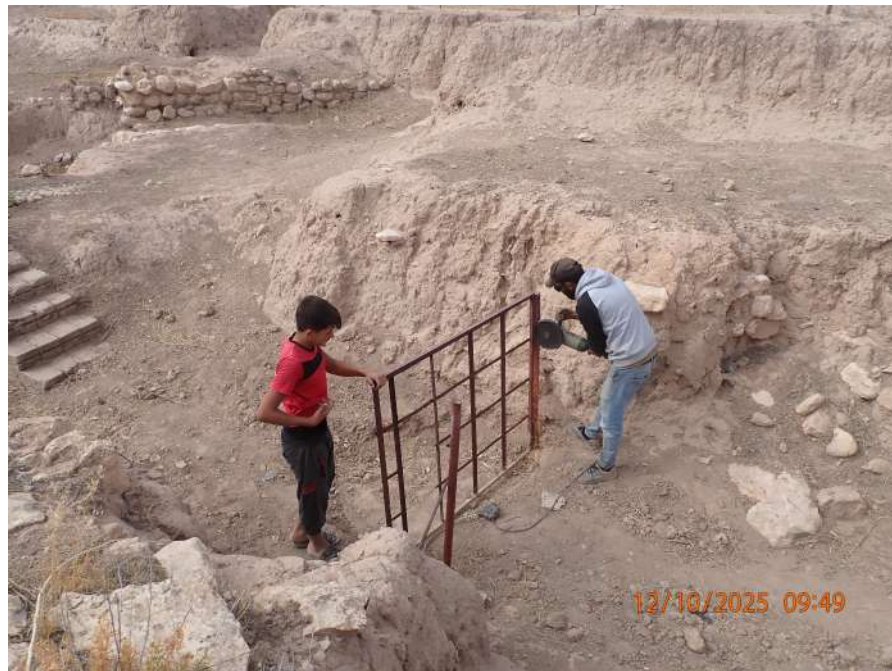
*Figure 15: Image showing the door during the raising process*

It was observed that one of the doors had become embedded in the ground due to accumulated debris over the past years, preventing it from opening properly and obstructing visitor movement. Two options were considered: excavating to enable proper door operation or slightly raising it above the ground. The latter option was chosen to avoid any excavation at the site at this stage, even if minor. The blacksmith raised the door and rewelded it in place (Fig. 15).

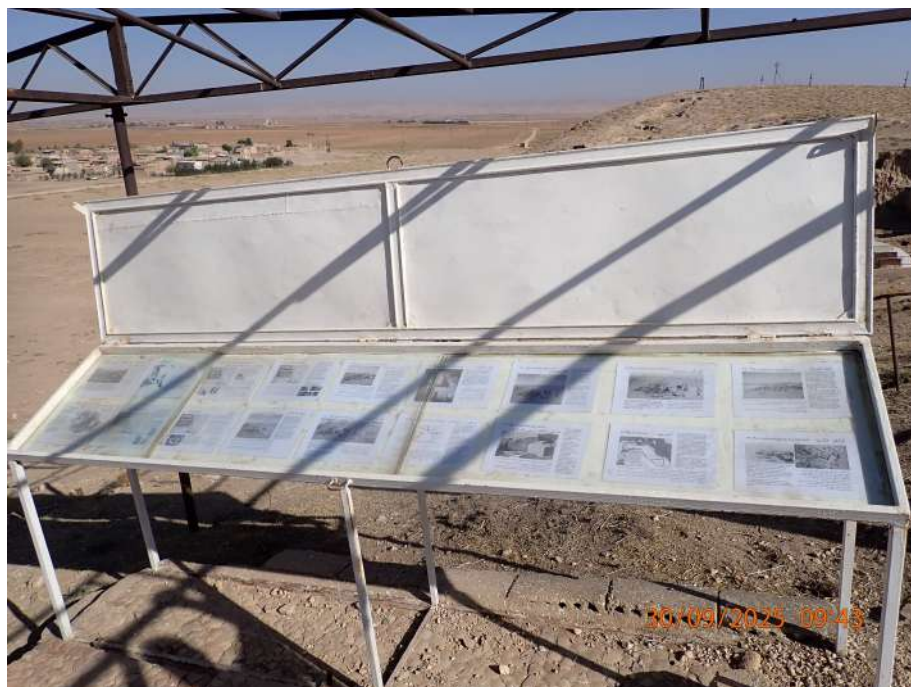
A previous defect was identified, where the cover of the palace panorama did not open in a manner that allowed it to rest flat on its base.

This hindered visitors' ability to simultaneously read the content of the panorama and view the palace (Fig. 16).

*Figure 16: Image showing the cover not resting flat on its base*

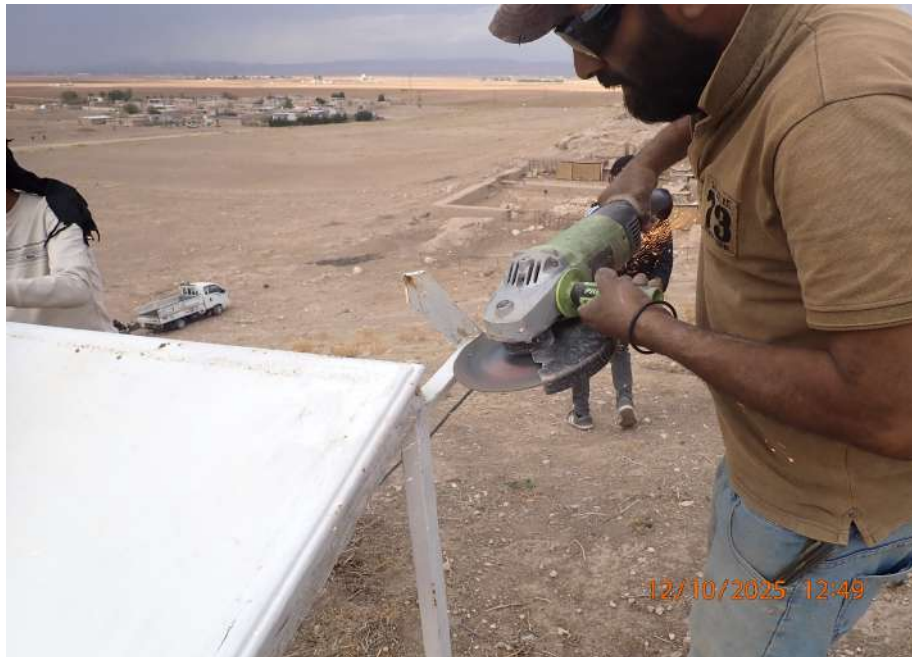
*Figure 17: Image showing the cutting of the iron rod that prevented the cover from lying flat*

To address this issue, the iron rod that was preventing the cover from lying flat was cut (Fig. 17), allowing the cover to achieve the desired flat position (Fig. 18).

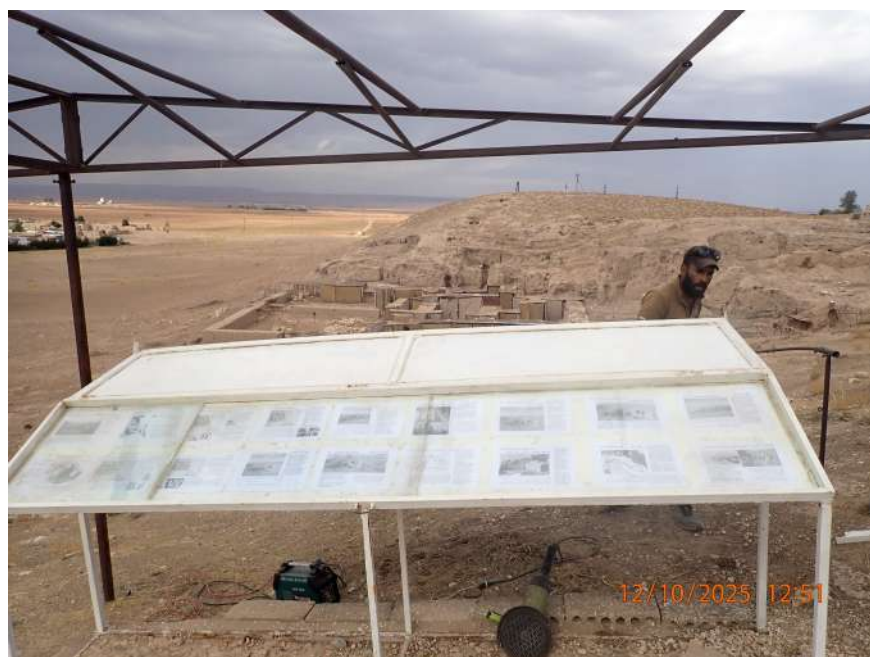
*Figure 18: Image showing the panorama cover after adjustment, lying flat on its base*

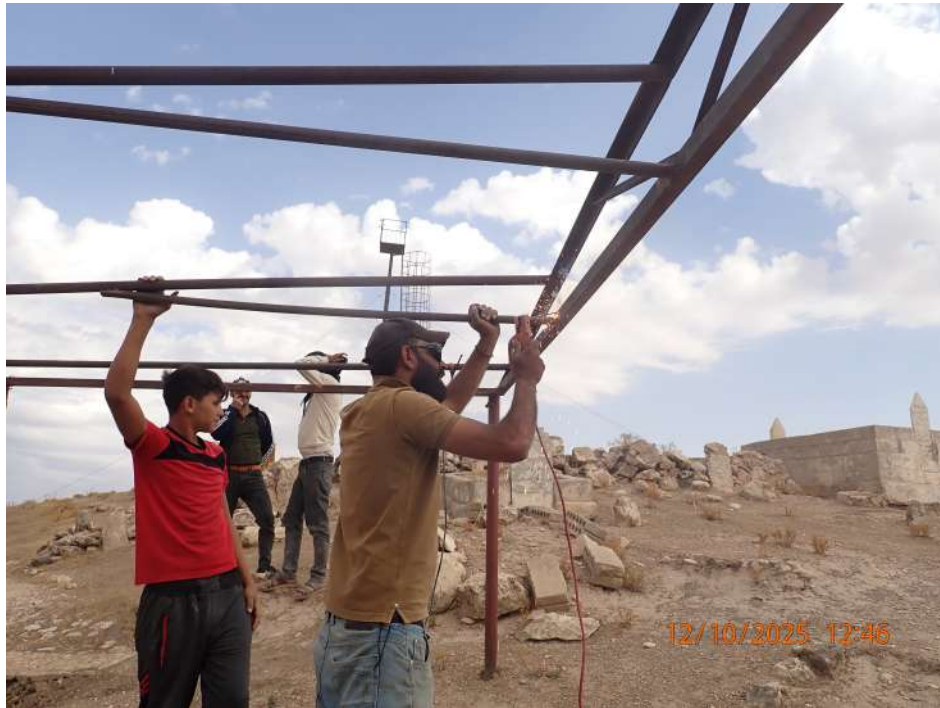
*Figure 19: Image showing the repair of the broken canopy above the palace panorama*

At the same site, the break in the metal canopy covering the palace panorama was also repaired (Fig. 19).

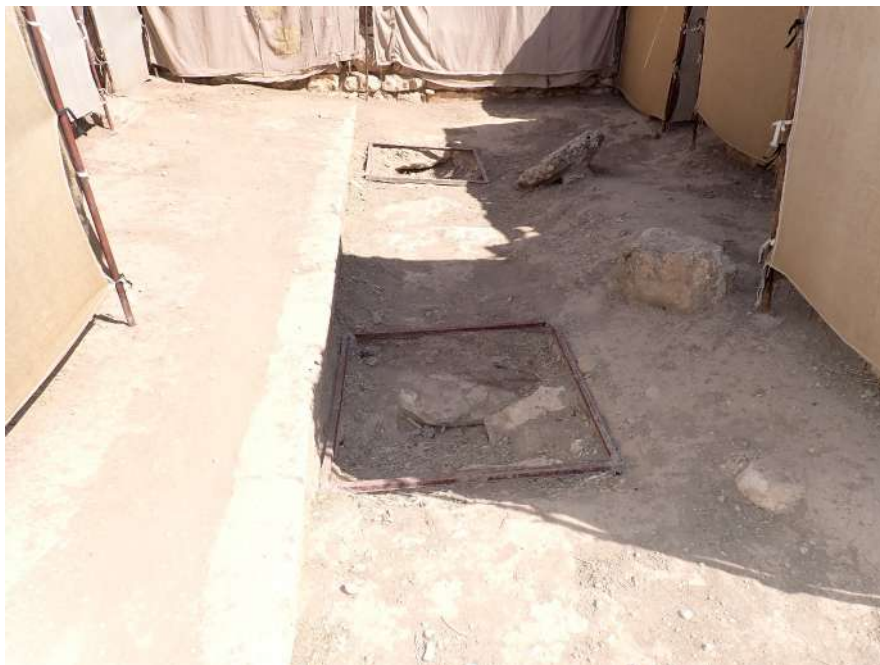
It was observed that the mesh covering the iron frames installed over the drainage system in Iwan C5 was missing (Fig. 20), which led to the accumulation of debris within the drainage pits due to the absence of the protective mesh. Consequently, a new mesh was installed on the two frames and secured in place, restoring it to its original condition prior to wear and loss (Fig. 21).

*Figure 20: Image showing the missing mesh on the drainage frames in Iwan C5*

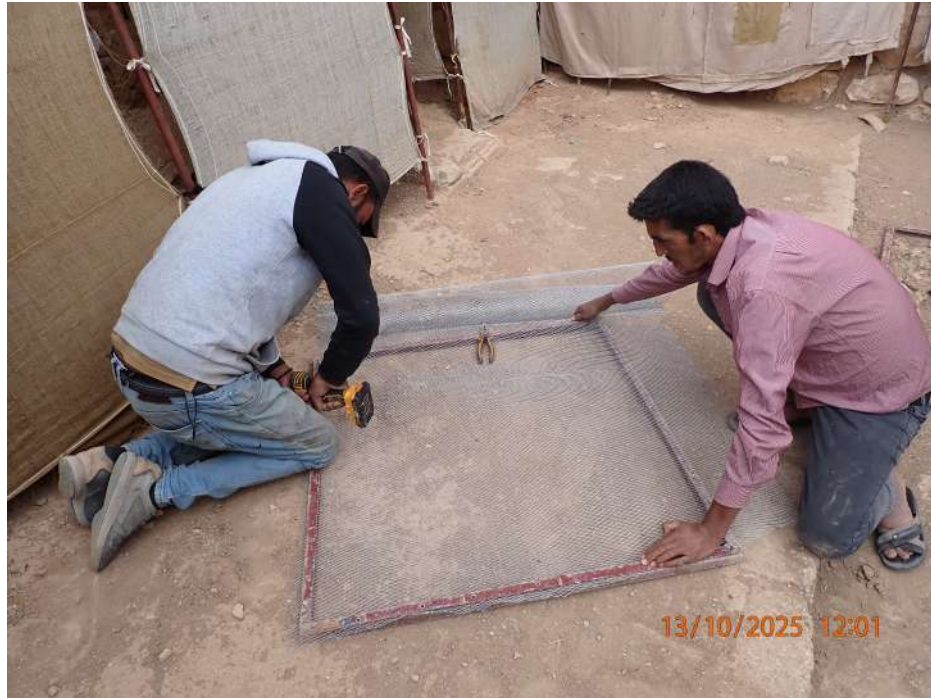
*Figure 21: Image showing the installation of the new mesh on the drainage frames*

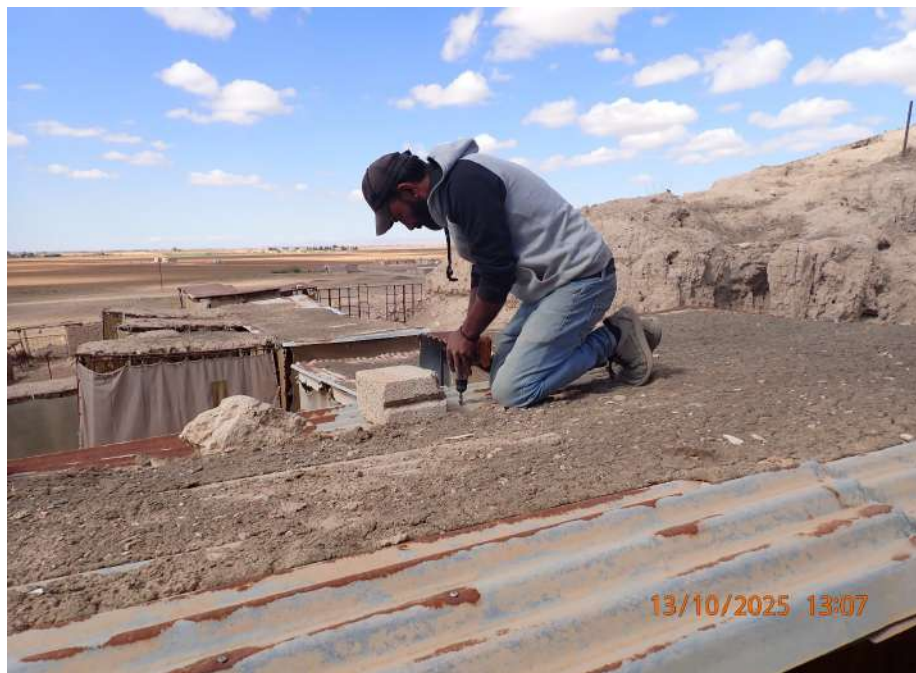
It was observed that the sheets (tutiya) on the protective systems above Wall D1-1 were not properly secured, or the bolts may have been removed from their positions. This situation exposed the sheets to potential displacement due to strong winds, which could result in their falling or in the dislodgment of the cement blocks placed above them for stabilization. Such occurrences could threaten visitor safety or, at a minimum, leave the wall exposed without protection against weather conditions.

*Figure 22: Image showing the securing of the tutiya sheets on Wall D1-I*

The tutiya was firmly secured using bolts to prevent any potential fall (Fig. 22). Additionally, the tutiya above Wall E1 was installed and secured (Fig. 23), and one of the missing bolts on the Abi dome was

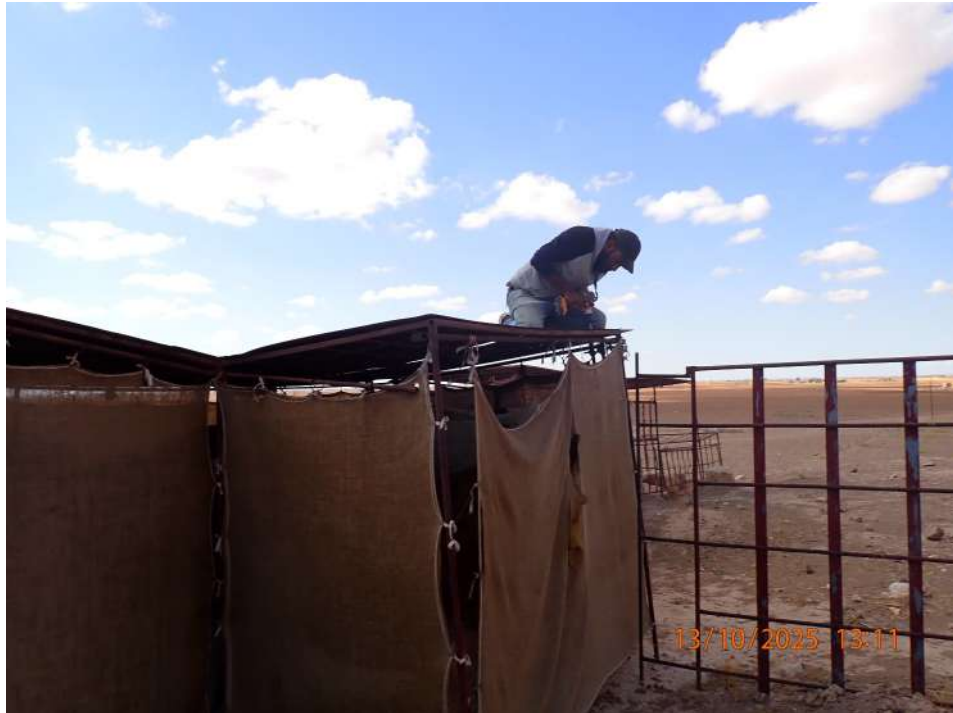
*Figure 23: Image showing the securing of the tutiya sheets on Wall E1*

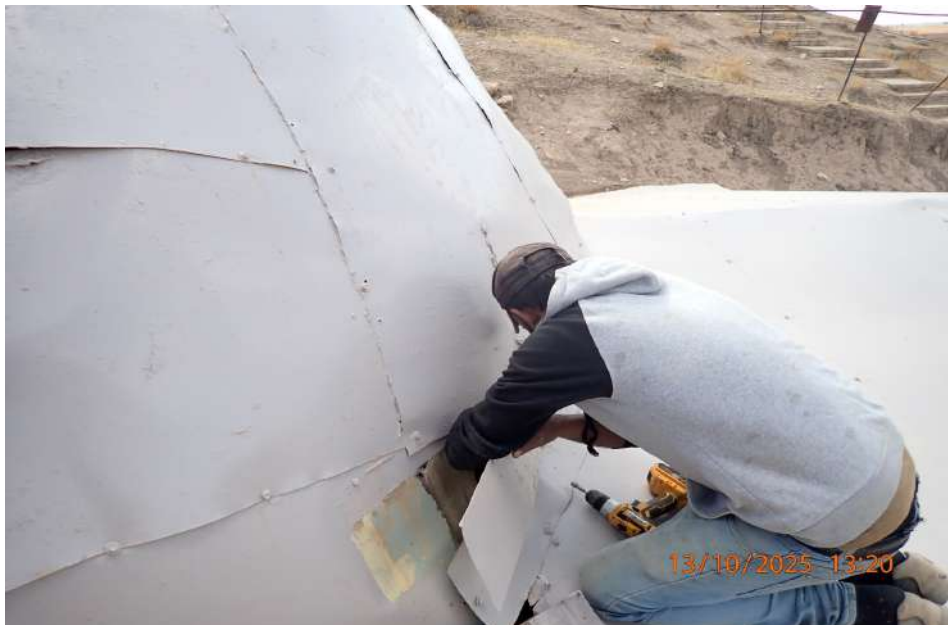
*Figure 24: Image showing the re-installation of a missing bolt on the Abi dome*

reinstalled, as its absence could have caused water leakage into the dome (Fig. 24).

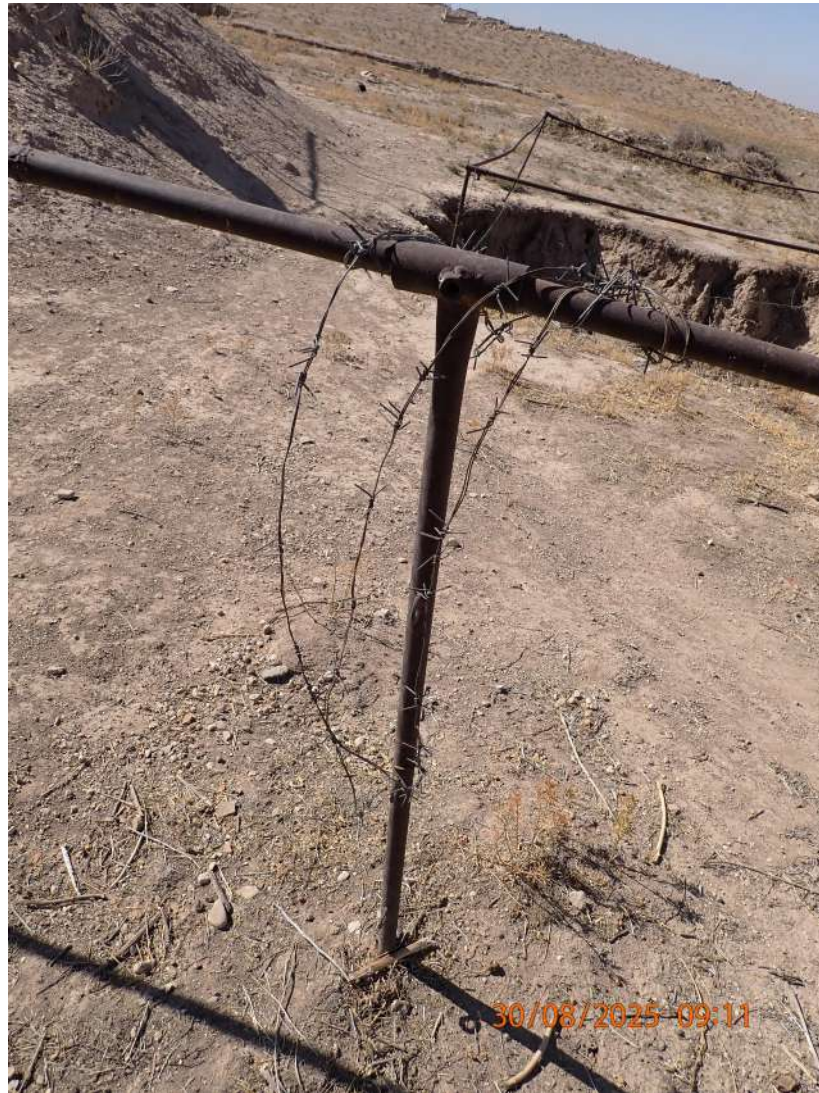
The primary function of the protective barbed wire is to support the iron fence, thereby protecting the excavations and maintaining the visitor pathways. It was observed that some sections of the protective barbed wire installed on the iron fence were deteriorated or not properly secured to the rods (Fig. 25), and other sections were missing in different areas.

*Figure 25: Image showing damaged protective barbed wire*

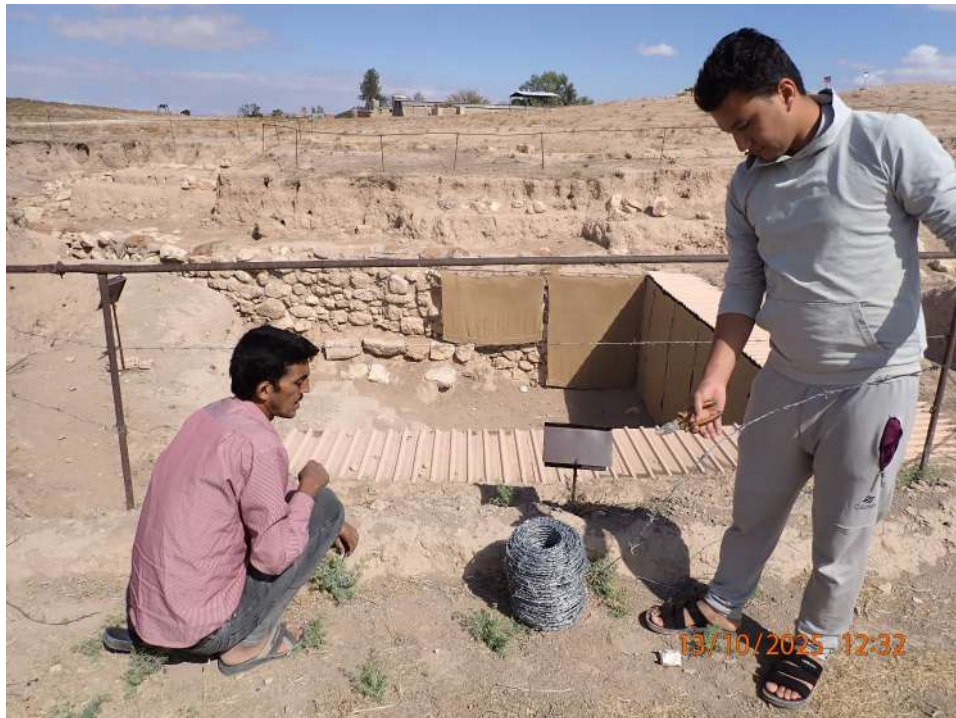
*Figure 26: Image showing the reinstalling of the new protective barbed wire*

To restore protective efficiency, on the second day of work, the intact sections of the wire were reinstalled, and new pieces were added in areas containing deteriorated or missing sections (Fig. 26).

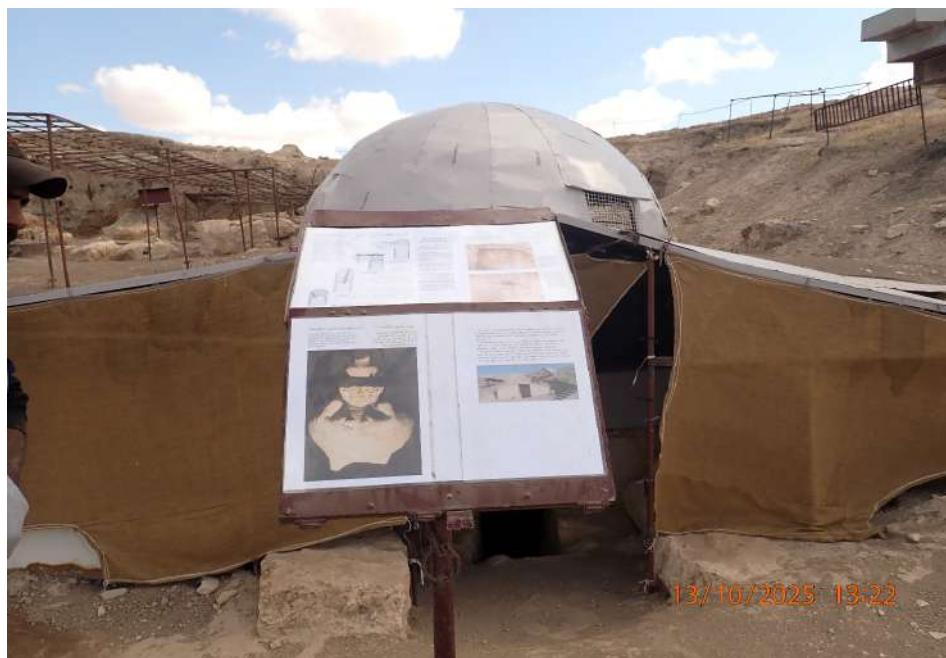
When opened, the Abi panel cover tilted excessively backward, rendering it unstable and inconvenient for display (Fig. 27). To address this, screws were installed at the bottom of the cover to serve as a support (Fig. 28), ensuring that the cover opens evenly and remains stable during use (Fig. 29).

*Figure 27: Image showing the Abi panel cover tilting backward*

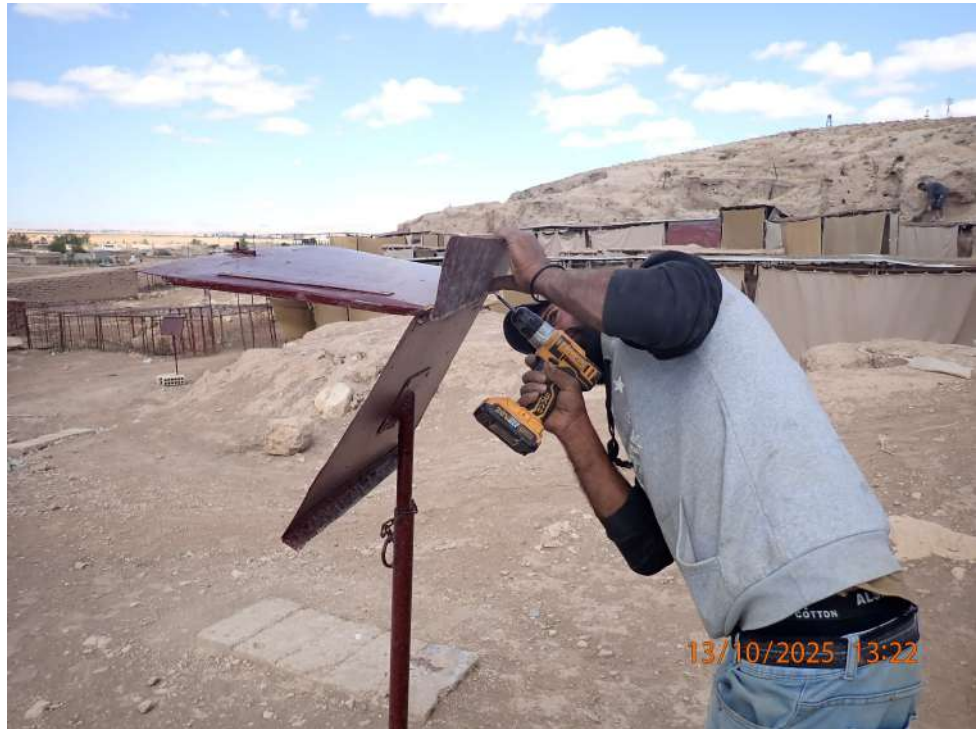
*Figure 28: Image showing the installation of screws at the bottom of the Abi panel cover*

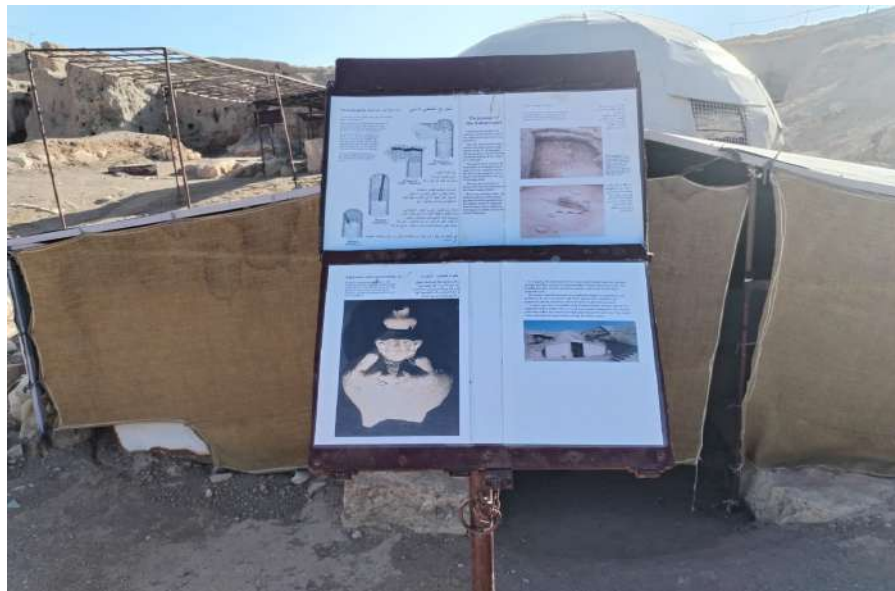
*Figure 29: Image showing the Abi panel after the installation of the support screw for stability*
