# **Plastering of the Protective System**

**Amer Ahmad**

**18.11.2025**

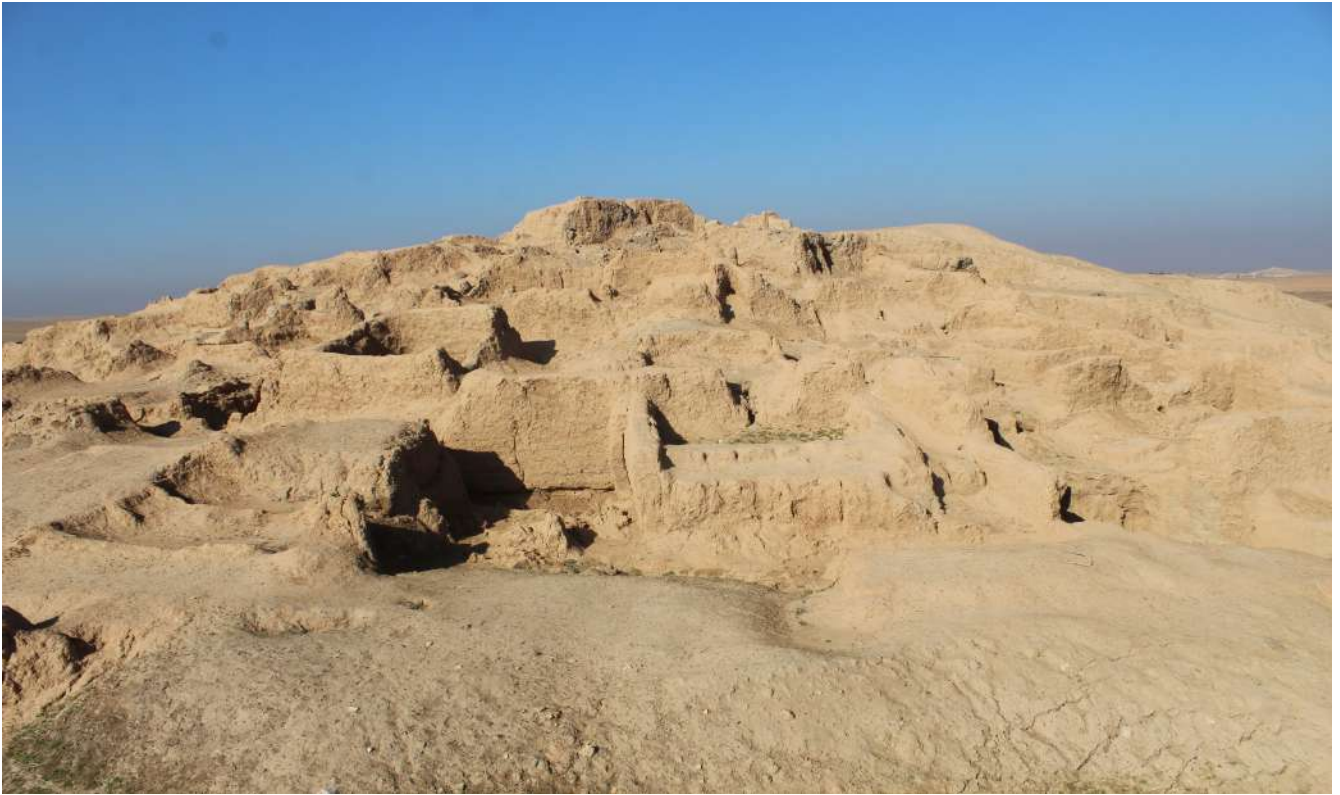
Erosion caused by rain and wind gradually removes the upper layers of soil, leaving the underlying architectural remains increasingly vulnerable to damage (Fig. 1).

*Figure 1: An image illustrating the impacts of weathering on the Tell Khazna excavations*

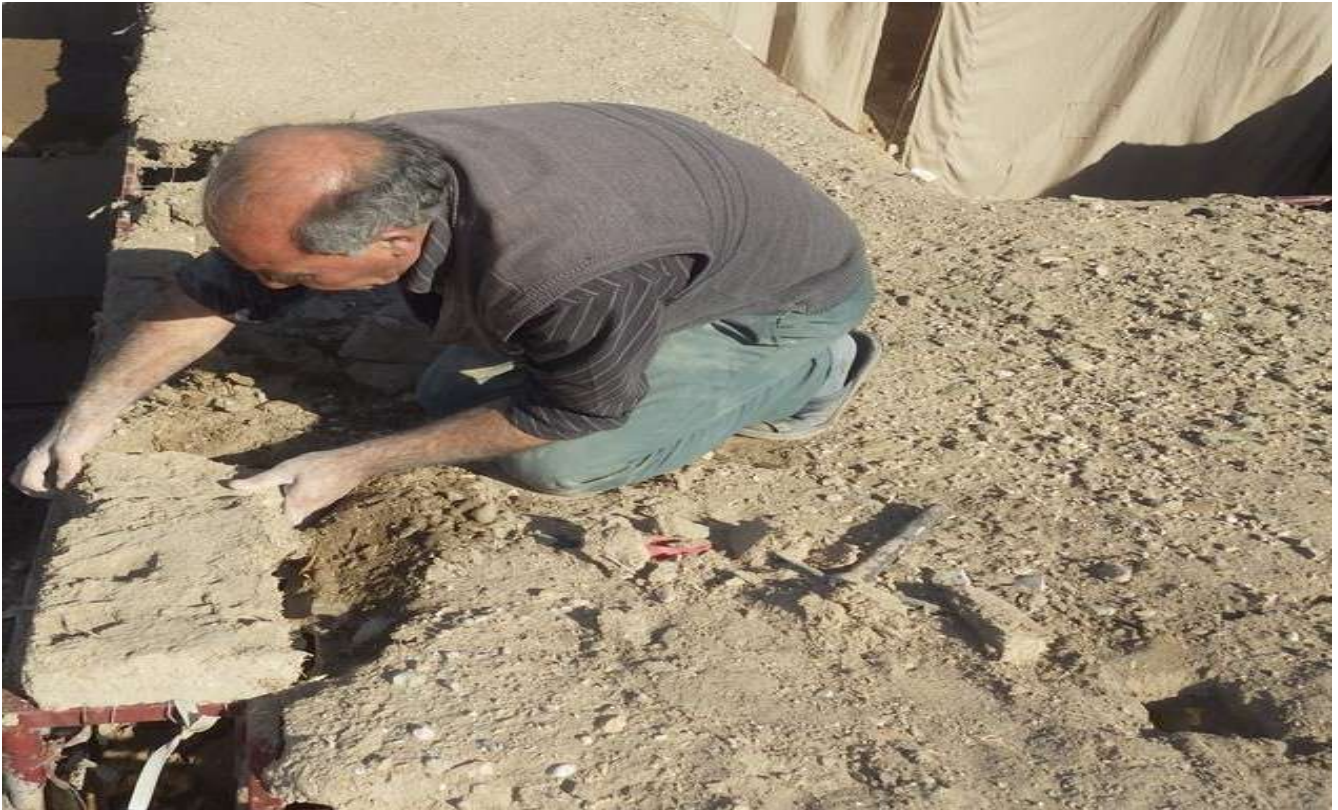
*Figure 5: Sealing the gaps on the surfaces of the protective systems*

Since the mission physically left the site, routine maintenance continued regularly. Damaged areas of the protective system were repaired using mud plaster. This included sealing gaps caused by weathering (Fig. 5), and occasionally reapplying thin surface layers of plaster (Fig. 6), the most recent of which occurred in 2021. Over time, large sections of the mud plaster became fragile and detached, diminishing its protective function (Fig. 7). The underlying fabric (burlap) also showed signs of deterioration in certain areas (Fig. 8), while in others the mud plaster appeared patchy and inconsistent—containing voids—particularly in sector H (Fig. 9).

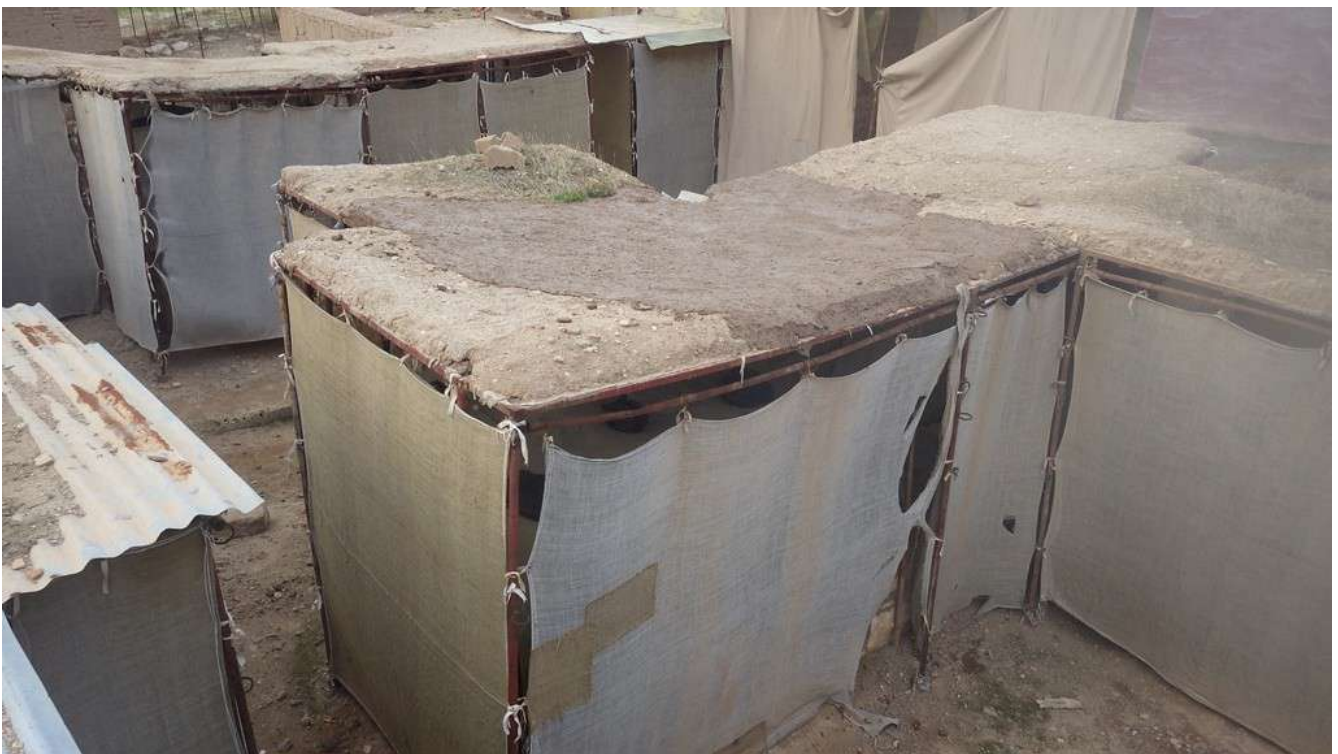
*Figure 6: Reapplying thin surface plaster layers to the protective system surfaces*

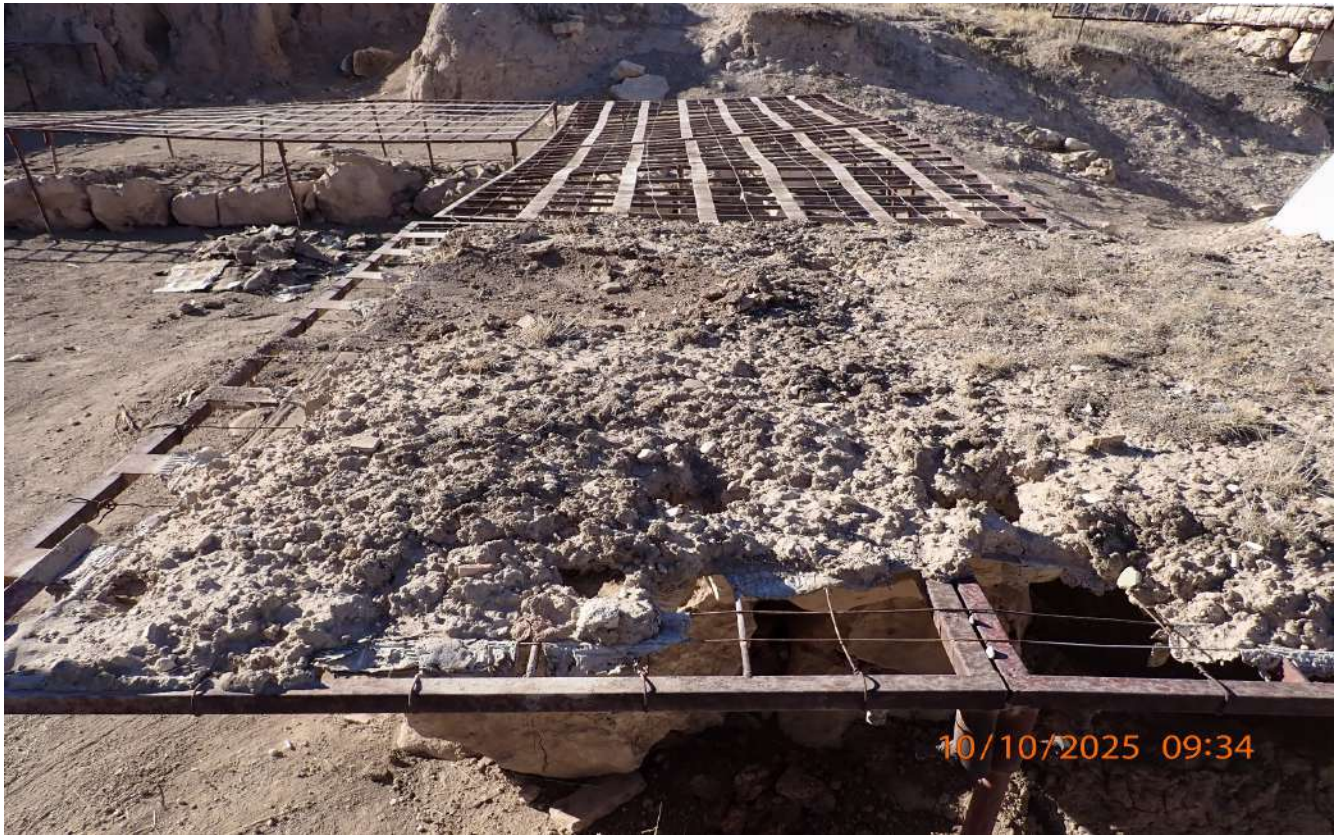
*Figure 7: An image showing the fragile and detached mud plaster*

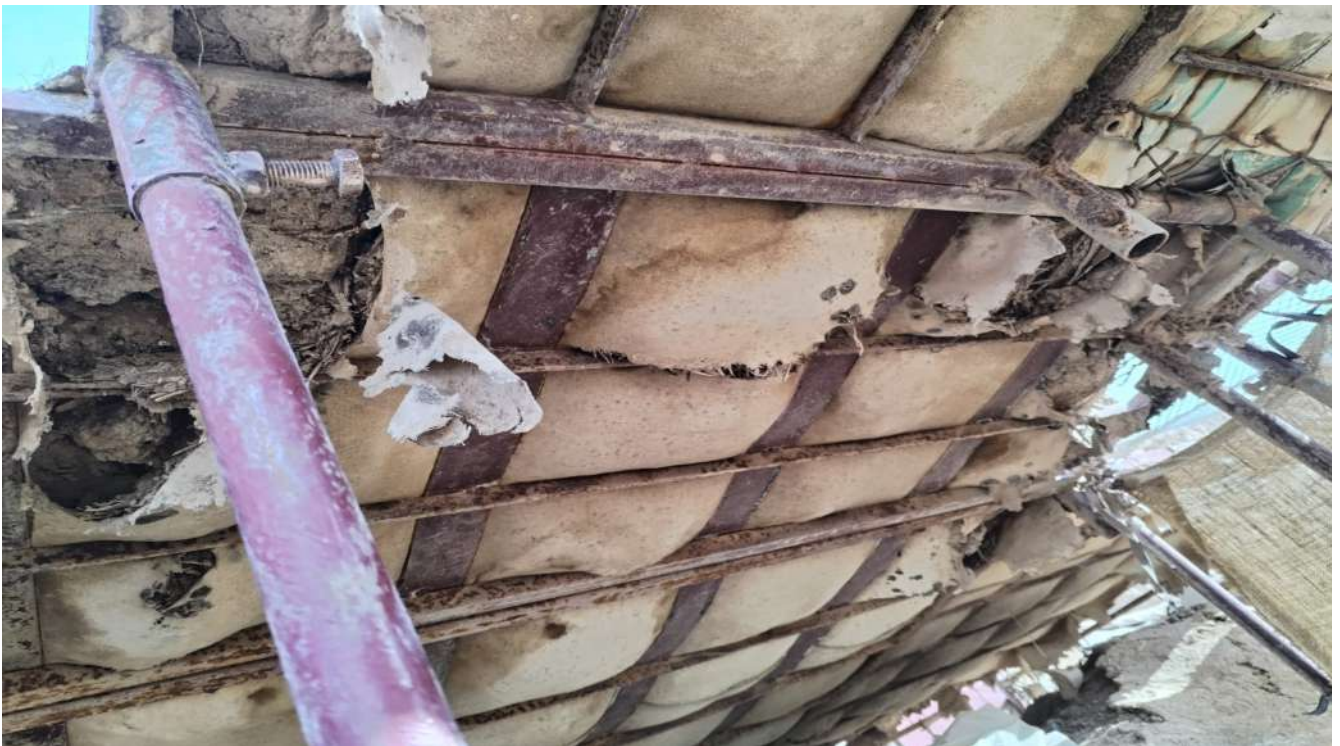
*Figure 8: An image illustrating signs of deterioration in the burlap*

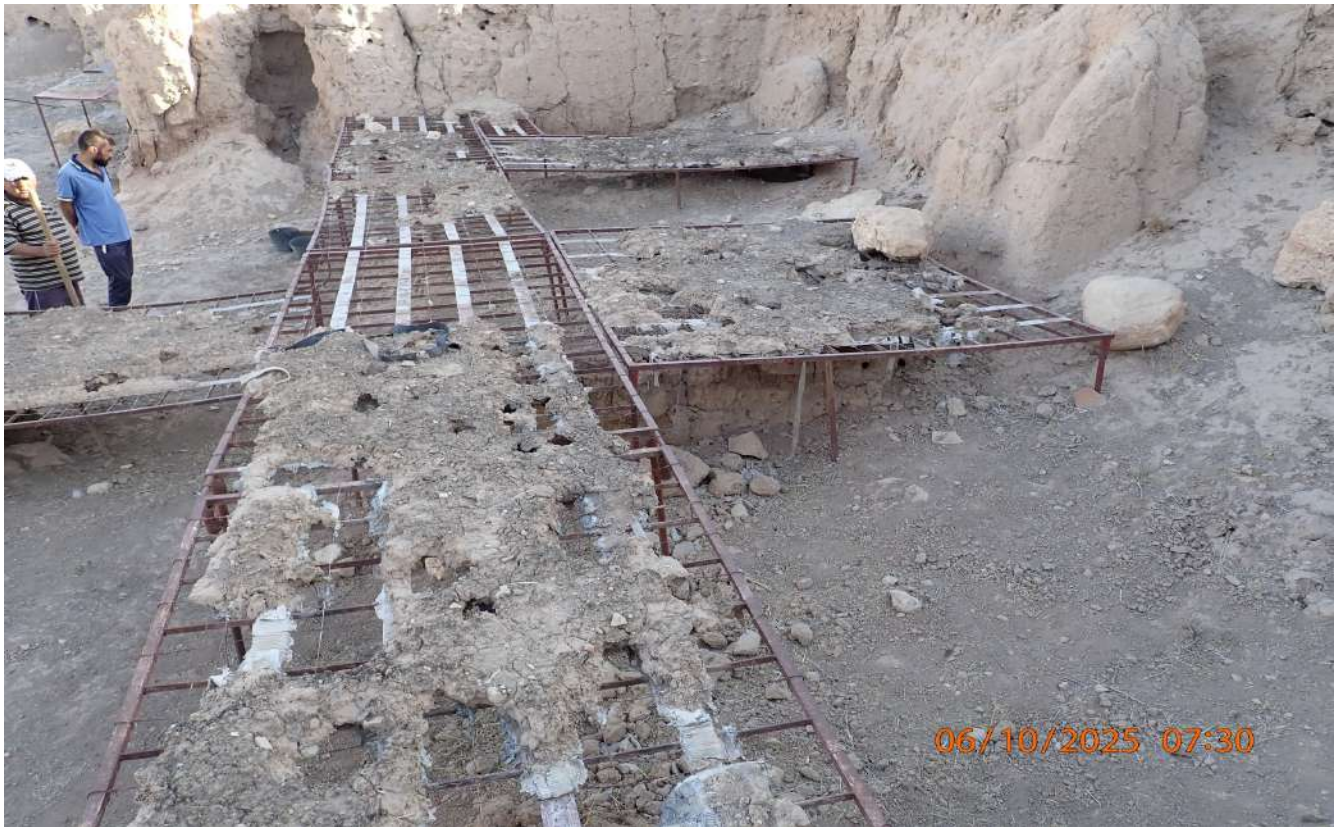
*Figure 9: Patchy and inconsistent mud plaster on protective shelters in sector H*

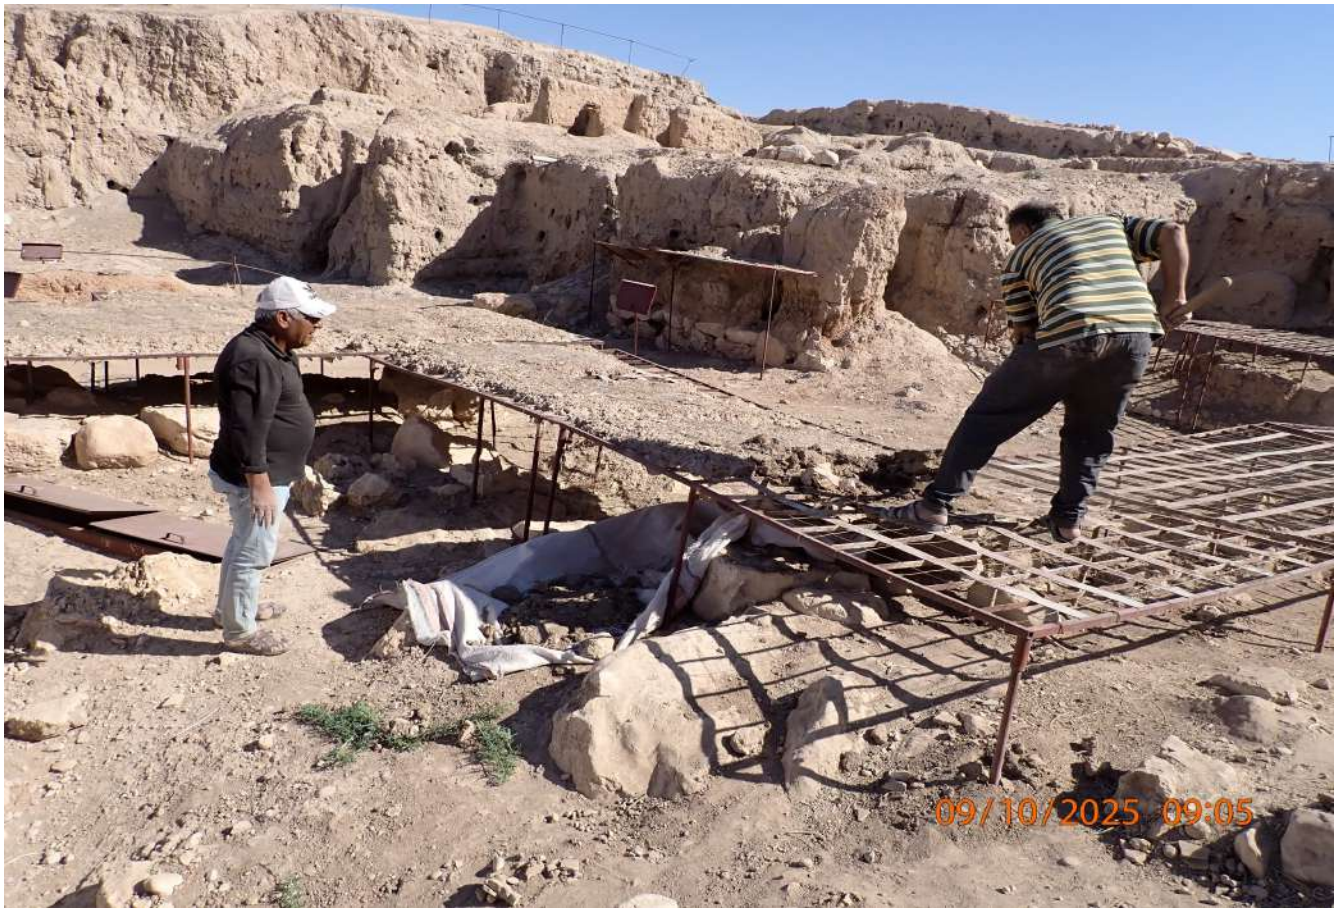
*Figure 11: Removal of the fragile and deteriorated mud plaster*

The work area consisted of two main sections: Sector H and the service wing sectors. Work began in Sector H before progressing to the other sectors. The process involved the removal of all fragile and deteriorated mud plaster (Fig. 11), which resulted in debris accumulating at the base of the walls and on the room floors (Fig. 12). The debris was collected (Fig. 13) and transported away from the excavation areas (Fig. 14) for disposal at a more distant location later.

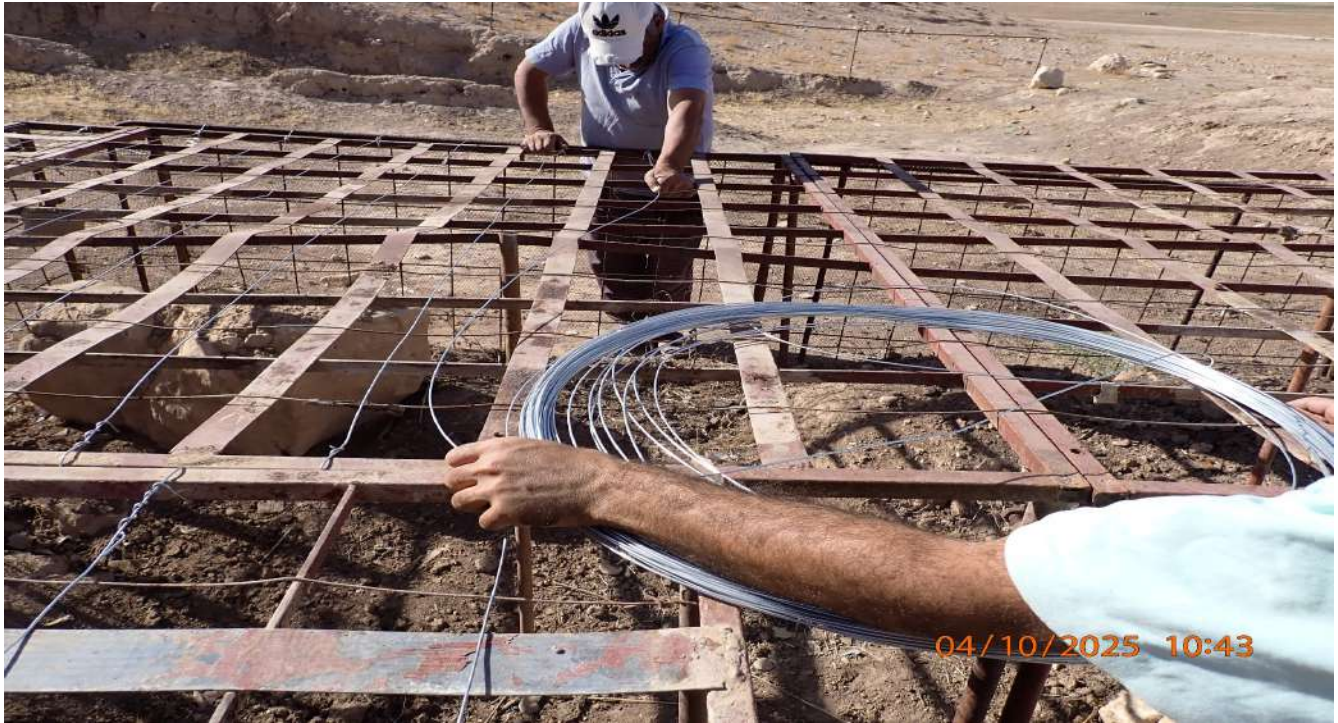
*Figure 15: Metal wires installation*

Additional metal wires were installed in areas requiring reinforcement (Fig. 15), followed by the placement of plastic sheet (Fig. 16) of the type commonly used locally to cover mud-brick houses (Fig. 17). A layer of cardboard was then added to reduce pressure on the plastic sheet and wires (Fig. 18) and to prevent clay blocks from slipping through lower openings.

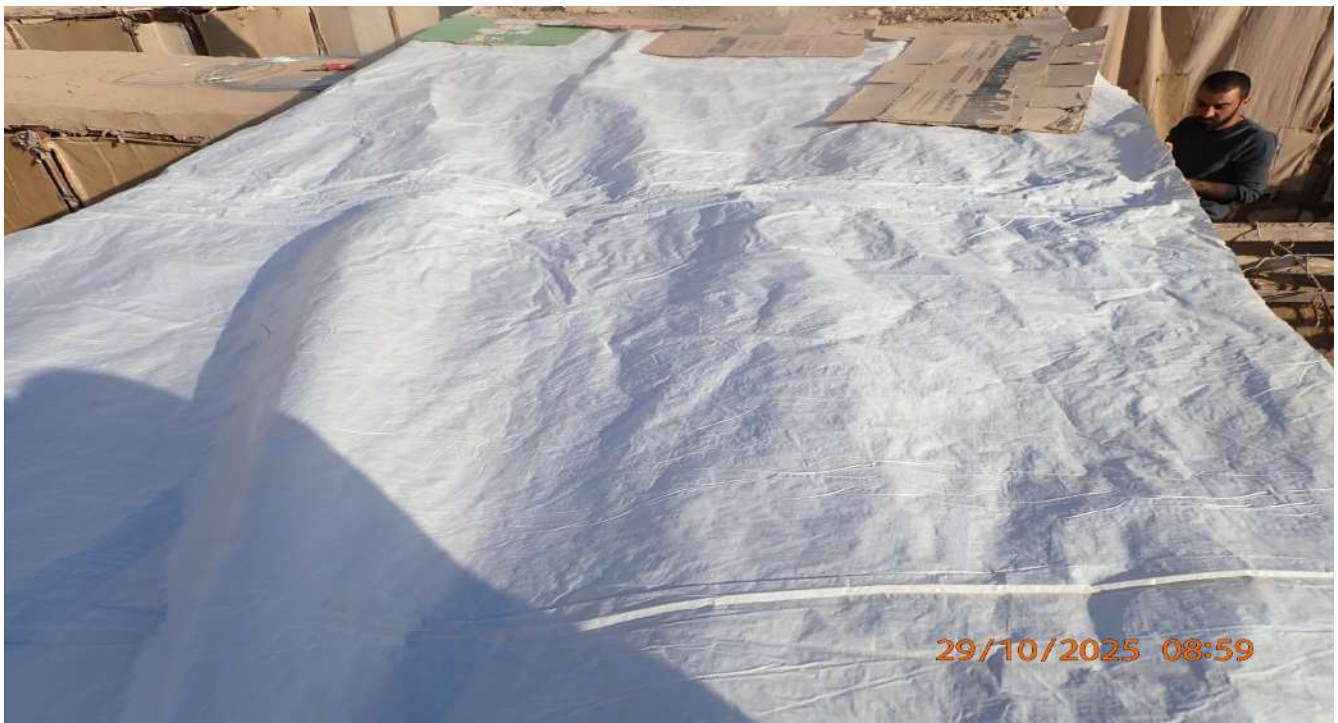
*Figure 16: Placement of plastic sheet*

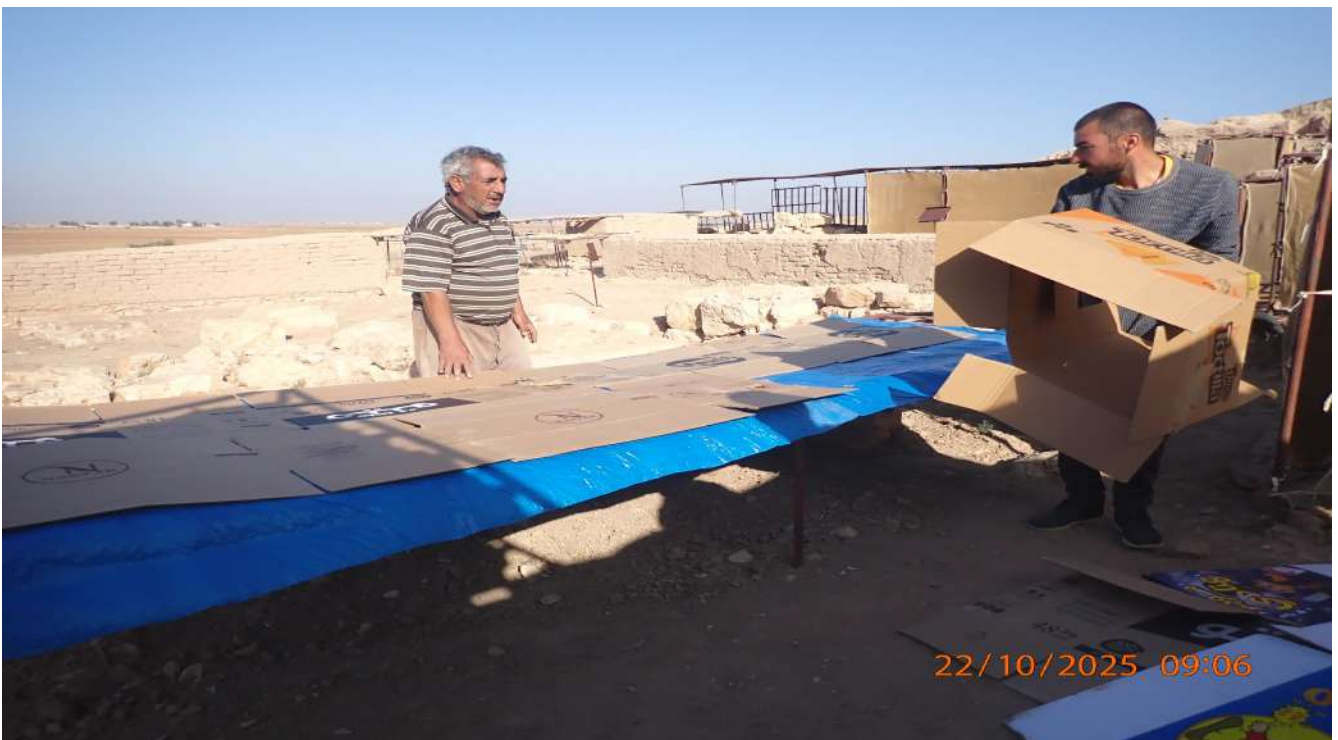
*Figure 18: Adding cardboard layers*

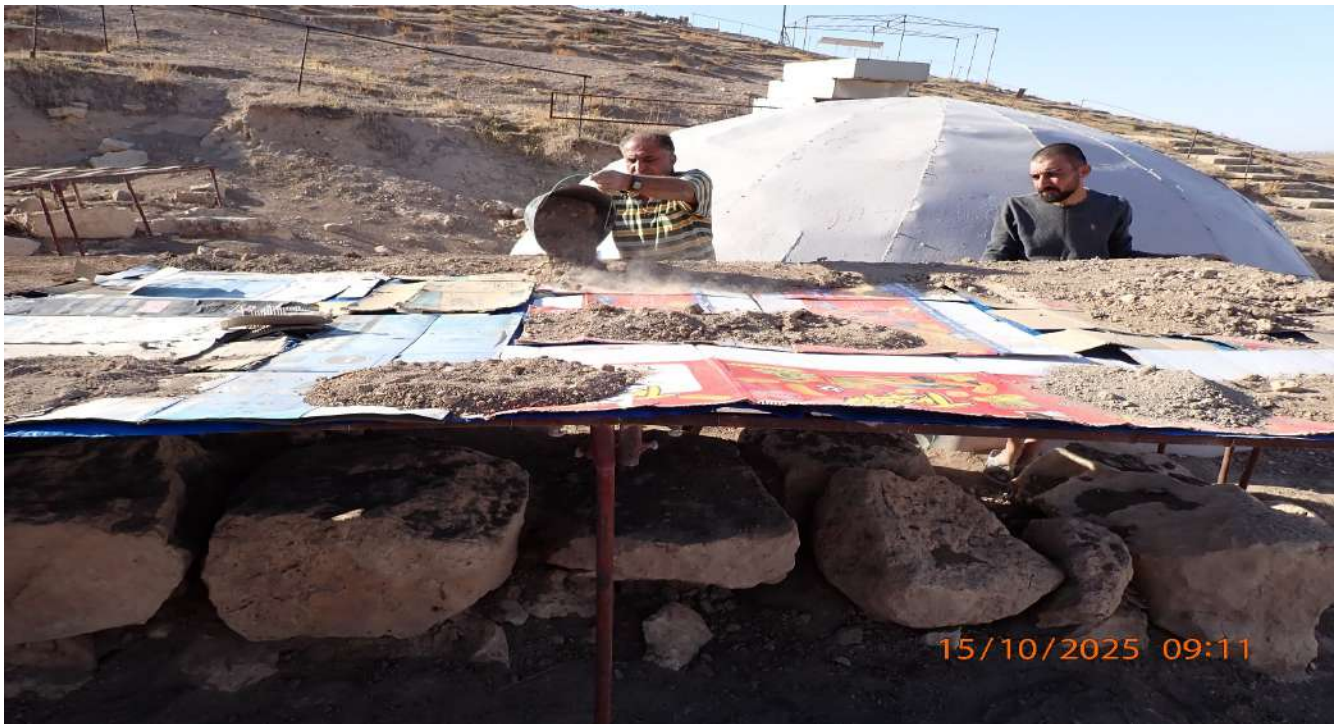
*Figure 19: Applying a layer of soil from the old mud plaster*

Subsequently, a layer of soil from the old mud plaster was applied (Fig. 19). Due to the fragility and deterioration of the old plaster, it was not used in its entirety. Additionally, excessive weight on the surfaces could cause the metal rods to bend, as observed in one of the rods at the opening of the south wall of Room C3 (Fig. 20), or lead to the lowering of the sheet metal (*tutiya*), which came into direct contact with the wall, as seen in Wall F1-4 (center) (Fig. 21). Although a blacksmith had previously been present on-site, the rods were not adjusted in order to avoid any unintended damage to the protective structure.

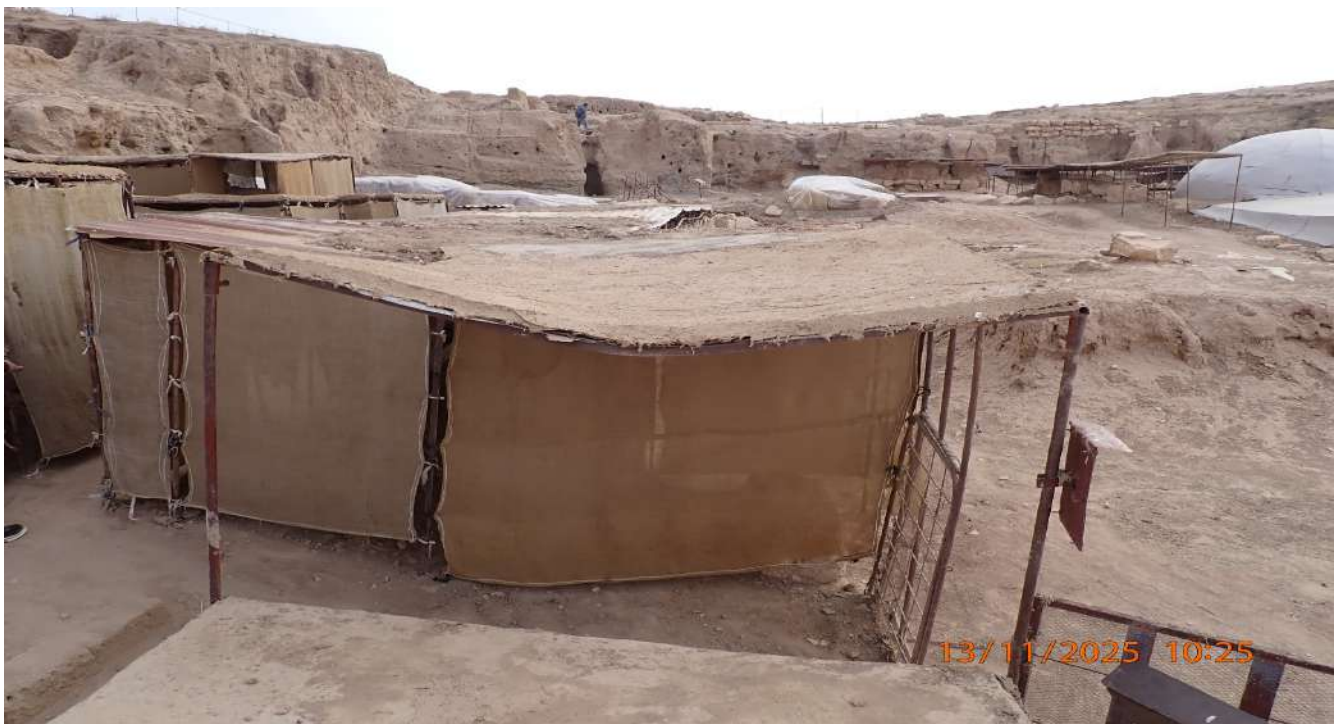
*Figure 20: Bent metal rod at the opening of the south wall of Room C3*

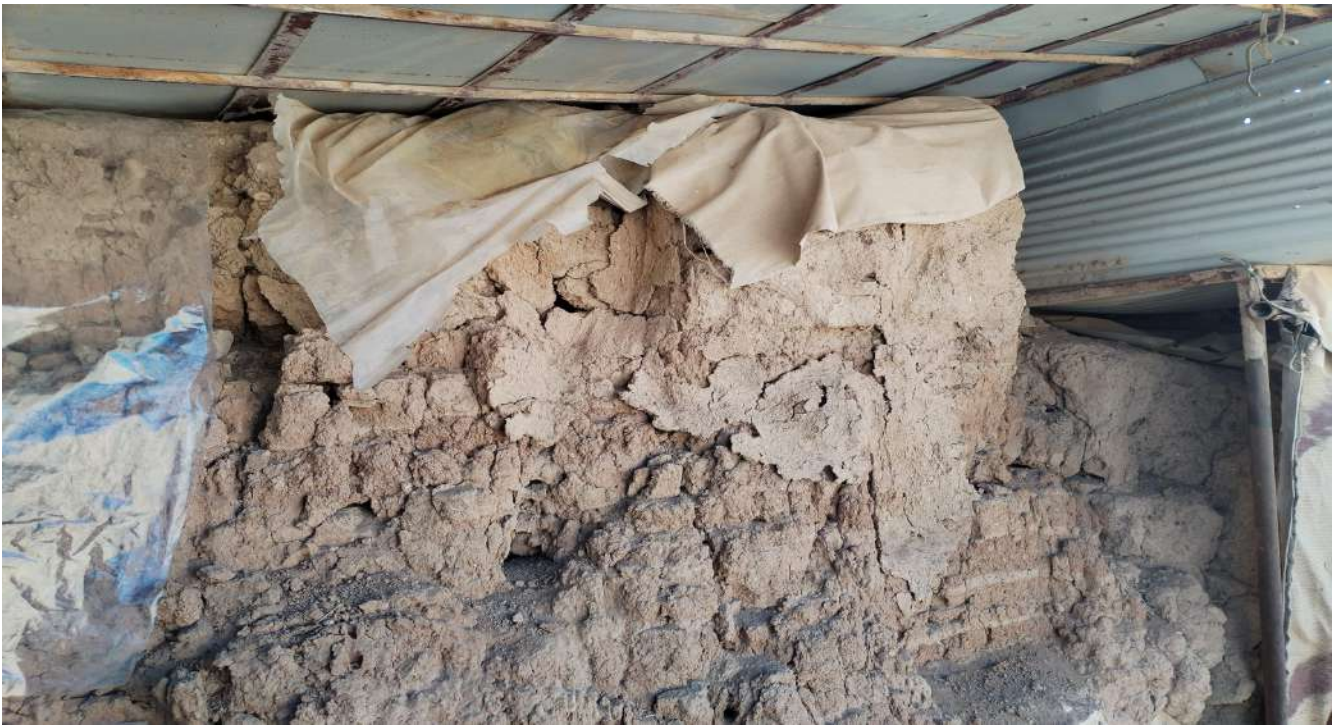
*Figure 21: Contact of the sheet metal (tutiya) surface with the top of Wall F1-4 (center)*

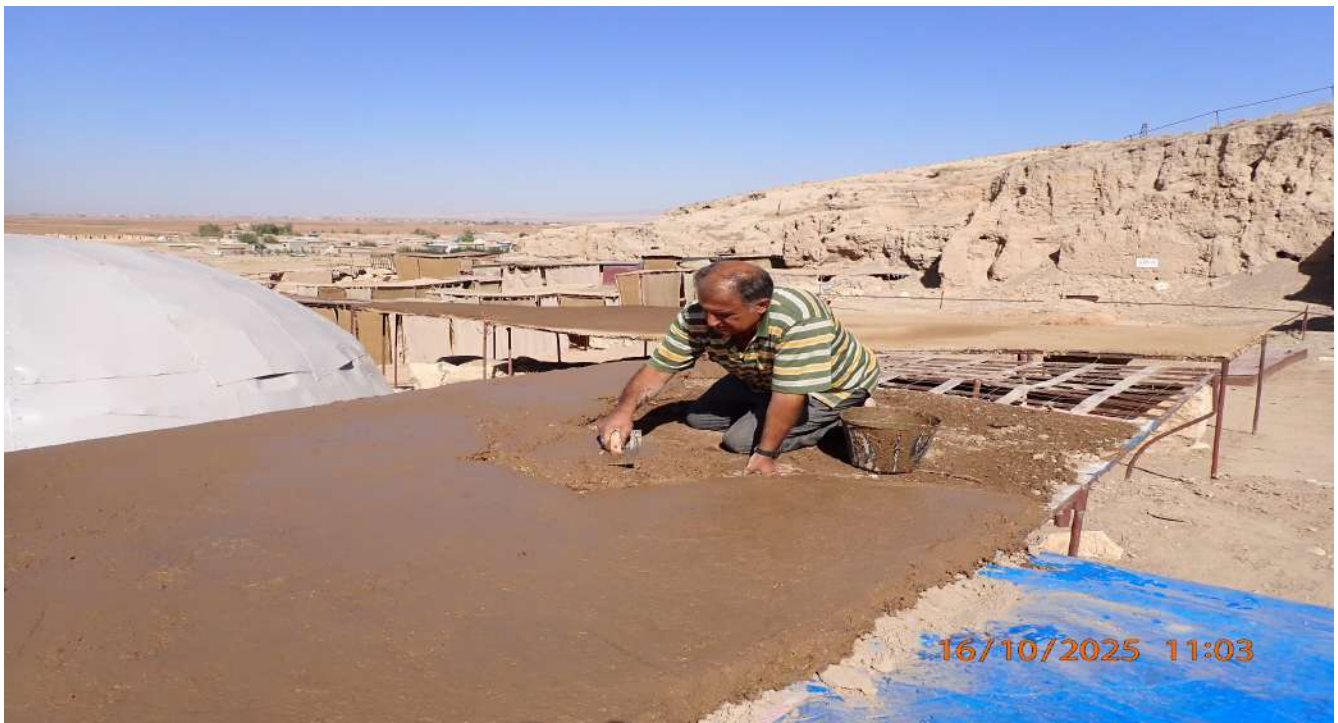
*Figure 24: Application of a thick plaster layer*

Once the surfaces were prepared, the soil was moistened to ensure adhesion with the new mud plaster (Fig. 22). The mud plaster was then prepared (Fig. 23), and a thicker-than-usual plaster layer was applied (Fig. 24), as traditional plaster layer is typically thin.

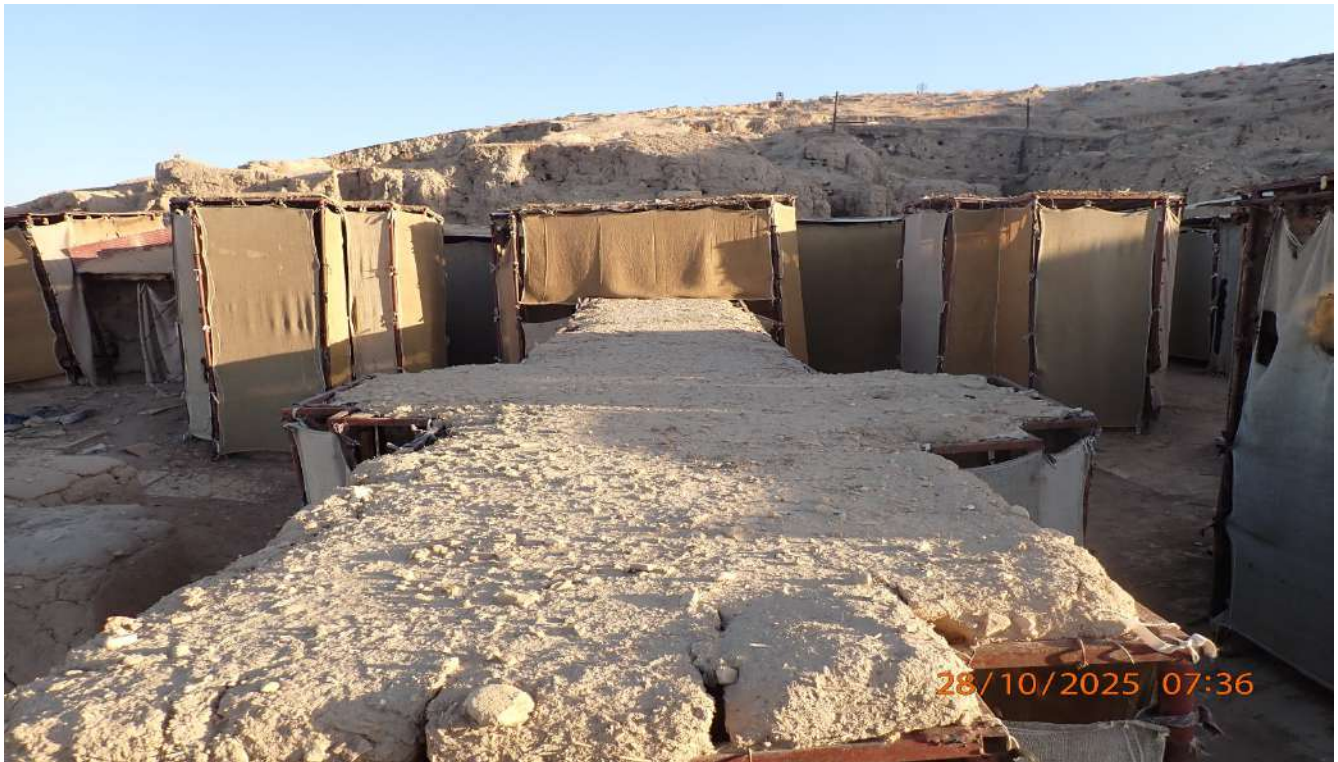
The mud plaster condition in the service wing was found to be better than in sector H (Fig. 27). The workers proposed limiting the intervention to filling weather-related gaps and applying a thin mud plaster layer without fully removing the old one, as had been done previously. This was tested on two walls (Fig. 28), where the protective

*Figure 27: Mud plaster condition in service wing*

Nonetheless, I determined that the optimal choice was to remove all old mud plaster and reapply it from scratch, despite workers' assurances that partial intervention would be sufficient. After consulting with the team and directors, it was decided to remove all old mud plaster before applying the new layers.

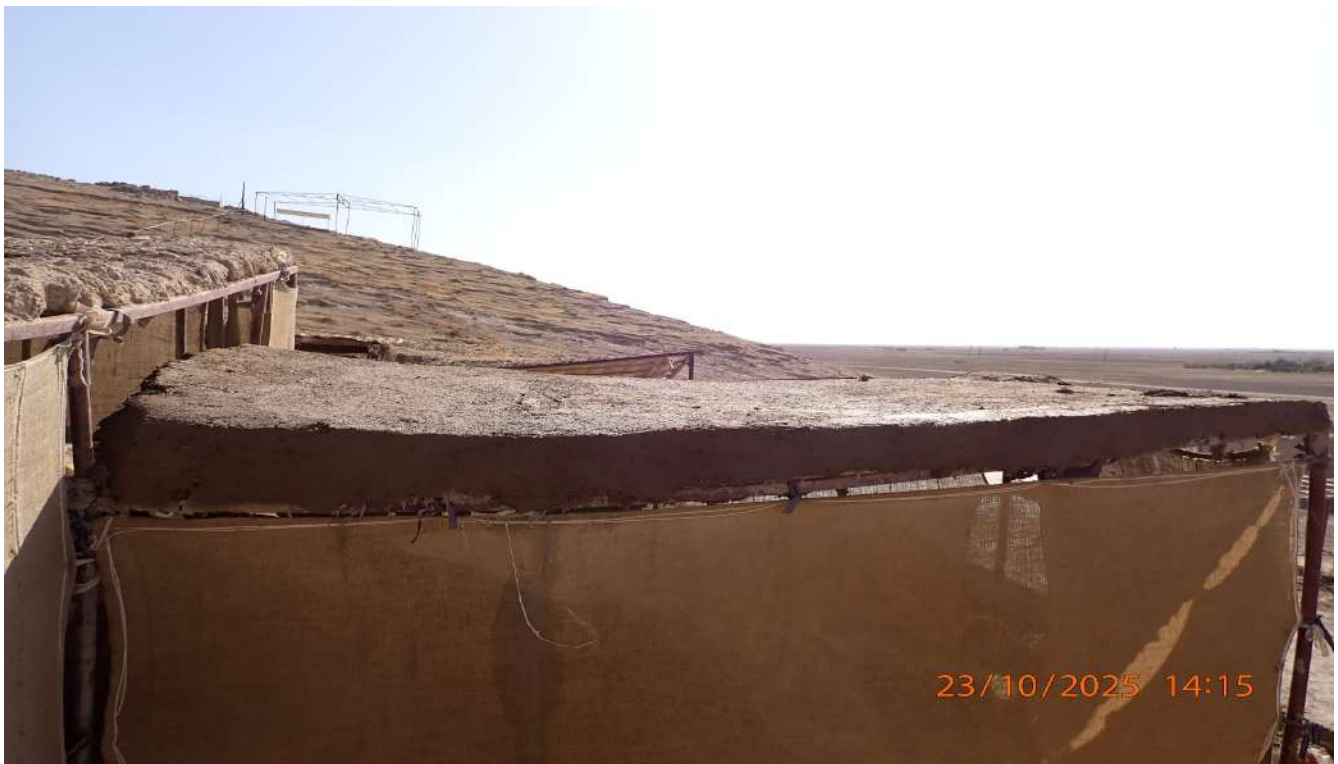
*Figure 28: Applying thin mud plaster on the protective system of one wall without removing the old plaster*

surfaces were plastered without removing the previous layers. These will be monitored during winter to assess the effectiveness of this approach.

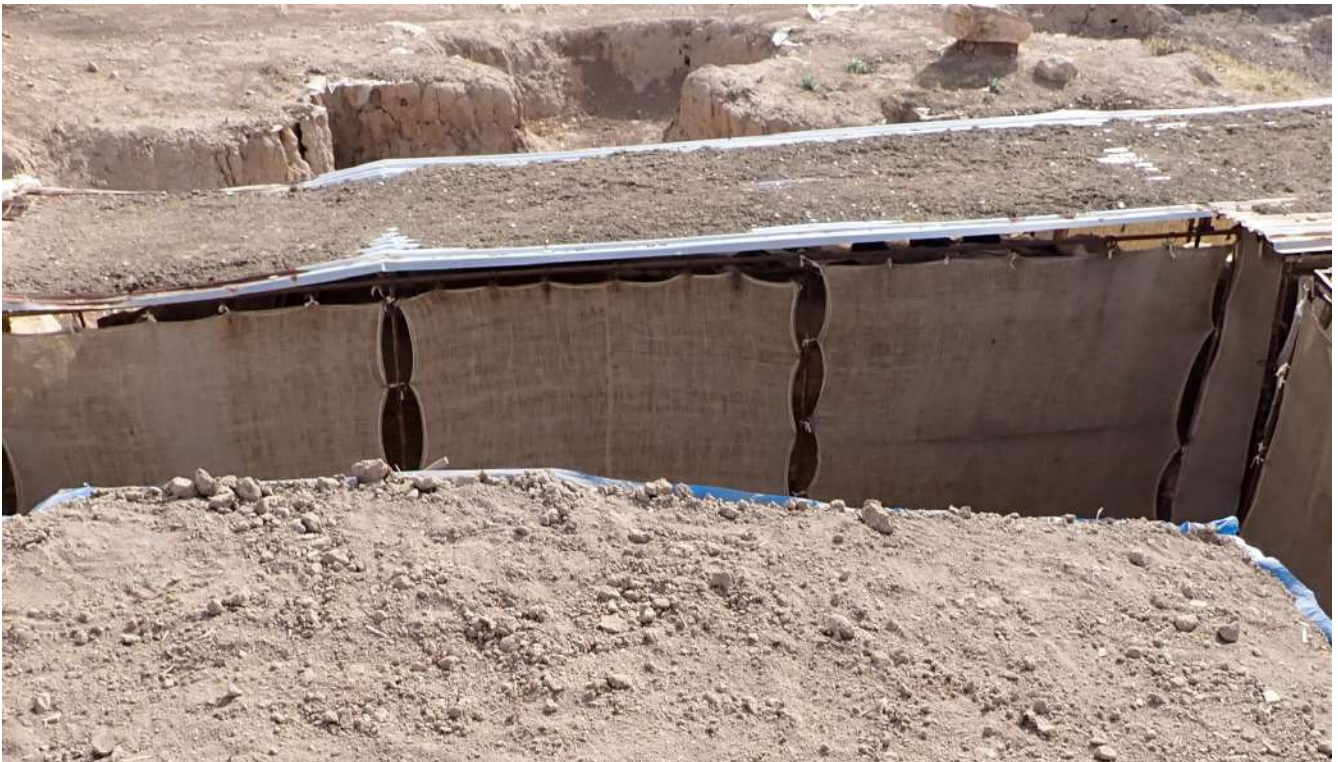
Some protective systems in the service wing are covered with sheet metal (tutiya) (Fig. 29). After evaluation, it was concluded that mud plaster should not be applied over the sheet metal (tutiya). Instead, a nylon layer directly on the walls is sufficient and should be monitored during the winter. Mud plaster does not adhere well to sheet metal (tutiya) surfaces, and moisture retained by clay can cause rust and deterioration beneath the plaster.

*Figure 29: Protective systems in the service wing covered with sheet metal (tutiya)*

Therefore, if a more visually coherent appearance is desired, the sheet metal (tutiya) may be painted with an earthy color similar to the walls. This ensures both visual harmony and effective protection against corrosion. Additionally, the gaps created by overlapping the sheet metal—as well as the existing holes—were sealed with silicone to prevent water leakage (Fig. 30).

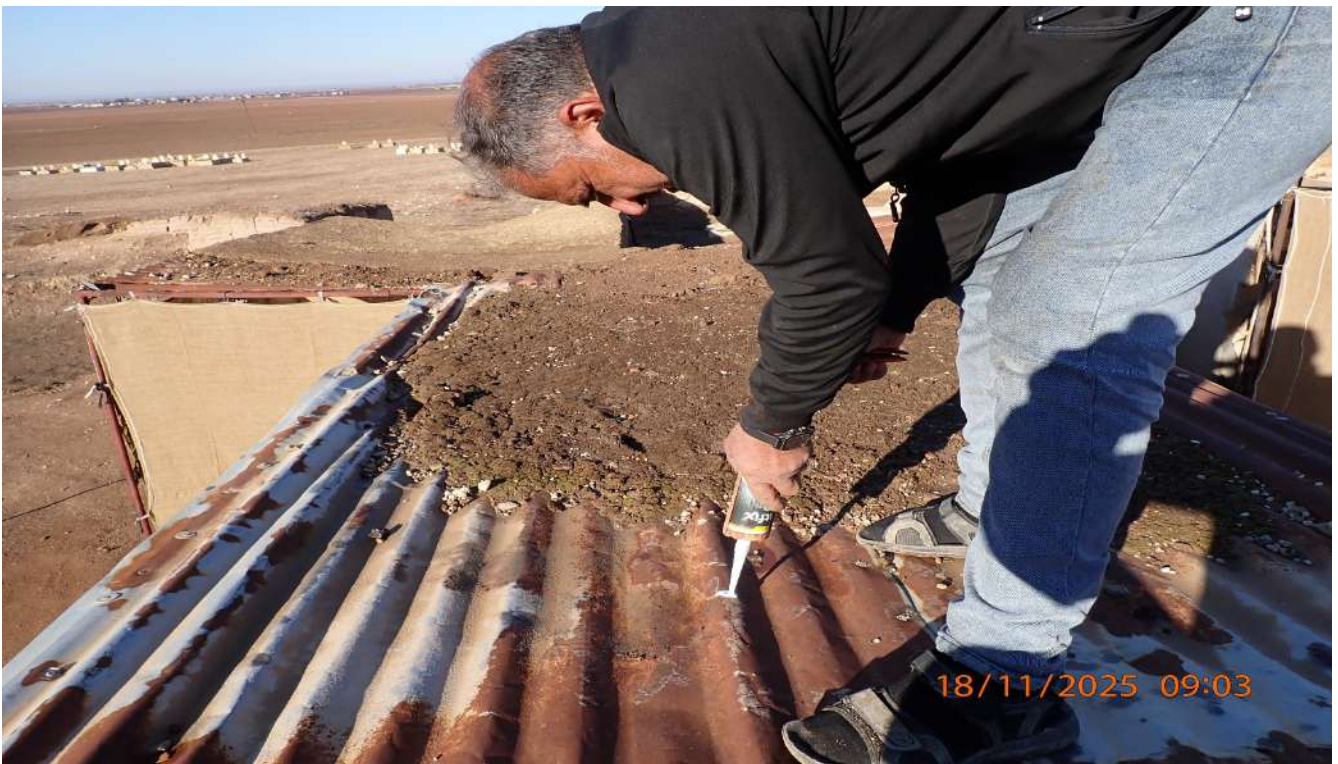
*Figure 30: Sealing gaps and existing holes in sheet metal (tutiya) with silicone*

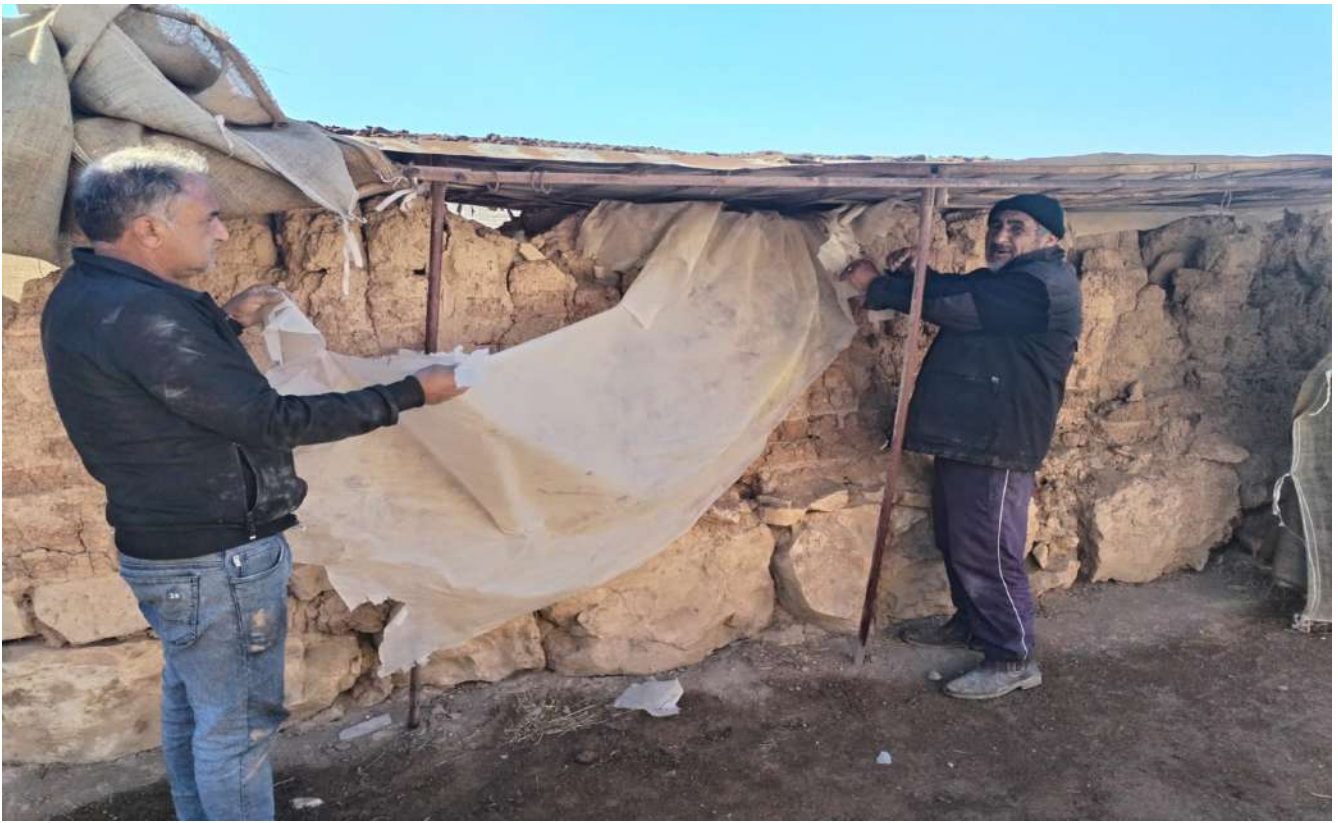
Alongside replacing deteriorated burlap in the palace area as part of the general maintenance plan, the plastering process constitutes the first phase of a broader conservation program. The second phase will involve a detailed assessment of the condition of the walls, followed by an evaluation of the nylon coverings and their replacement when necessary as part of the third phase, as the nylon has become brittle and cracks easily (Fig. 31).

*Figure 31: Torn and worn nylon over the walls*
