# **Urgent Interventions in Areas J5, A17, and J6**

## **Introduction**

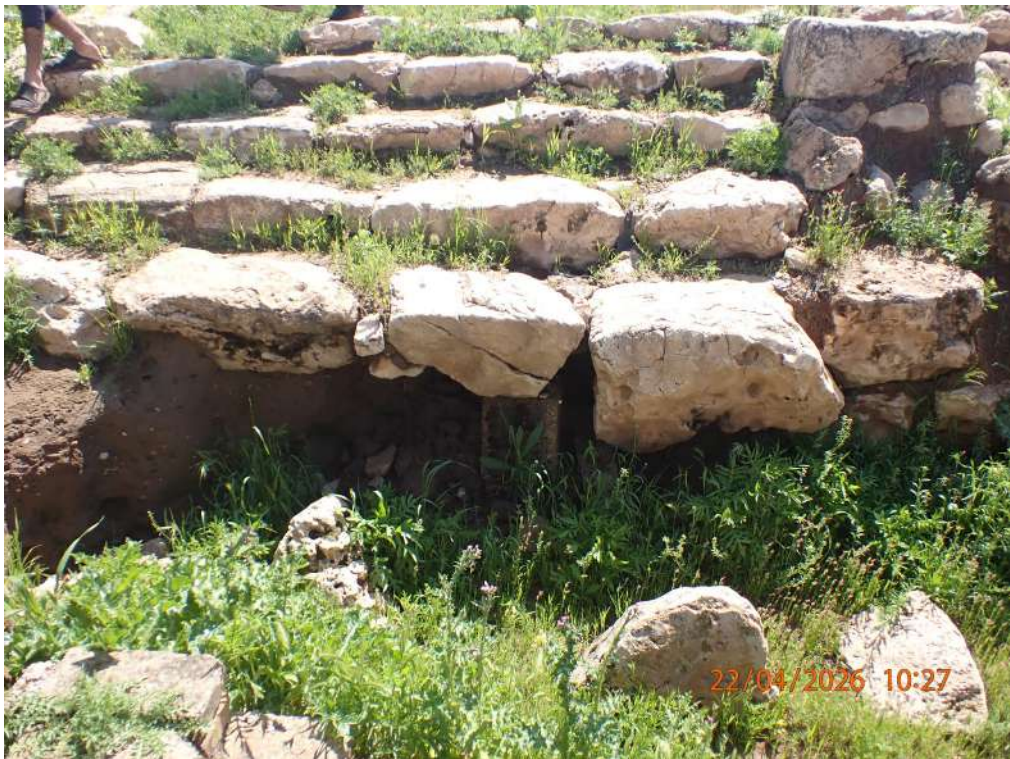
Fig. 1

In Area J5, it was observed that two large stones forming part of the temple terrace wall had become unstable (Fig. 1), making them vulnerable to displacement from their original positions. In Area A17 (Fig. 2), rainwater runoff caused erosion of the topsoil layer, resulting in the exposure of the tannur walls (Fig. 3).

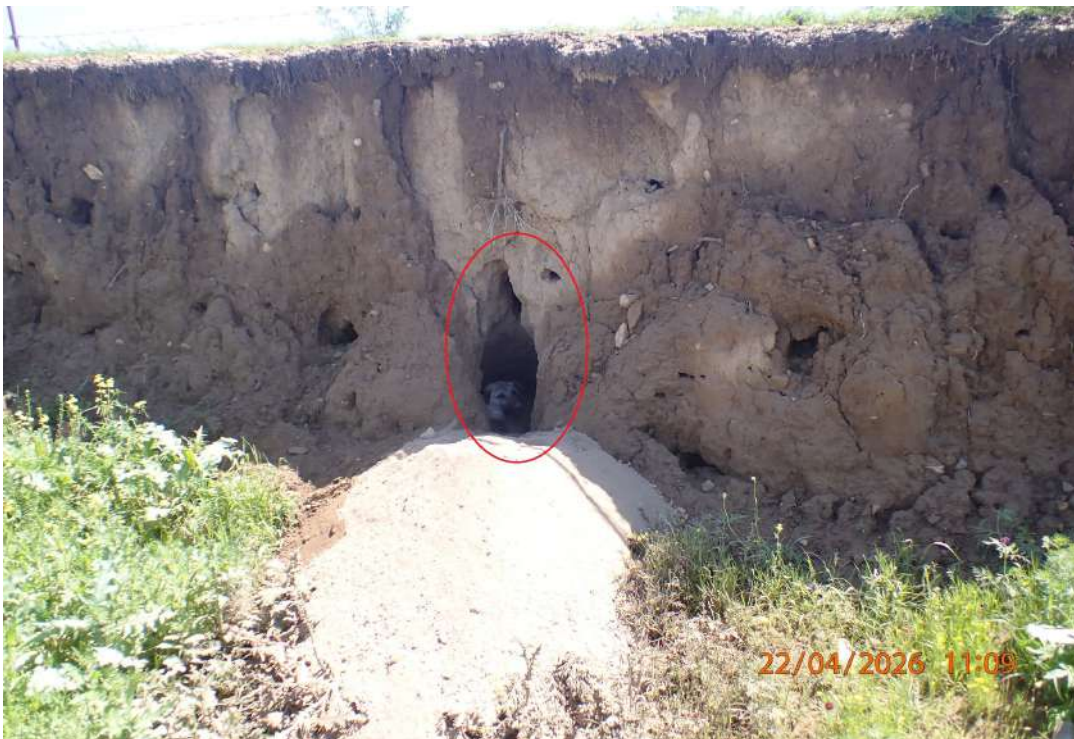
*Fig. 14*

In Area J6, it was observed that a dog had excavated a hole in the eastern section and used it as a shelter from the rain (Fig. 14). The hole was backfilled and the soil returned to its original position (Fig. 15). No archaeological finds were identified within the redeposited soil.

However, this measure may not be entirely effective, as the animal is a pregnant female and is likely to return to the same place to establish a shelter, which may lead to recurrence of the issue in the future, and possibly bring along some “young guests” to the site.
