# **Conservation Works at Tell Mozan / Urkesh – 2025**

**Amer Ahmad**

**August 2026**

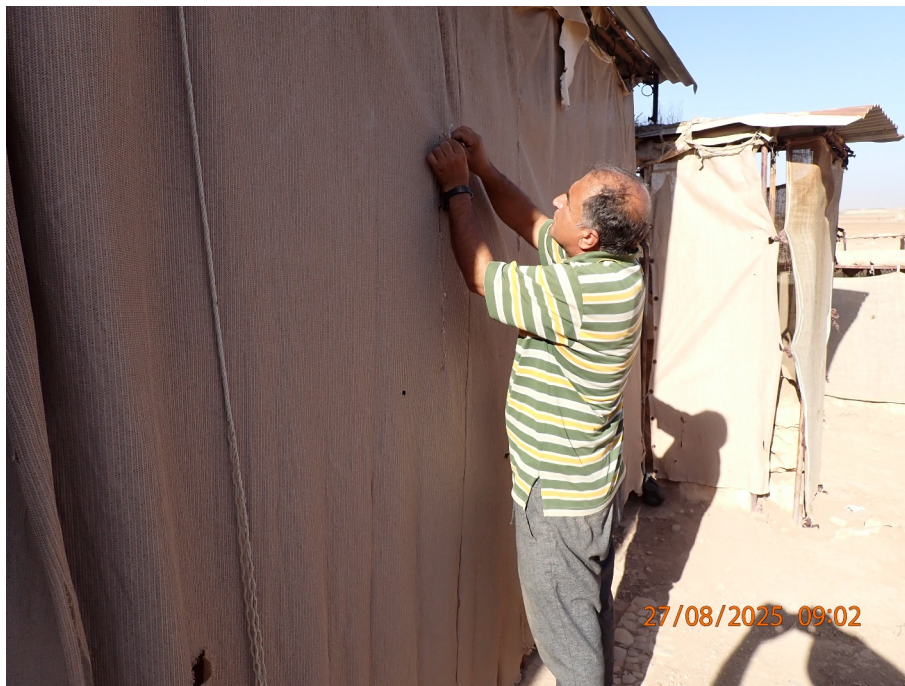
*Fig. 1: Stitching of the Burlap in the Palace Area*

These works differ from the routine activities that are continuously carried out at the site, such as cleaning, maintenance of the burlap used to protect the palace walls (Fig. 1), preparation of the annual general report on the condition of the walls, as well as removal of weeds (Fig. 2), and other routine maintenance activities. In addition to these daily routine activities, a number of maintenance, rehabilitation, and intervention works on the protective systems and metal elements were carried out at the site during 2025. These works aimed to preserve the archaeological remains, enhance visitor safety, ensure the continued efficiency and effectiveness of the protective systems surrounding the archaeological structures and walls, and reduce the impact of factors that could lead to their deterioration or put them at risk.

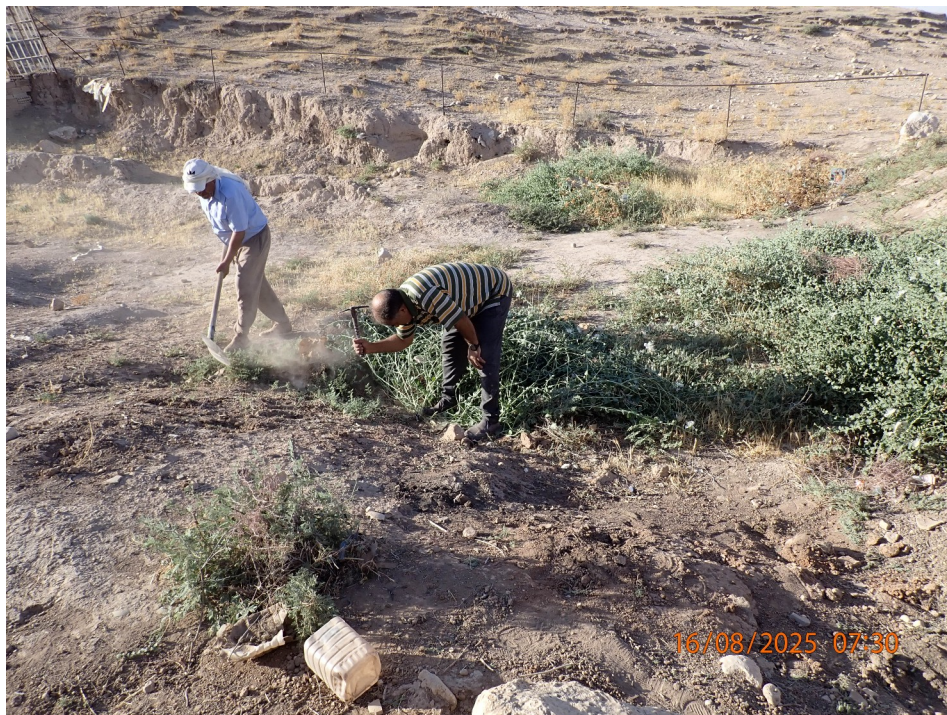
*Fig. 2: Weeds Removal*

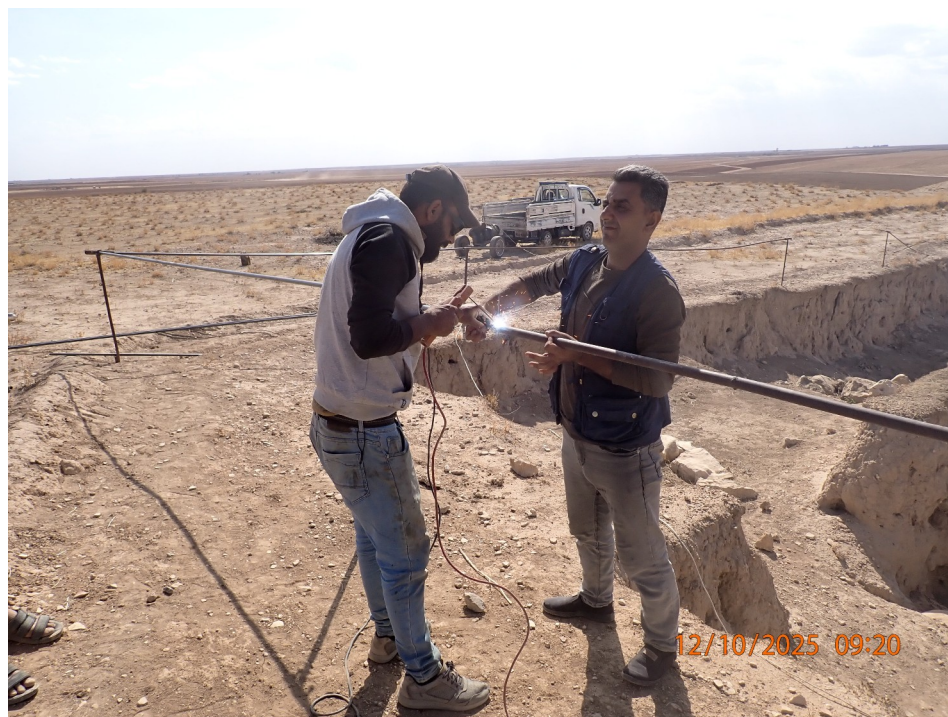
***Figure 3: welding of the rods***

The works included the repair of the iron fence by straightening the bent sections, welding the broken parts, and replacing the missing elements, particularly in the temple and palace areas (Fig. 3). The metal panorama in the temple area was also repaired by treating the broken section and the cracks in its cover (Fig. 4). In addition, the tannur cover in the palace area was repaired, with the damaged rings replaced.

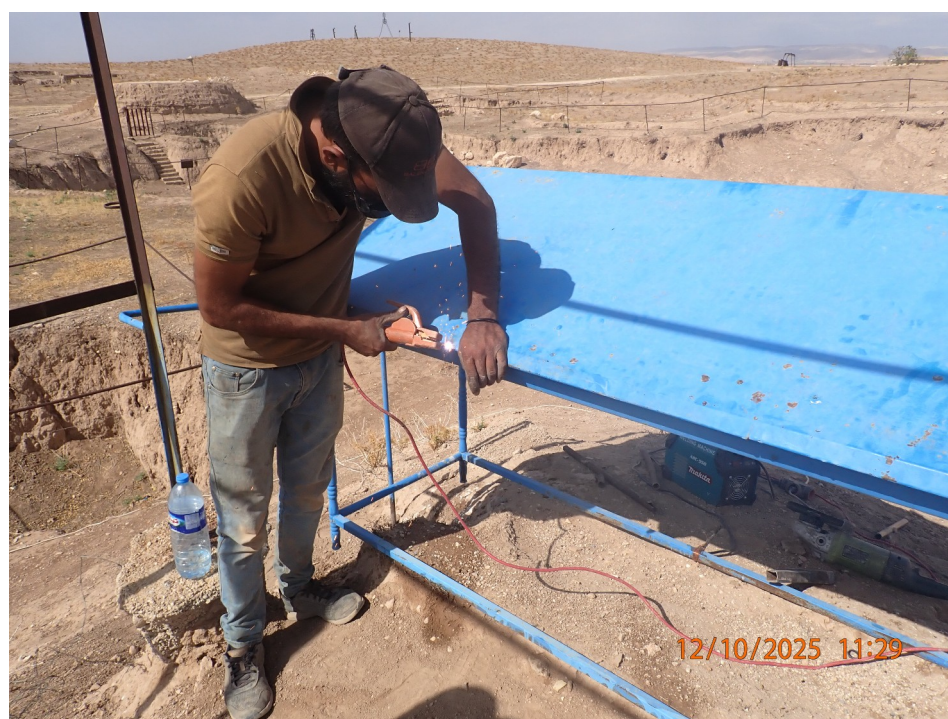
***Fig. 4: welding of minor cracks in the temple panorama***

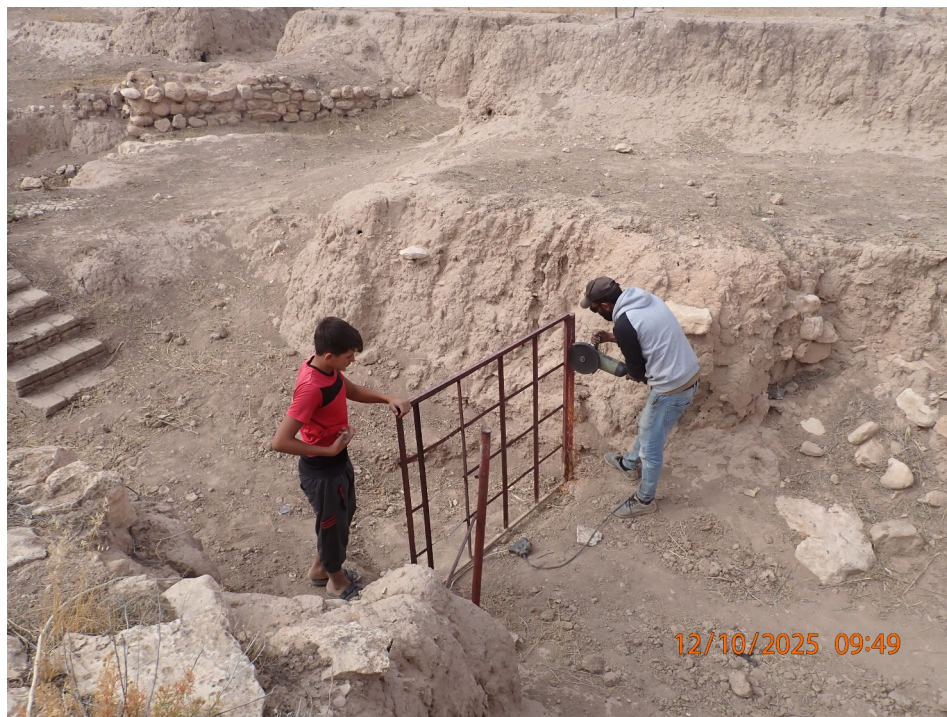
***Fig. 5: The door during the raising process***

The maintenance works also included the repair of one of the doors that could not be opened due to the accumulation of soil and debris. The door was raised and re-secured without carrying out any additional excavation works (Fig. 5). The palace panorama cover was also modified to ensure that it opened properly, and the metal canopy covering it was repaired (Fig. 6).

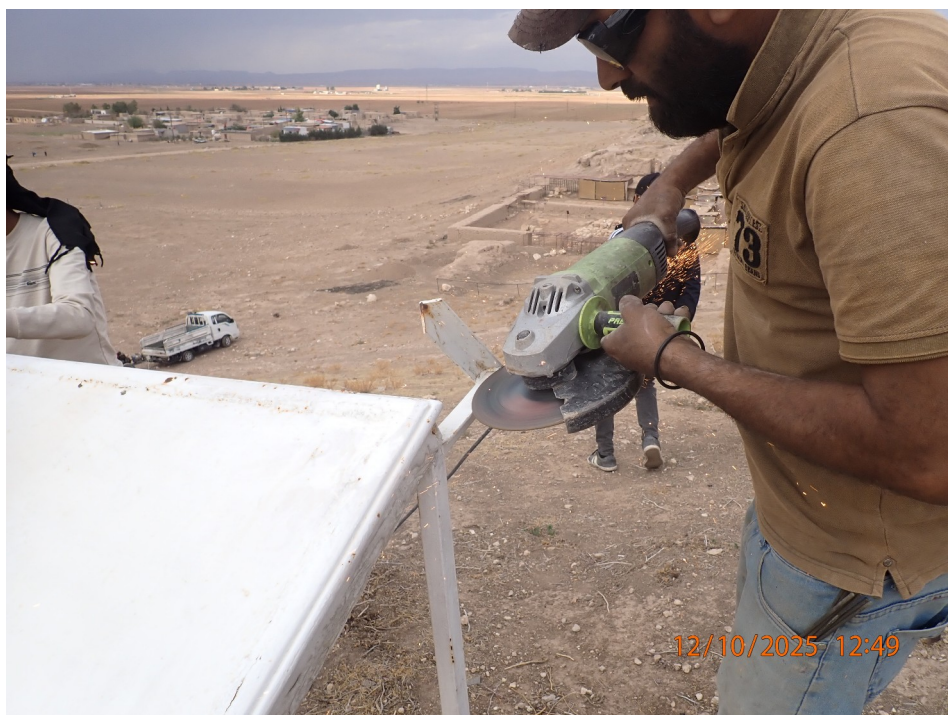
***Fig. 6: The cutting of the iron rod that prevented the cover from lying flat***

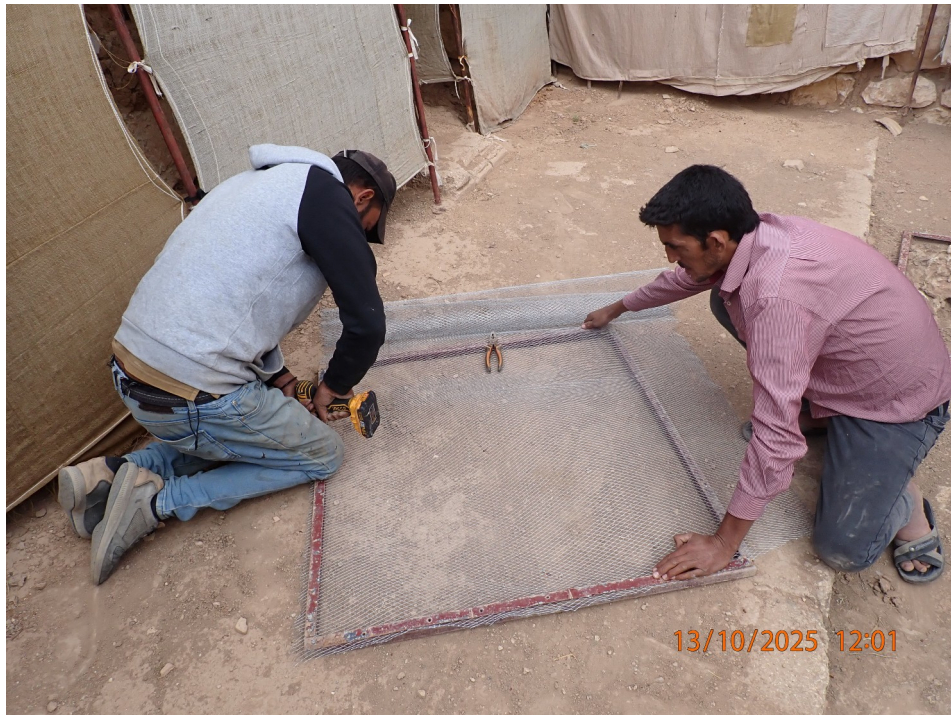
***Fig. 7: The installation of the new mesh on the drainage frames***

In the drainage system in Iwan C5, a new mesh was installed on the iron frames to protect the drainage openings from the accumulation of debris (Fig. 7). The metal protective sheets (Tutiya) above walls D1-1 and E1 were also secured (Fig. 8), and one of the missing bolts on the Abi dome was reinstalled to reduce the possibility of water leakage.

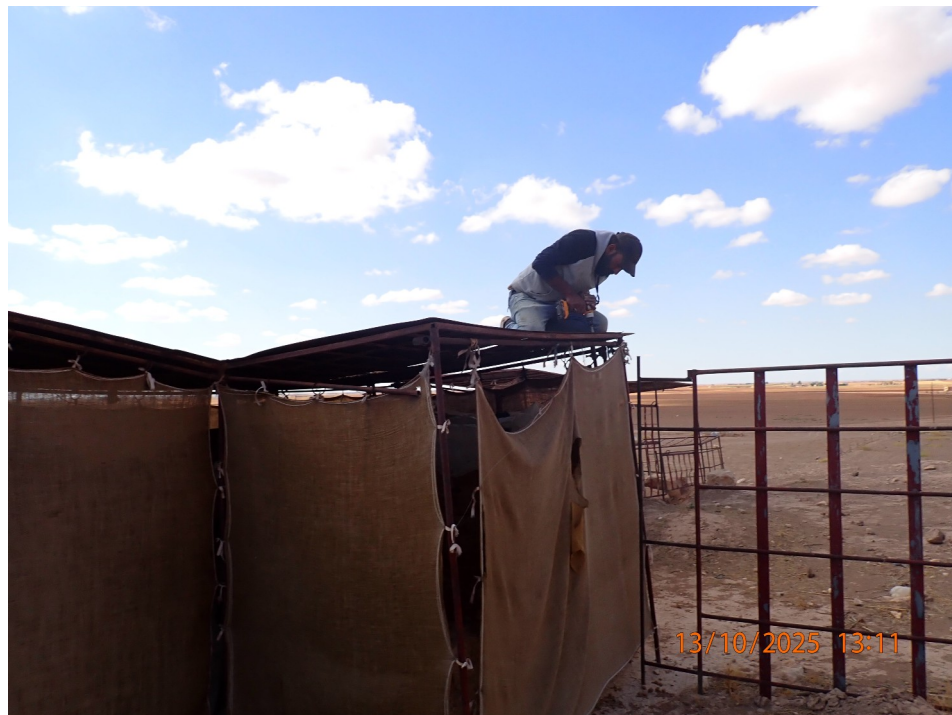
***Fig. 8: The securing of the tutiya sheets on Wall E1***

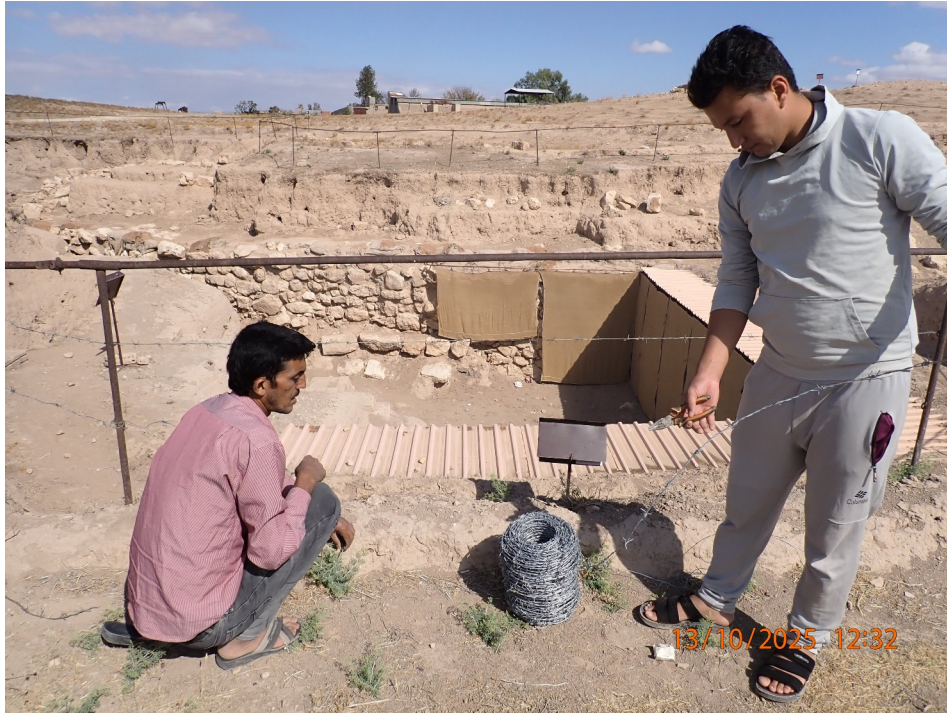
***Fig. 9: The reinstalling of the new protective barbed wire***

The maintenance works also included the rehabilitation of the protective barbed wire attached to the iron fence by reinstalling the intact sections and replacing the deteriorated or missing sections (Fig. 9). In addition, additional screws were installed on the Abi panel cover to improve its stability and ensure that it remained stable when opened and in use (Fig. 10).

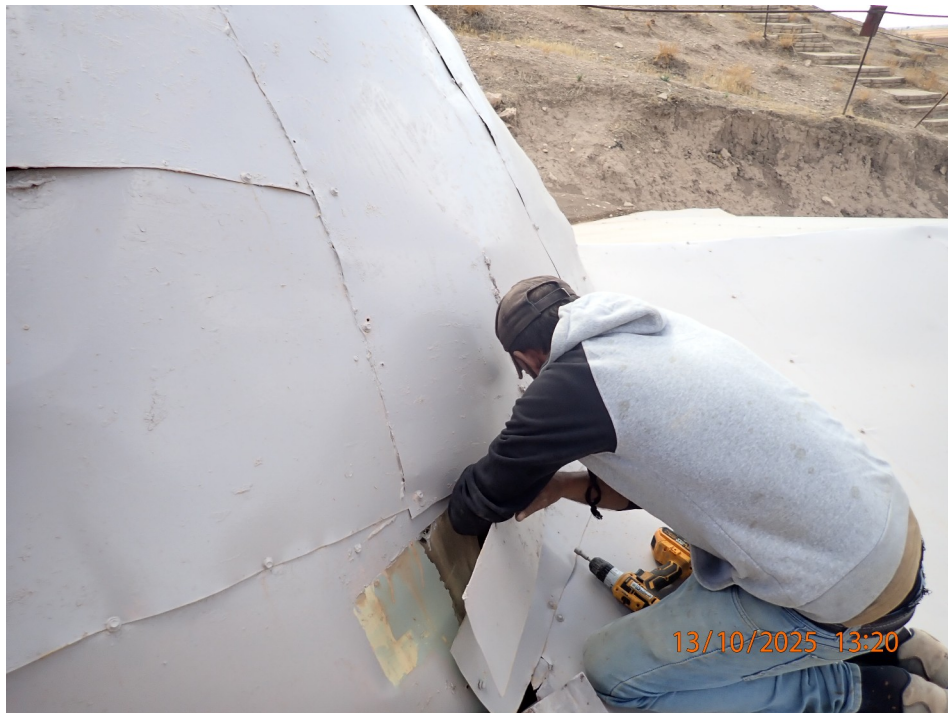
***Fig. 10: The re-installation of a missing bolt on the Abi dome***

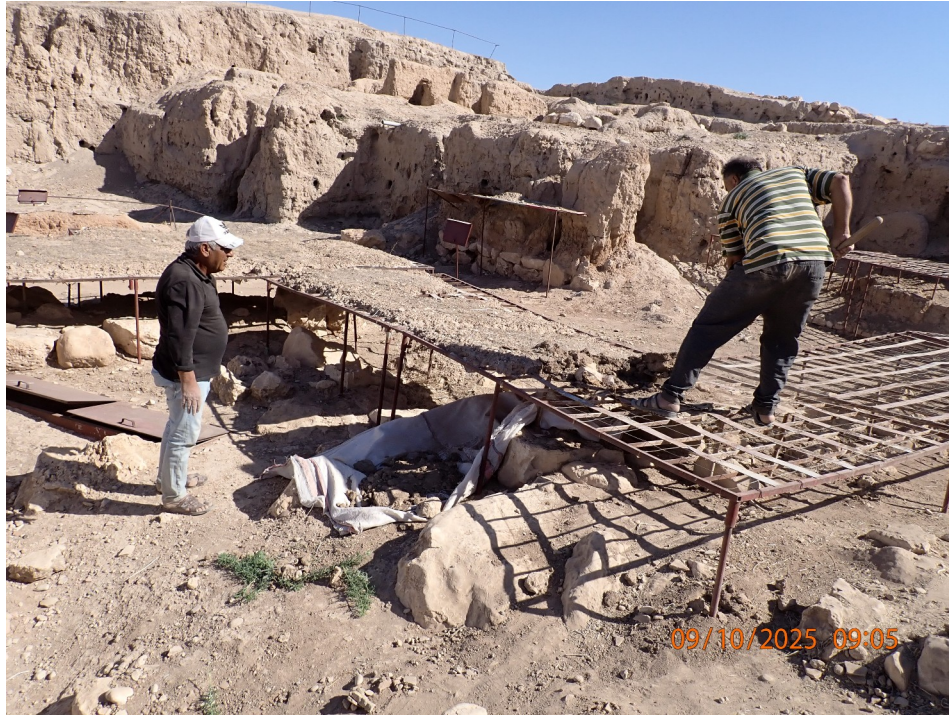
***Fig. 11: Removal of the fragile and deteriorated mud plaster***

The works began with the complete removal of the old and deteriorated mud plaster layers (Fig. 11), particularly in Sector H and the service wing sectors. The debris resulting from the removal process was collected and transported away from the excavation areas. Subsequently, some areas were reinforced with metal wires (Fig. 12), followed by the installation of layers of plastic sheet and cardboard (Fig. 13). The surfaces were then prepared and moistened before the application of the new mud plaster layers.

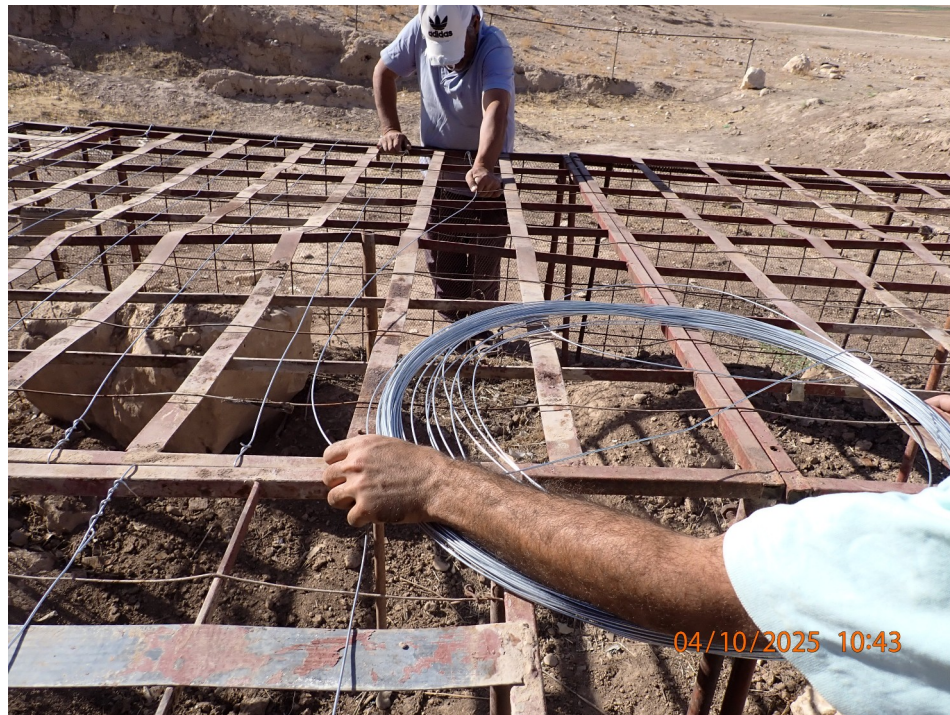
***Fig. 12: Metal wires installation***

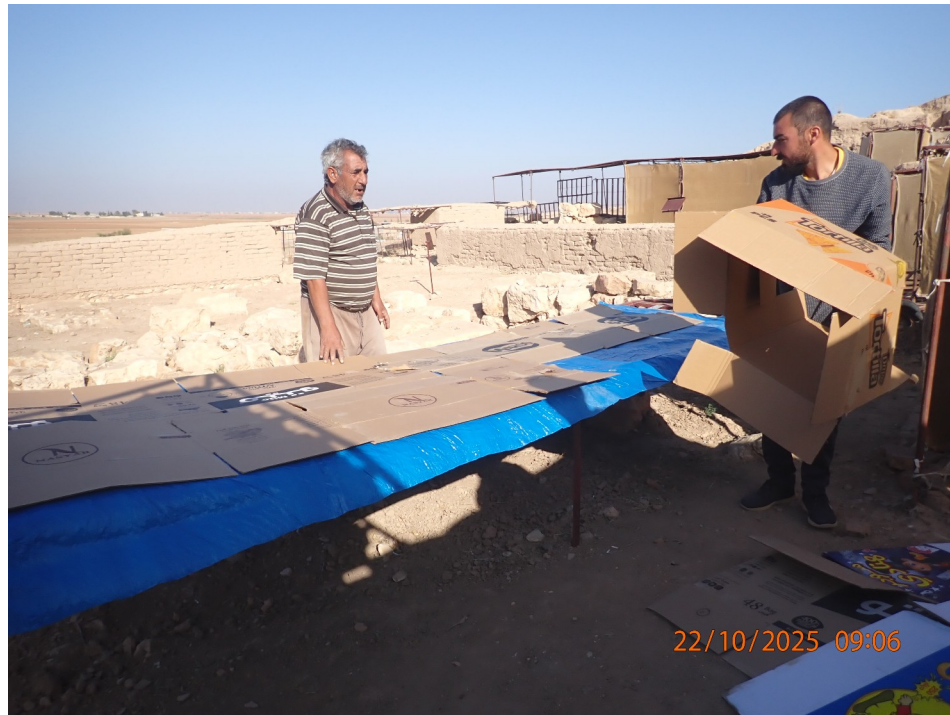
***Fig. 13: Adding plastic sheet and cardboard***

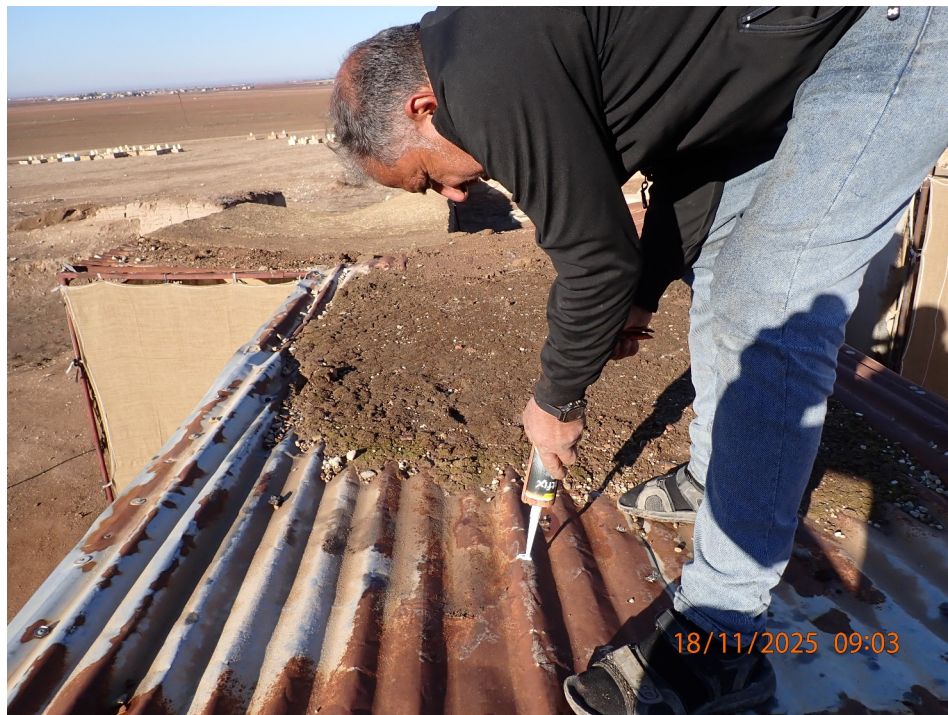
***Fig. 14: Sealing gaps and existing holes in sheet metal (tutiya) with silicone***

Some protective systems covered with metal sheets (tutiya) were treated differently. It was decided not to apply mud plaster directly over the metal sheets due to poor adhesion and the possibility of moisture retention, which could result in the corrosion and rusting of the metal elements. Instead, a layer of nylon was adopted as a protective measure, and the gaps and holes between the sheets were sealed with silicone to prevent water leakage (Fig. 14).
