# **A Report on New Damage in Area J7 / C2**

**Amer Ahmed**

**April 2026**

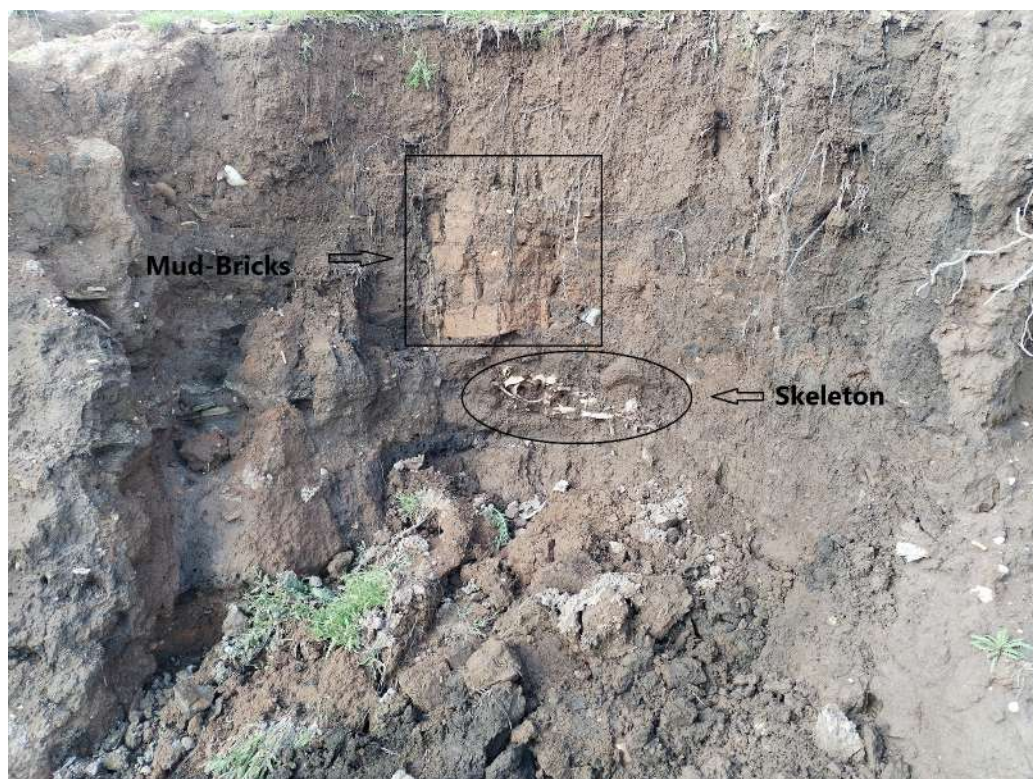
*Fig. 1*

As a result of heavy rainfall, as I noted in the previous report, a collapse occurred in Area J7 or C2 as referred by Patrizia . This collapse exposed a burial feature containing a skeleton, mud-brick, and basalt stones (Fig. 1).

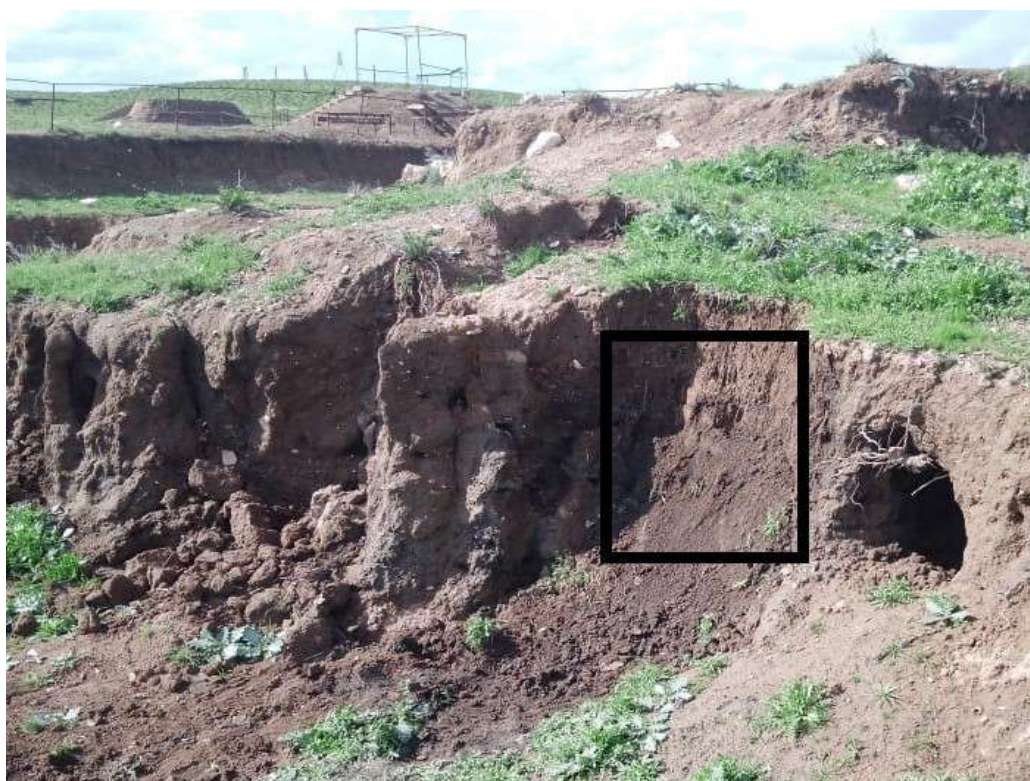
*Fig. 2*

As an immediate protective measure, the burial was re-covered with soil (Fig. 2) to conceal it and prevent tampering, while awaiting a detailed assessment and the implementation of an appropriate long-term conservation strategy.

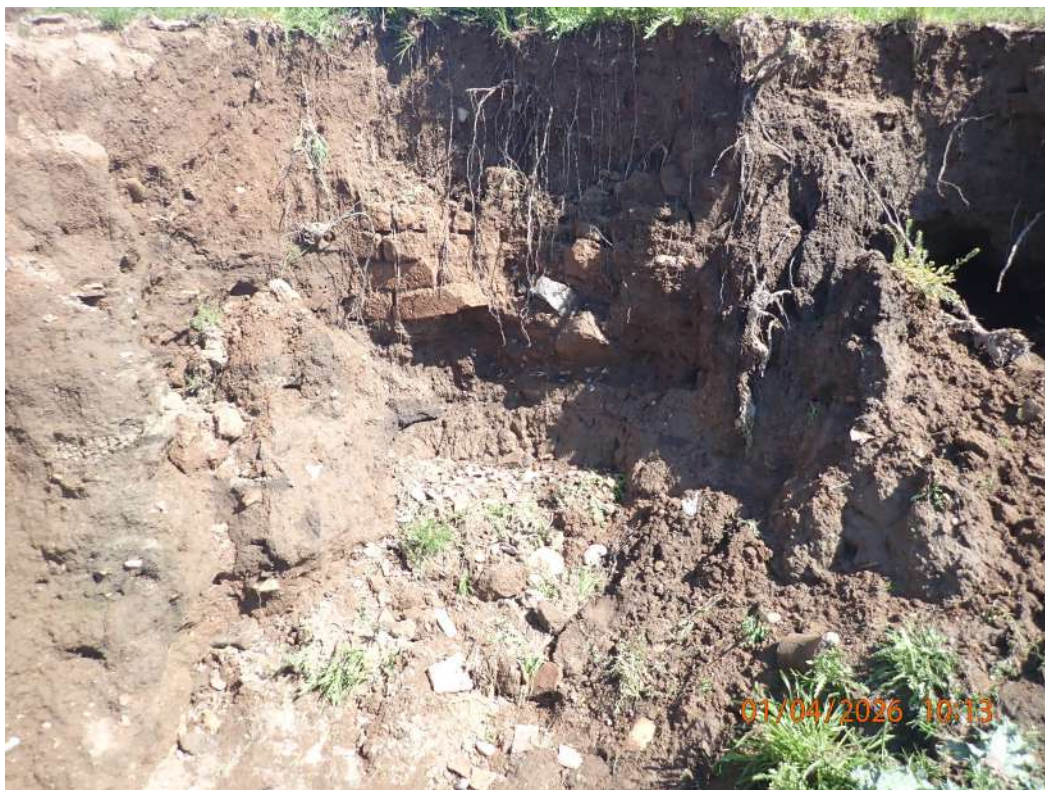
**Fig. 3**

However, rainfall in the following days exceeded expectations, leading to a significant collapse of the section. As a result, the skeleton remains were almost entirely lost (Fig. 3), while a small ceramic jar became visible.

Despite this damage, the mud-brick structure of the burial remained relatively well preserved. This situation required urgent intervention, particularly under favorable weather conditions, to prevent further deterioration of the remaining archaeological context.

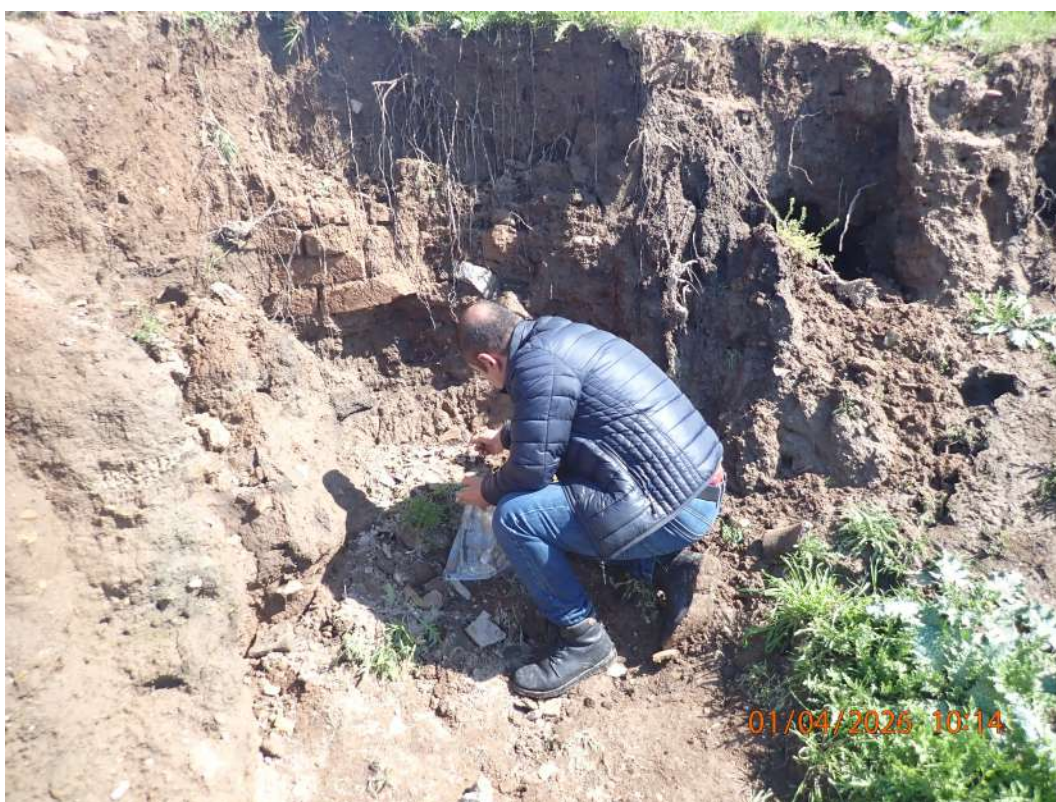
**Fig. 4**

All visible bone fragments and pottery sherds scattered on the surface were collected and placed in bags (Fig. 4). It should be noted that it cannot be confirmed with certainty that all collected pottery sherds belong to the burial, due to the widespread presence of pottery sherds across the area due to natural erosion and runoff caused by rainfall.

It is also possible that additional bone remains are still embedded within the collapsed sediment. Only surface-visible materials were collected, without excavation. The same approach was applied to the pottery sherds, as leaving them within the sediment may contribute to their protection until an excavation can be conducted.

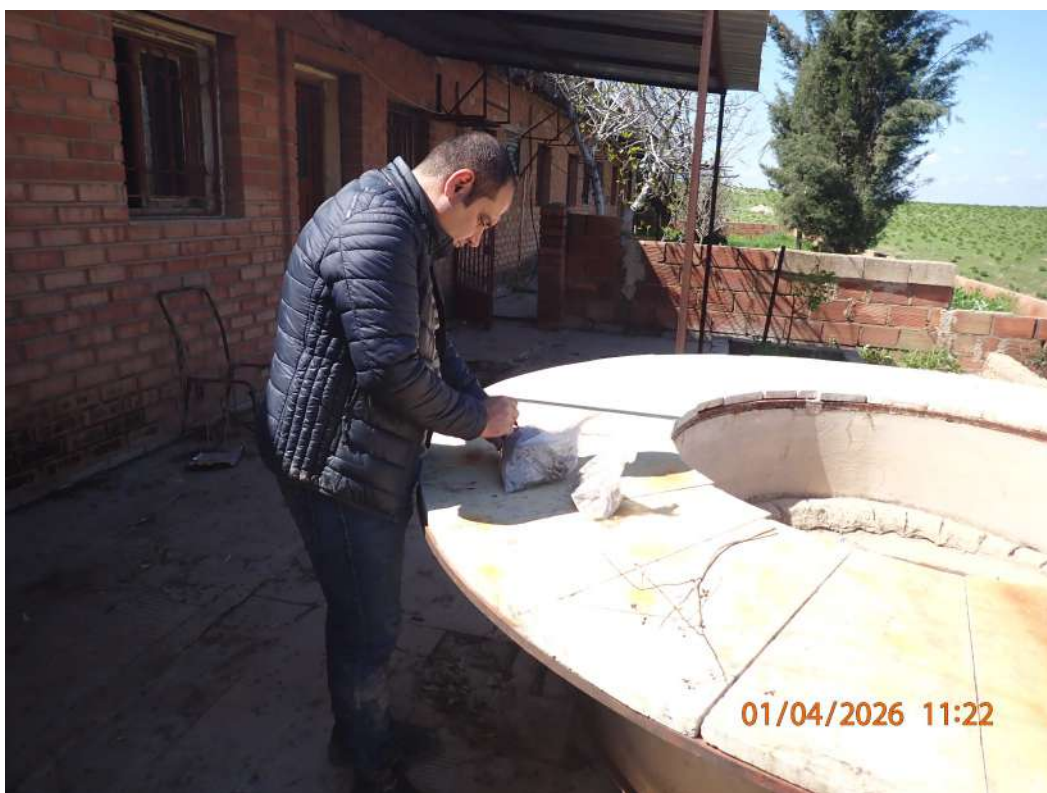
**Fig. 13**

The recovered bone remains and pottery sherds were transported to the expedition house, where they were placed in labeled bags indicating their association with burial C2 (Fig. 13).

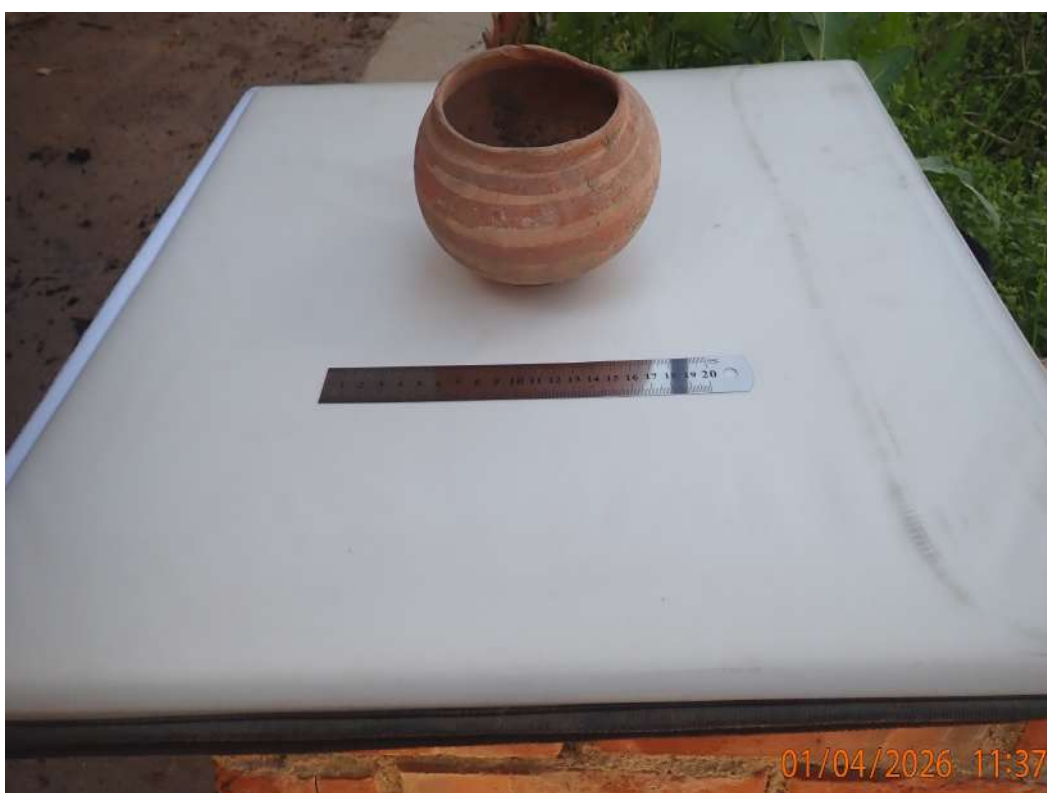
**Fig. 14**

- **Description:** A small ceramic vessel decorated with red painted lines. A very fine hairline crack extends from the rim to the middle of the body. Minor erosion is visible in the rim (Fig. 14).
- **Height:** Approximately 9 cm
- **Maximum Diameter:** Approximately 14.9 cm
- **Rim Diameter:** Approximately 10.5 cm
- **Base Diameter:** Approximately 5.4 cm
- **Thickness:** Approximately 0.4 cm

Following documentation, the jar was stored together with the rest of the finds in the main storage within the expedition house.
