**A “new” Abi**  
**Report on the Abi operation**  
**Stefania Ermidoro- Yasmine Mahmoud**

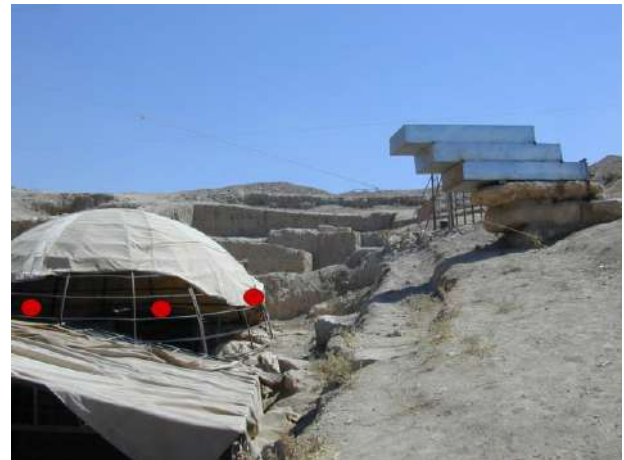
Sketches with the indication of the openings to be created in the new metal dome for aeration and light inside the Abi

We needed to be sure that the metal sheets were light enough to ensure the removal of the complete dome when necessary (possibly with the use of handles, to be placed at the bottom of the structure). Some light needed to reach the inside of the Abi, therefore we considered the installation of some glass or plexiglass panels at the base, that could if necessary also be removed to allow for ventilation in summer.

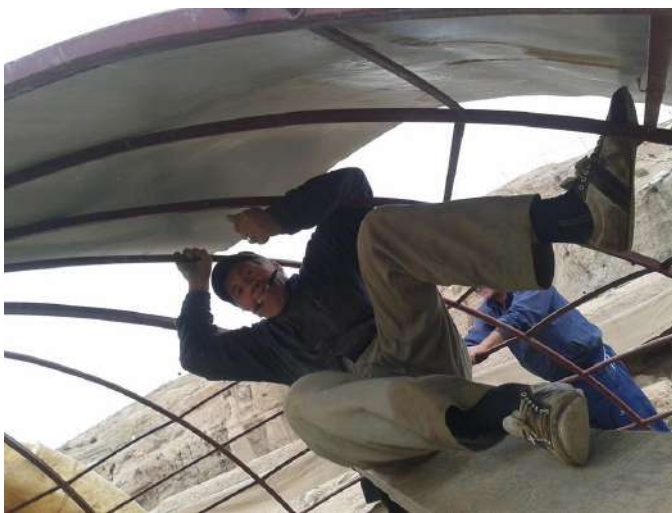
Unfortunately, some problems with the bank in Qamishli connected with the money transfer and the telephone lines, which were often broken and impeded thus fast communication to Syria, delayed again the beginning of the job, which then started only December, 3rd (the first shot taken this day can be found here below).

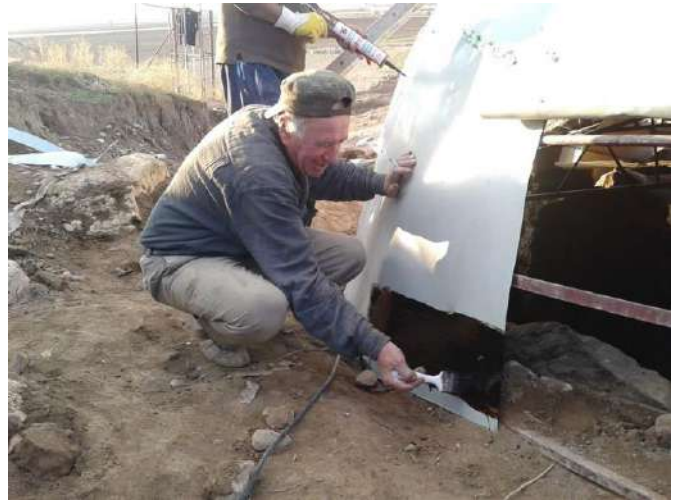
Hiba Qassar was able to speak with Sabah on the phone while he was working on the structure and we could thus get a hint of the progress of his work. He initially suggested that, having bought a type of metal which was already in a light color, he could avoid painting it on its whole surface: he decided instead to paint only the base with pitch - on those parts of the structure that would have been covered again with soil, as shown in the photo on the right.

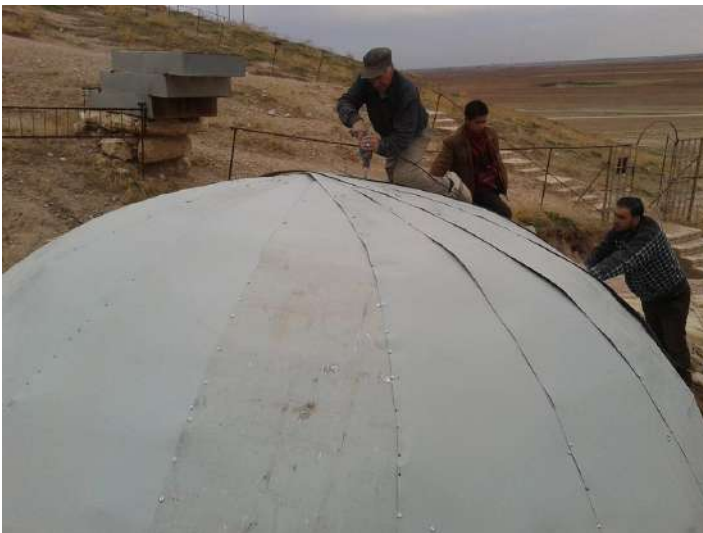
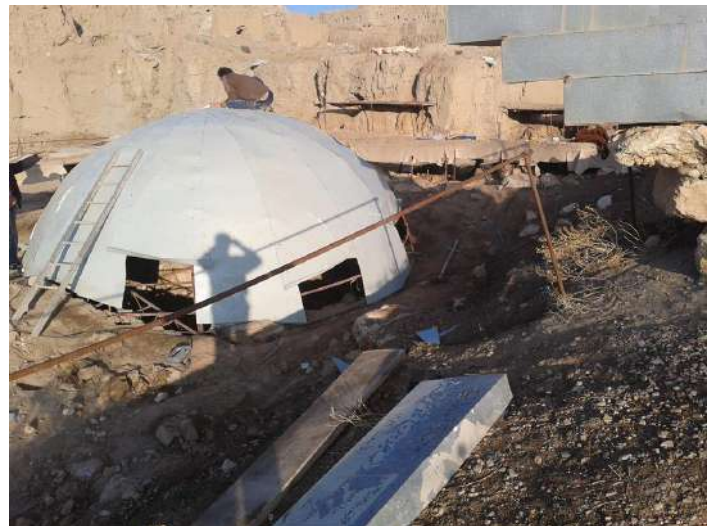
Sabah Khasseem at work (left) and detail of the openings at the base of the new Abi “dome”

Having discussed with **Mohammed Omo** the project, the smith initially decided to use only metal for the dome, adding openings for the ventilation inside the Abi but not including thus the transparent panels that were included in the project. Thanks to the constant communication that we had started with him through internet and the telephone, it was possible to stress the importance of having some light inside the Abi, and he changed the structure accordingly.

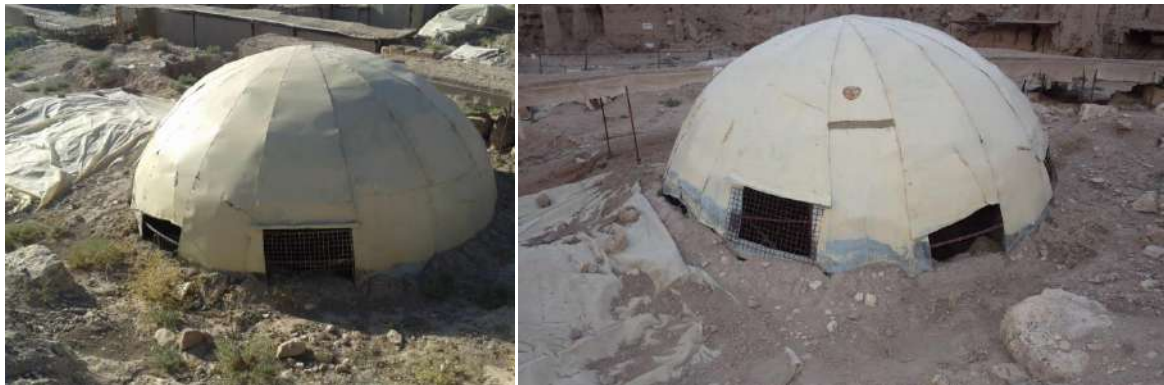
**Figure 1** Photo showing the openings and the drains above the openings

It was stressed earlier, the importance of leaving ventilation openings in the dome to prevent overheating and to allow some light inside the Abi. Therefore, 3 small openings were left at the bottom of dome on the southern side and southern western side. The openings are rectangular in shape, and covered by a metal net to prevent the anything from entering into the Abi.

The openings were placed so that they are directly under one piece of the metal sheets, and they are designed to be smaller than the base of the metal sheet. This was done for a reason. As you can see in the photo, the bottom end of the metal sheet right above the opening is tilted upwards forming a small drain, where rain water will be gathered and seep from the sides of the “drain” away from the opening, preventing thusly the water from leaking into the Abi.

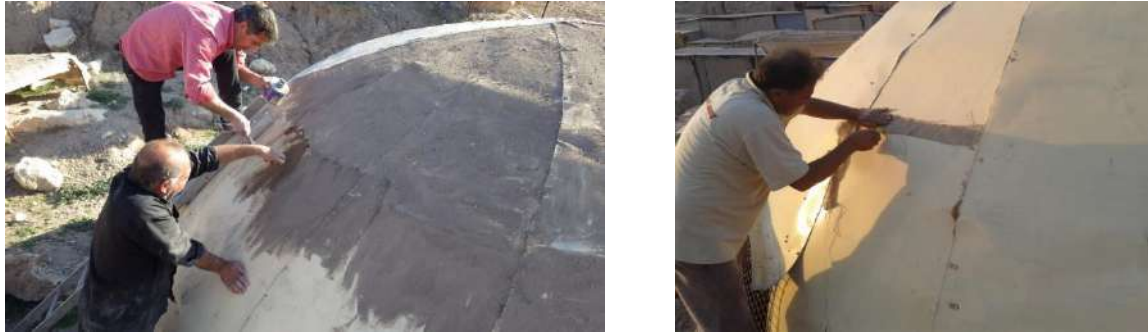
Figure 2 Showing the covering of half the dome with dirt and the experiment with burlap

The workers experimented with two methods. One is covering the dome with adhesive and then put dirt on the adhesive. And the second method is to cover the dome with adhesive and place burlap on it. This was done in June 2014. Eventually, the covering of the dome took place in March 2015.

The dome was covered using the two methods. They covered half with dirt, and the other half with the burlap. Both methods seem to give the dome a very natural look and make's it unobtrusive to its surrounding. But later, we asked each one of the workers who were involved

in this procedure about his opinion regarding the best solution on this matter. They all prefer covering the dome with burlap. Because the dirt might cause the forming of rust on the long run, and might not endure the heavy rainy seasons.

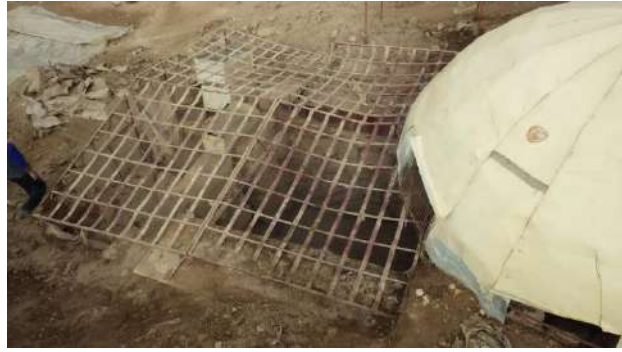
Now the metal frame has suffered recently from a breakage due to weather conditions (especially snow), plus it was dented in several places and needed welding and maintenance to ensure full protection of the Abi.

The workers took some emergency measures to stop the seeping water, by placing a nylon piece in the brakeage location. But the frame could not be left without a serious intervention.

The suggestion was to place metal sheets on top of the grid like metal frame. This would ensure maximum protection, and it would be a long lasting solution.

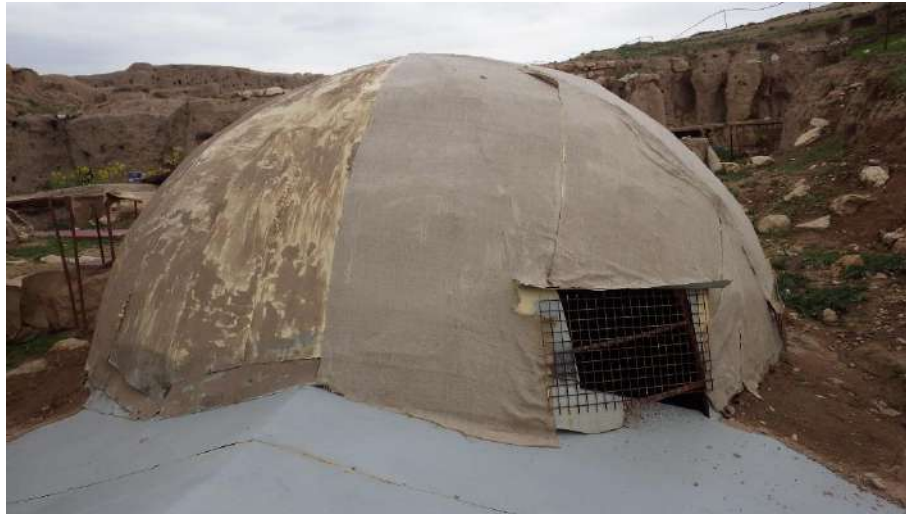
In 2014 and 2015 the dome of the Abi and the roof of the entrance were covered with overlapping metal sheets. The last stage of the restoration process, was the covering of the Abi dome. We experimented with 2 methods. We covered half of the dome with glue and burlap, and the other half was covered with glue and dirt.

Abi dome after restoration in March 2015

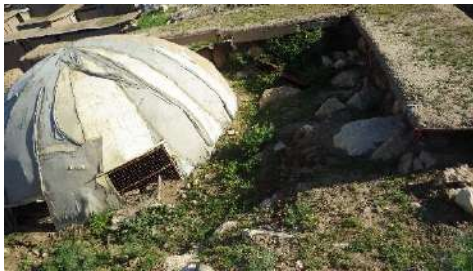
Torn burlap- Abi dome  
April 2016

The covering of the Abi dome was meant to serve 2 purposes. It was meant to prevent the formation of rust on the metal, and to make the dome less obtrusive to the surrounding landscape. These 2 methods made the dome of the Abi look like a part of its surrounding, but did not prove very durable.

By the end of the winter in 2017, the dirt was washed away, and the burlap was torn and needed to be replaced. So we thought about trying a different method: Paint!

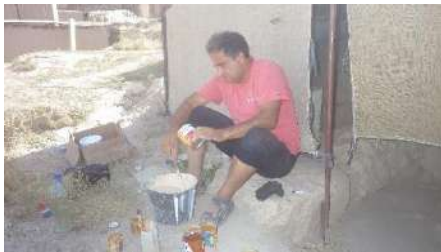
The first step was to remove and clean the dirt that was still stuck on the dome, and to scrape off what is left of the burlap and glue.

Cleaning the Abi dome before painting-  
July 2017

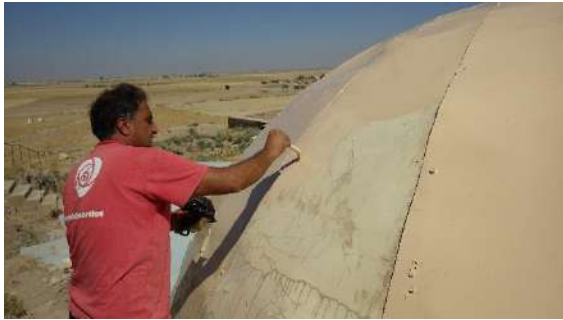
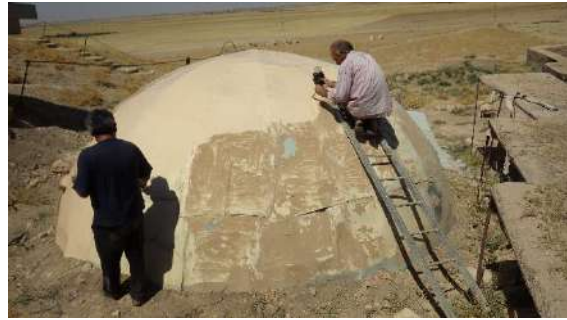
Once the Abi was cleaned, our friends mixed the paint and began painting.

This task took 3 days to be finished, painting the dome with layers of rose-beige paint.

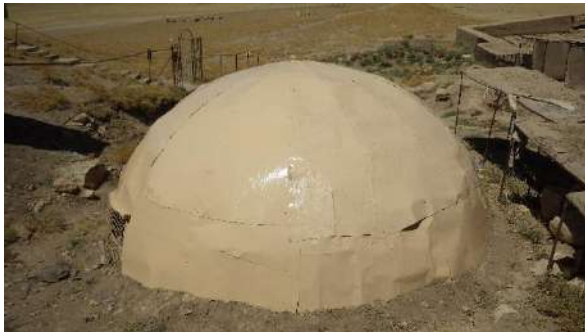
Final results- July 2017

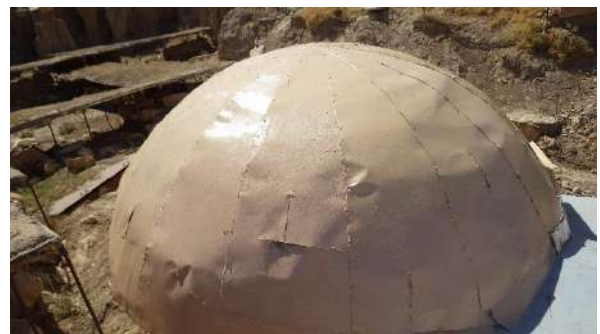
The negative aspect so far is an esthetic aspect. Even though the color is close to the color of the surrounding landscape, the dome does have a metal shining that is not completely coherent with the site. But it is something that can be overlooked, if the safety of the Abi is ensured with this method.

Shiny metal
