# **Intervention on the Retaining Wall in Unit J5**

**Amer Ahmad**

**September 2026**

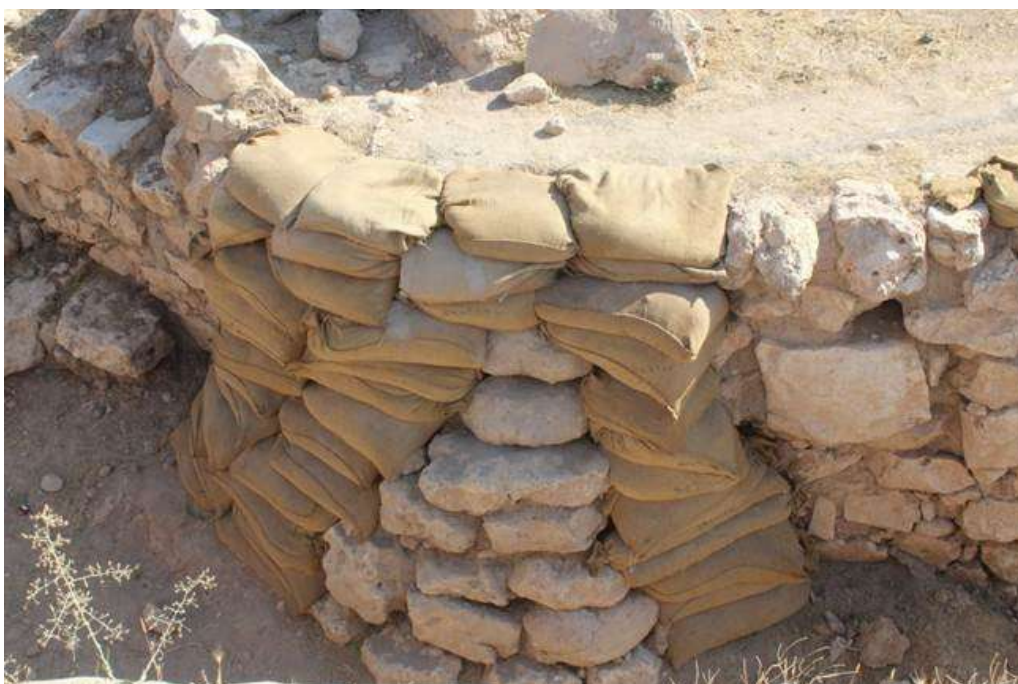
*Fig. 1: General view of the retaining wall in 2019.*

The heavy rainfall that occurred during the spring of 2019 caused damage to the retaining wall in Excavation Unit J5, located in the Temple area. As a result, immediate intervention was required at the time to address the situation. The stones were repositioned in a manner intended to protect the temple terrace from further damage. In addition, soil-filled sandbags were placed around the stones to provide additional support to the temple terrace (Fig. 1). For further information, please refer to the previous report:

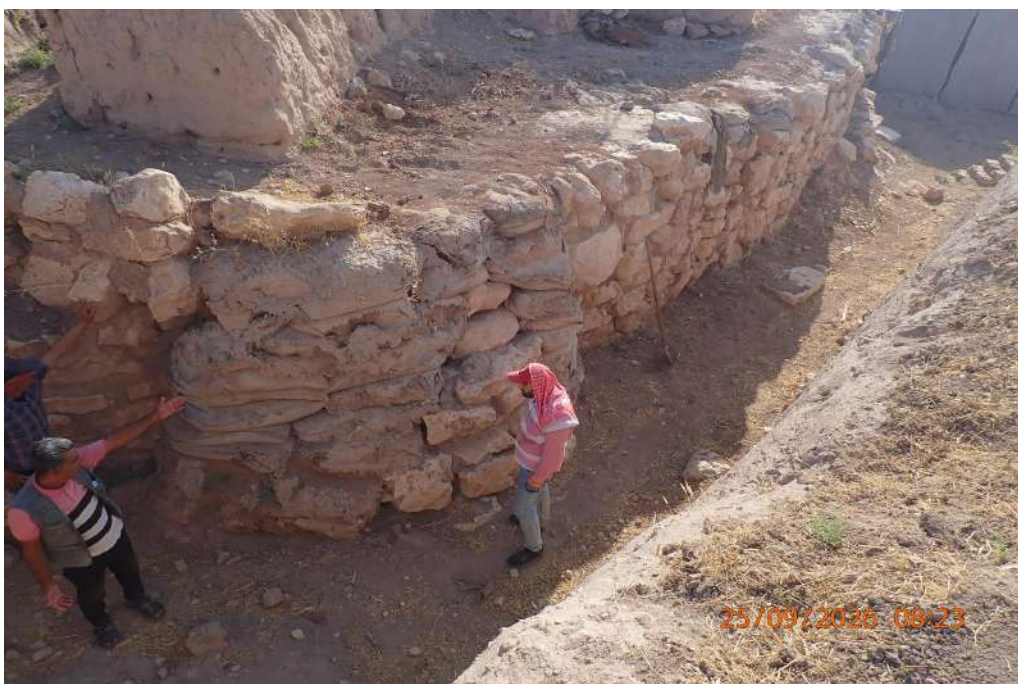
Approximately seven years later, the sandbags deteriorated and became weathered as a result of exposure to environmental factors, particularly in their lower sections (Fig. 2). Consequently, there was a continuing concern that the deterioration could lead to the erosion and loss of the soil contained within the damaged sandbags, which could, in turn, result in the collapse of the upper sections. In addition, some of the stones in the upper sections (Fig. 3) were also at risk of collapsing in the future if they were exposed again to adverse weather conditions, particularly given the conditions experienced during the past year, when rainfall and snowfall reached exceptionally high levels compared with previous years.

*Fig. 2: General view of the retaining wall before the intervention.*

Accordingly, further intervention was required to address this deterioration. Carrying out this work would also contribute to improving the overall appearance of the unit.

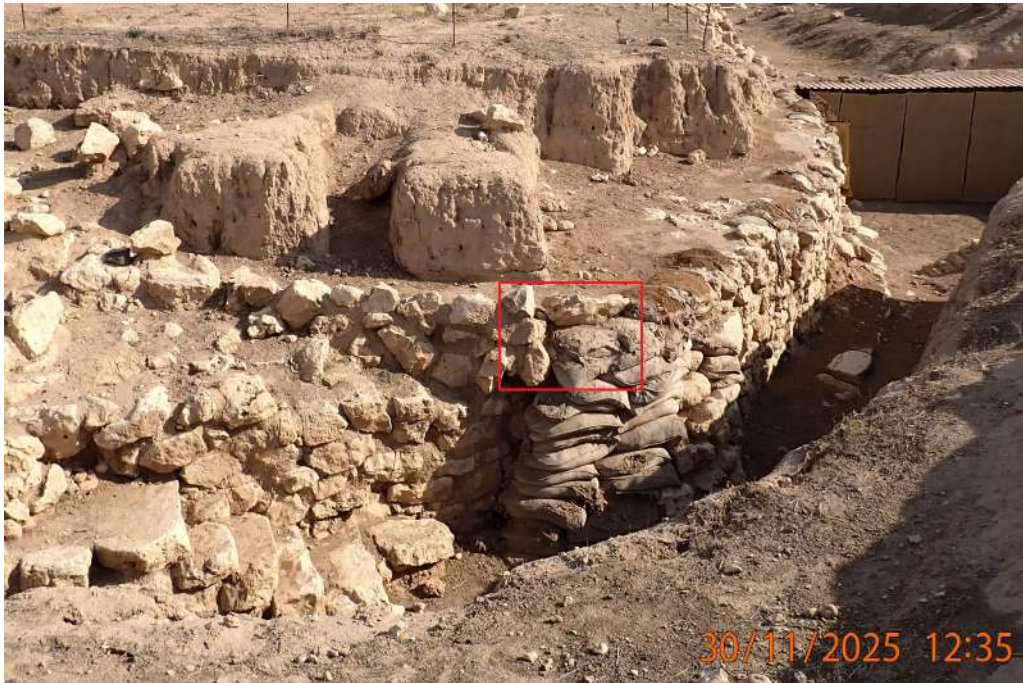
*Fig. 3: Stones at risk of future collapse.*

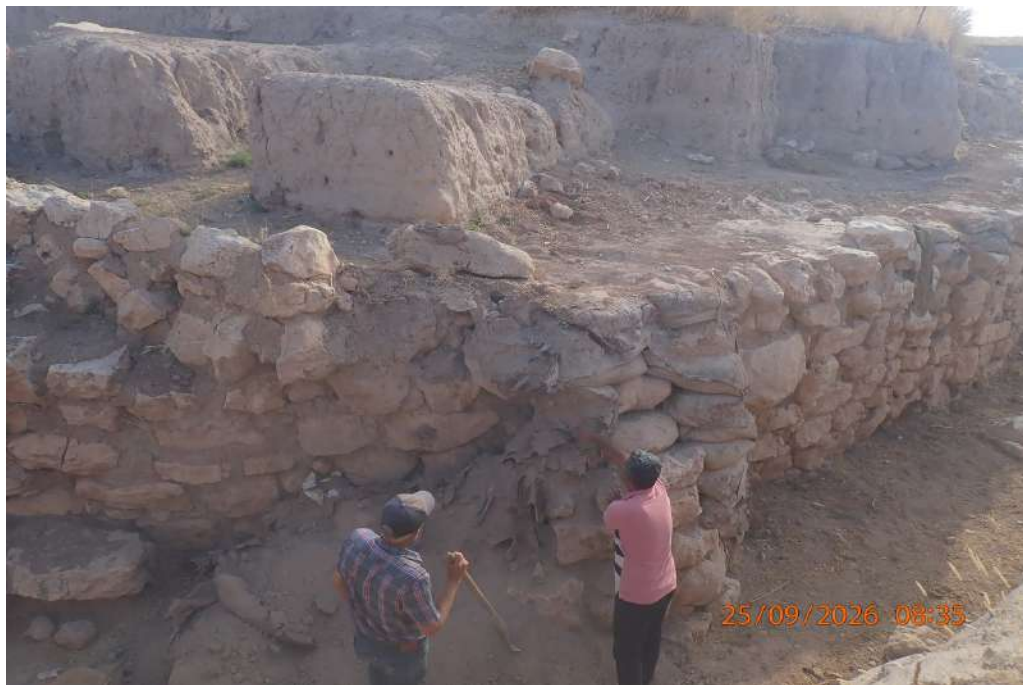
*Fig. 4: Emptying the upper sandbags.*

Initially, the upper sandbags were carefully emptied in order to prevent any sudden collapse that could damage the stones or cause them to fall (Fig. 4). In fact, the upper sections appeared to be more coherent and stable than the lower sections, although some of the bags on the left-hand side had deteriorated. This was also the side where the largest number of sandbags had been placed.

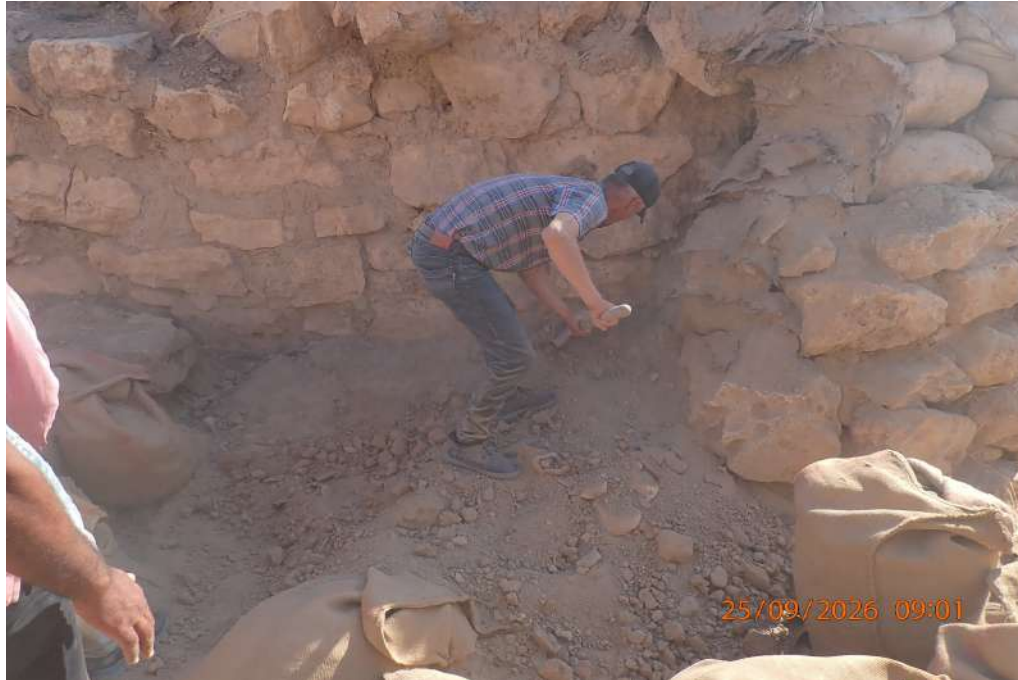
***Fig. 5: Levelling the ground before placing the sandbags.***

After reaching the base and removing the deteriorated sandbags, the ground was carefully levelled (Fig. 5). We then began filling new sandbags using the same soil that had previously been contained within the removed bags (Fig. 6), after first removing any remaining fragments of the deteriorated bags from the soil. The bags were subsequently placed on top of one another (Fig. 7) until the upper section was reached (Fig. 8).

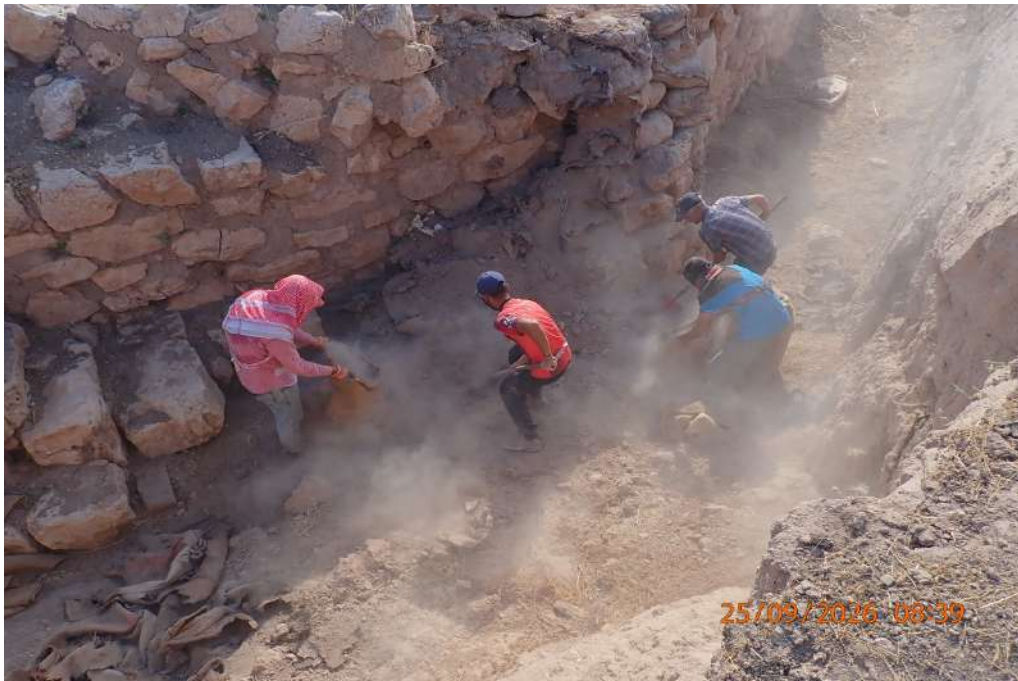
***Fig. 6: Filling the sandbags with soil.***

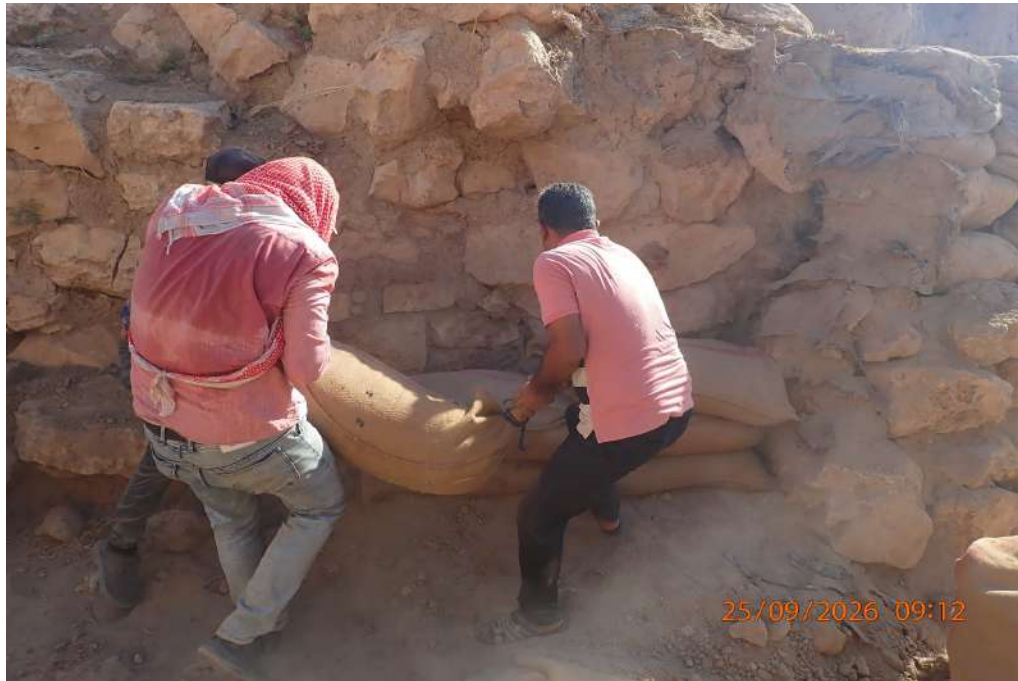
***Fig. 7: Placing the sandbags on top of one another.***

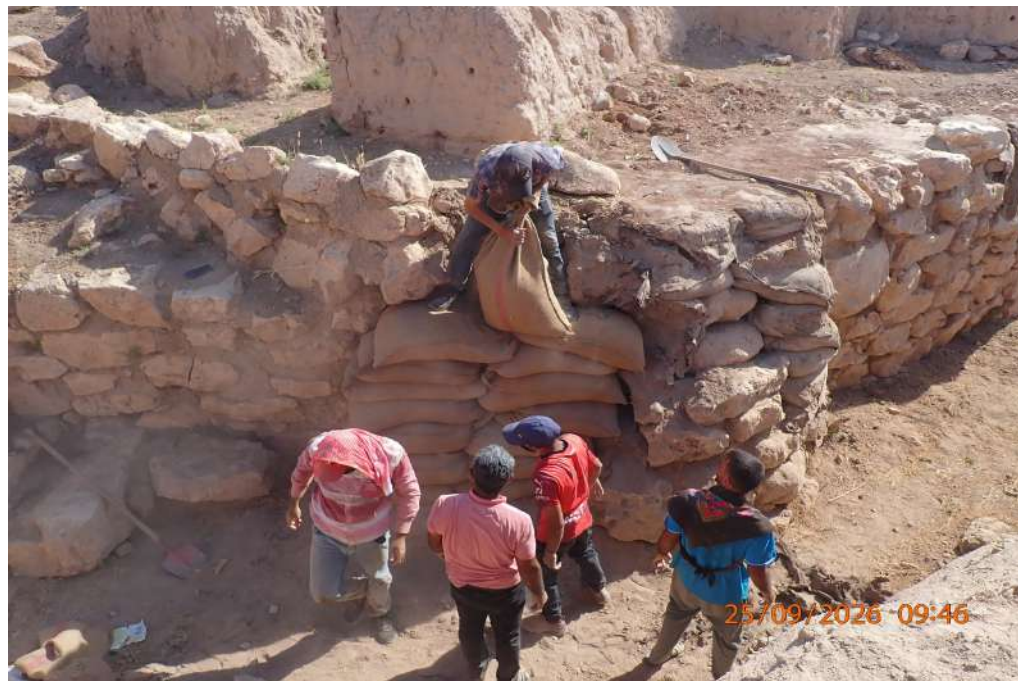
***Fig. 8: Reaching the upper levels.***

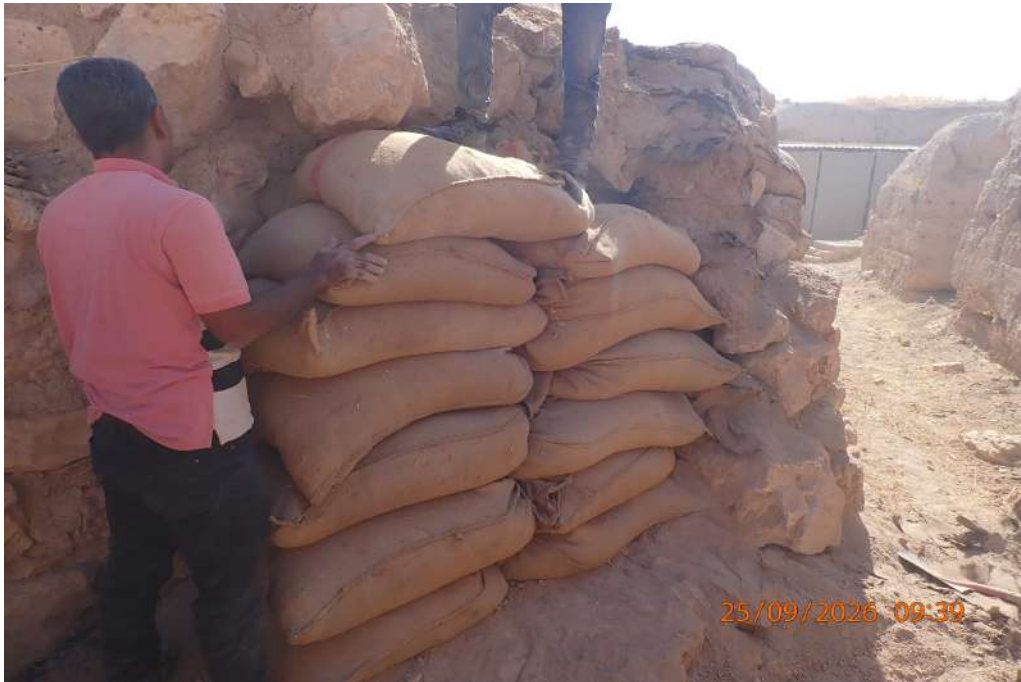
***Fig. 9: Placing a sandbag beneath the stone.***

At this stage, one of the sandbags was positioned beneath one of the aforementioned stones, with the bag placed directly against the stone. This was intended to ensure that, in the event of any future settlement or downward movement of the stone, the sandbag would act as a supporting element (Fig. 9).

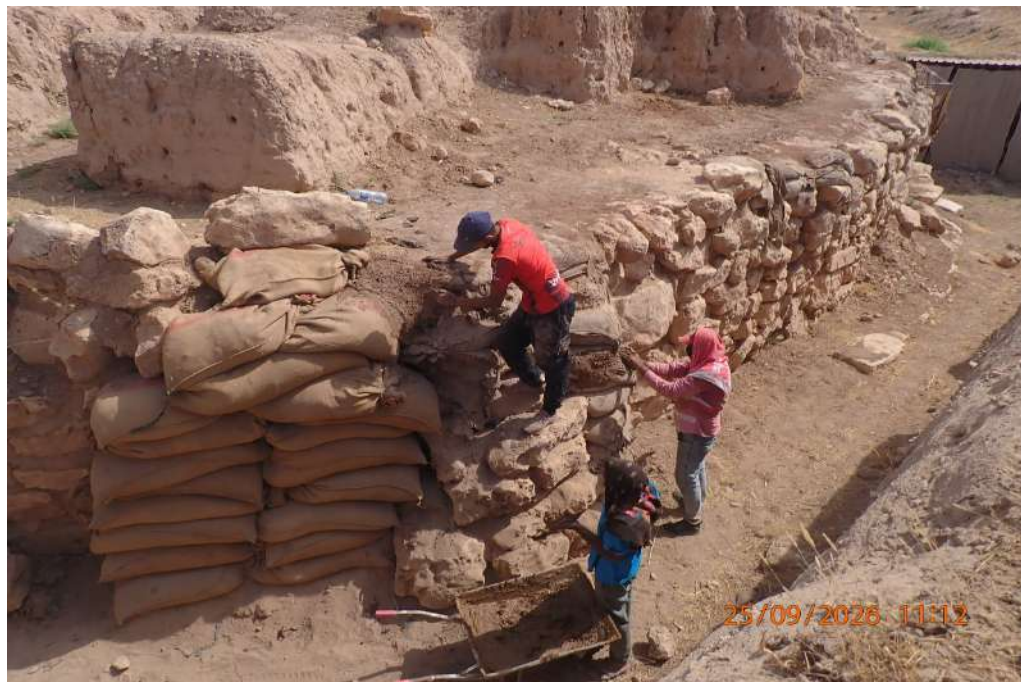
***Fig. 10: Plastering the upper levels of the wall***

During the course of the work, as mentioned above, we observed that some of the sandbags remained stable. Therefore, it was not necessary to remove them, and a completely different approach could be adopted: leaving them in place and applying a layer of mud plaster over them (Fig. 10).

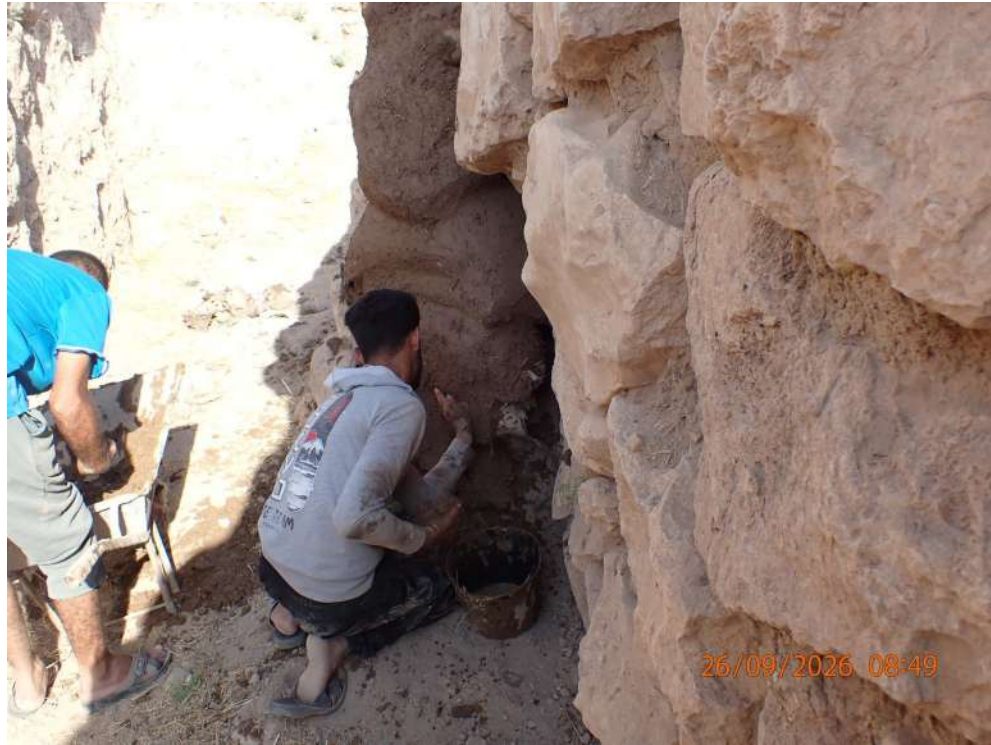
***Fig. 11: Plastering the right-hand side***

The same approach was applied to the right-hand side of the retaining wall, which appeared to be in relatively good condition and structurally stable (Fig. 11). This section was plastered in order to fill the deteriorated areas with mud and strengthen them.

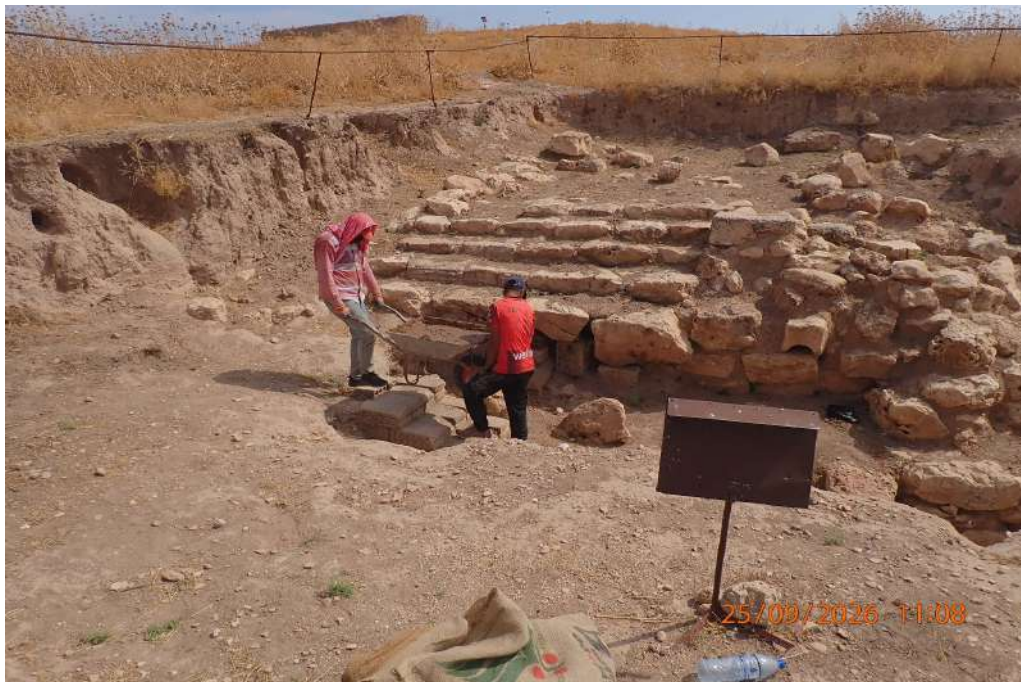
***Fig. 12: Mud transportation***

In this case as well, we used soil that had previously been brought to the site for use in plastering the storeroom wall. This soil was used to prepare the mud required for the plastering process. Although transporting the soil was somewhat difficult, a handcart was used to move it to the work area, after which the workers carried it manually in order to avoid causing any damage to the visitor pathways or to areas containing archaeological excavations (Fig. 12). Nevertheless, we avoided using the soil that had collapsed from the section opposite the retaining wall, due to the potential for mixing materials and losing archaeological information associated with their original context. Instead, we used soil that had previously been brought to the site and designated for restoration work.

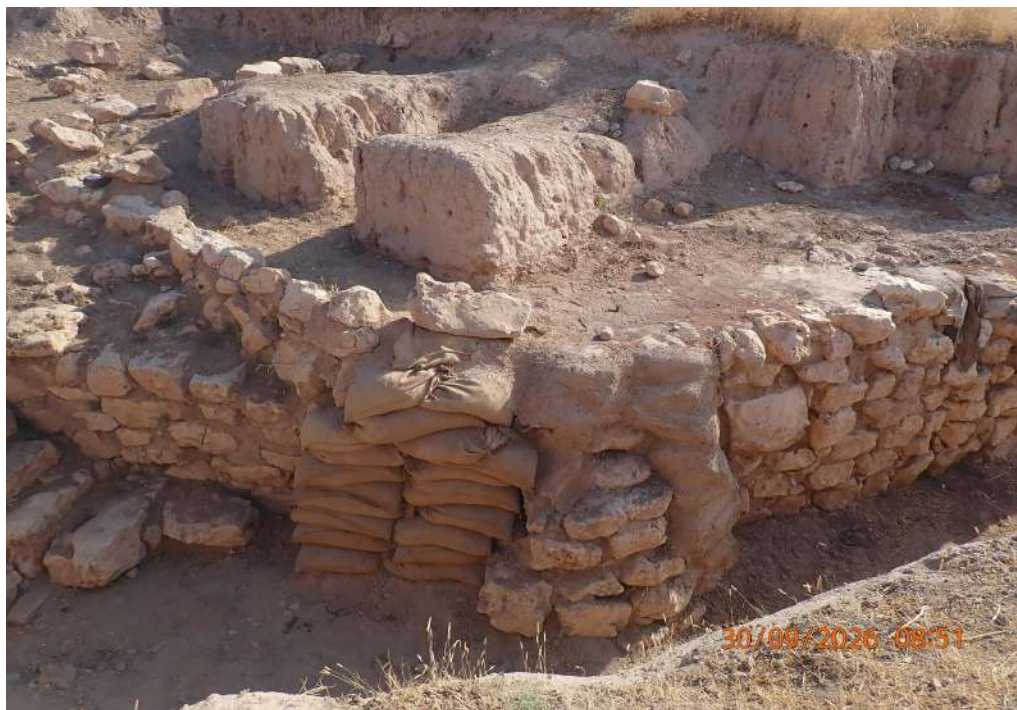
*Fig. 13: The completed intervention*

As a protective measure that could contribute to increasing the durability and preservation of the completed work, the area can be covered with a protective plastic sheet (*Shader*) during the winter season. This would reduce its direct exposure to rainfall and other environmental factors and, consequently, minimize or prevent potential damage as far as possible. I intend to implement this measure during the current year as an additional preventive step to help preserve the overall appearance and condition of the completed intervention (Fig. 13).
