# **Report on Covering the Pit Between Walls C1-1 and H3-H1**

## **Introduction**

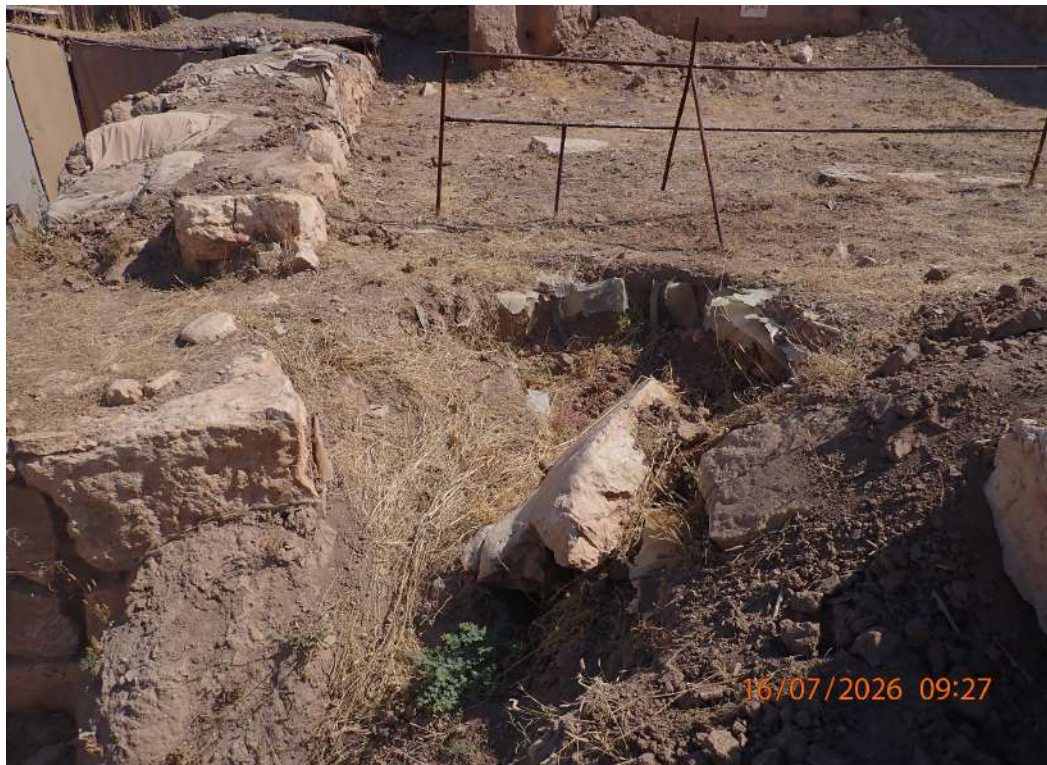
**Fig. 2: Accumulated Vegetation**

One of the most important pending tasks that should have been completed before last winter was covering the pit located in the southwestern corner of the palace's main courtyard (Fig. 1). This pit had formed as a result of the cumulative effects of rainwater over the past several years and gradually became a place where dirt and windblown vegetation accumulated (Fig. 2).

Although cleaning the pit on a regular basis was not difficult and could have been carried out with relative ease, the main concern was its continued expansion due to rainwater erosion. Over time, this could have affected the courtyard pavement or the adjacent walls, C1-1 and H3-H1. Therefore, the most appropriate solution was to restore the pit to its previous condition by covering it and addressing the causes of its deterioration.

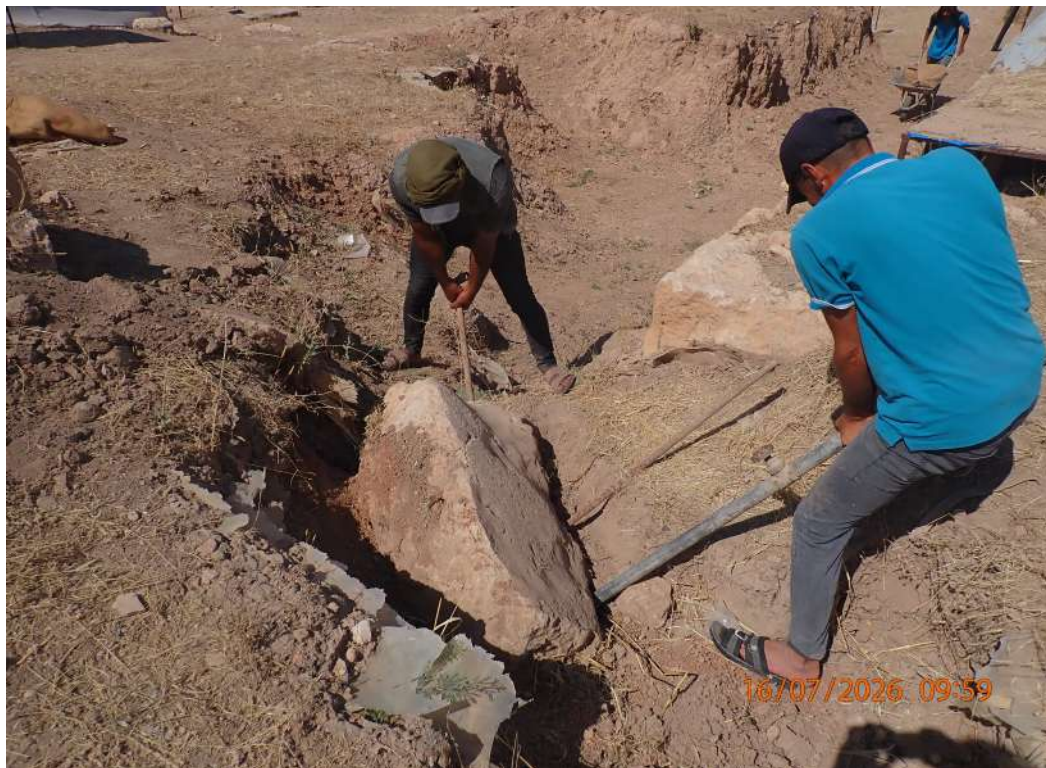
***Fig. 3: Stone Levelling***

Initially, we attempted to reposition the large stone located inside the pit in order to level it and place a burlap bag of soil beneath it to ensure that it rested in a horizontal position (Fig. 3). However, due to the stone's considerable size and weight, it could not

be moved. Consequently, I decided to leave it in its position and proceed with covering the pit without altering its location.

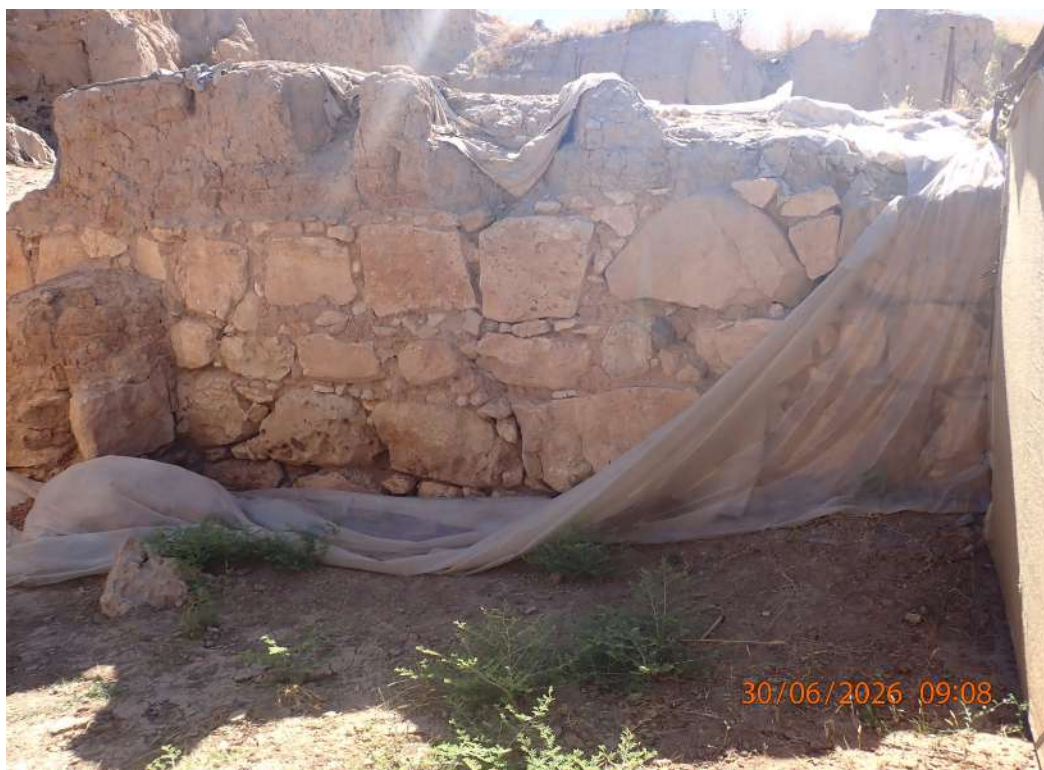
***Fig. 5: nylon from wall C1-1***

The work began with the removal of the weeds and accumulated debris from inside the pit. A layer of plastic sheeting (nylon) was then laid down (Fig. 4), using the remaining piece of nylon that had previously covered Wall C1-1. This nylon had become torn and was no longer suitable for reuse in protecting the wall during the coming winter (Fig. 5).

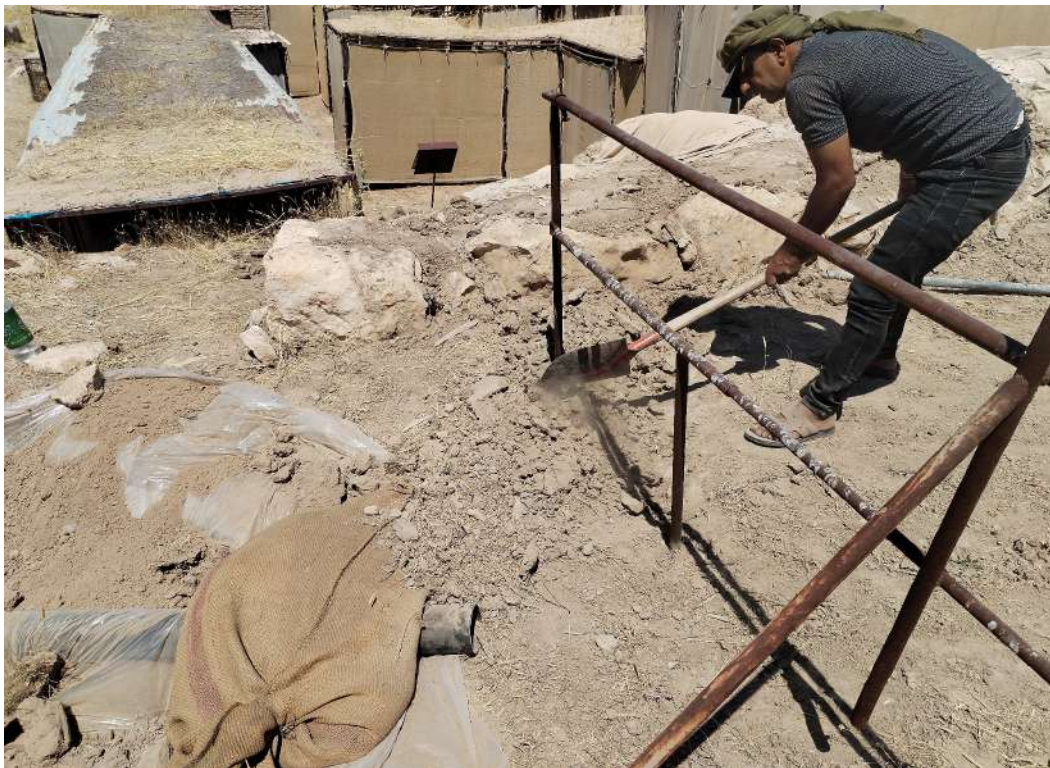
*Fig. 12: Berm Formation*

Nevertheless, this berm will require additional reinforcement before the coming winter to ensure the drainage system functions efficiently.

The pit was then backfilled with soil until the drainage pipe was completely covered (Fig. 11). A small earthen berm was subsequently formed around the pipe inlet to prevent water from bypassing the opening and to direct runoff into the pipe (Fig. 12).
