# **Report on the Review of Panels and Visitor Paths at the Site**

**Amer Ahmad**

**24.06.2026**

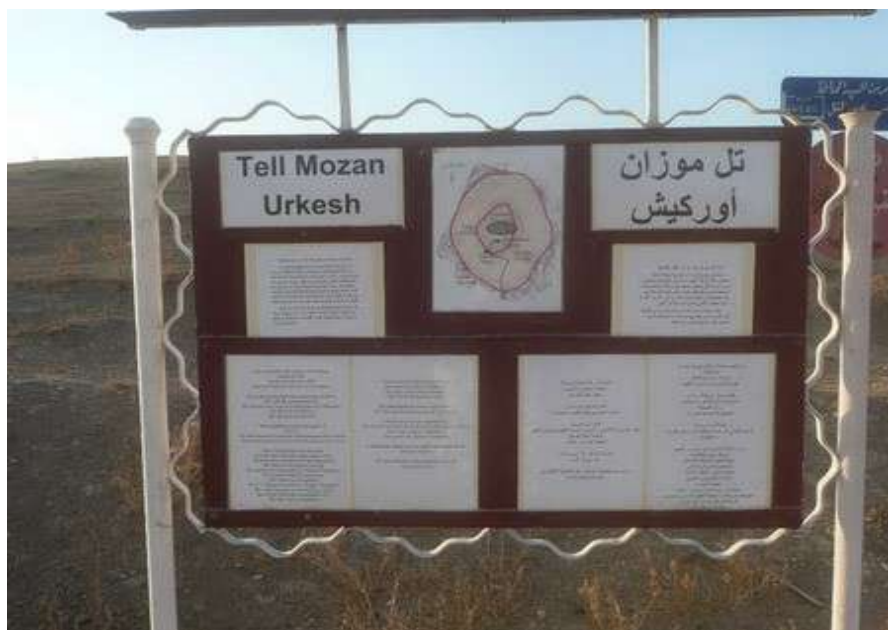
*Figure 1*

On several occasions while at Tell Mozan, I also had to inquire about the fate of panels that had existed in the past. One notable example is the large welcome panel that used to stand at the foot of the mound, at the beginning of the road leading up to the site (Fig. 1): <https://urkesh.org/MZ/A/MPR/TEXTS/A3/238-0.htm>. Unfortunately, I was

unable to locate it or determine what happened to it. Searches conducted at the mission house also yielded no results.

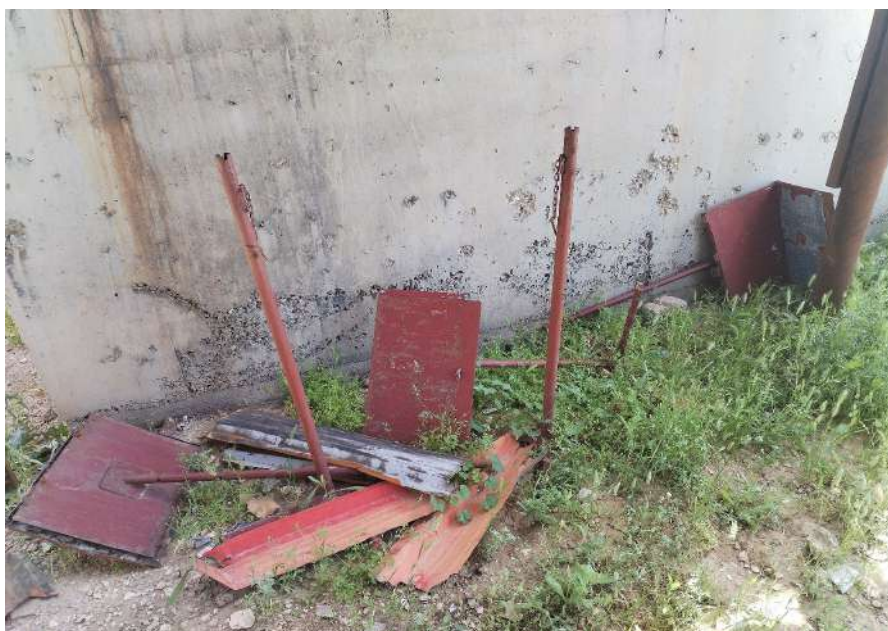
*Figure 2*

On the other hand, I was able to locate three panels “with cover”. However, they are in poor condition and require renovation of their display boards (Fig. 2). I also found three panels “without cover” (Fig. 3) that remain in relatively good condition and could be reused after some basic cleaning.

As for the panels with “covers” mentioned earlier and subsequently found in storage, I think that if they are to be reused within the site's interpretive system, only their display boards will need replacement, while the existing supports can be retained because they remain structurally sound.

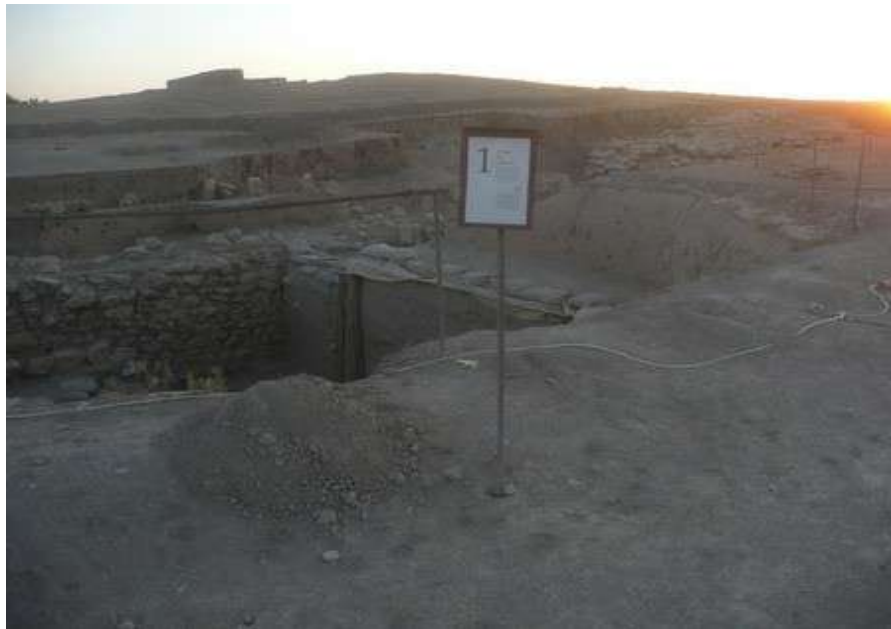
*Figure 4*

- **Facing the Centuries panel** (Fig. 4): This panel is currently missing. It should be located near Area J1, along the path leading to Area J2.  
<https://urkesh.org/pdf/signposts/01.pdf>
- **Depositional History panel** (Fig. 5): This panel is also missing from the site. In addition, the PDF file available on UGR does not correspond to this panel but rather to the previous section, *The Ancient Perception*.

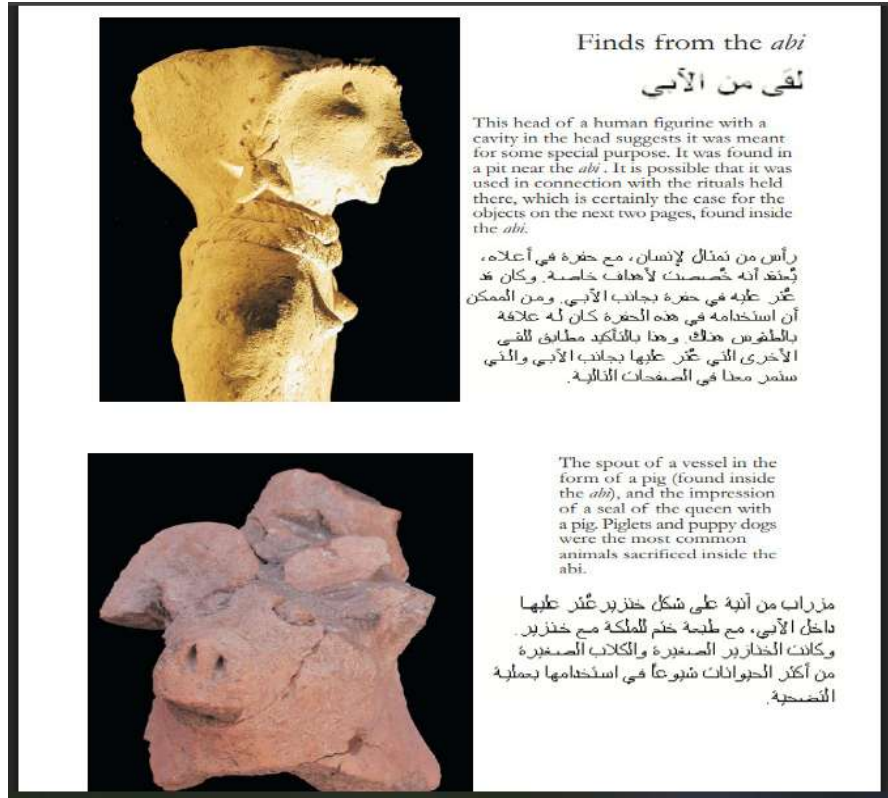
Figure 12

- **The Signpost page** (Fig. 11) is missing:  
<https://urkesh.org/pdf/signposts/07.pdf>
- **The Finds from the Abi page** (Fig. 12) is missing:  
<https://urkesh.org/pdf/stands/07a.pdf>
- In addition, the Abi panel is not available on UGR, and the images do not appear on the following page:  
<https://urkesh.org/MZ/A/MPR/TEXTS/A3/238-7.htm>

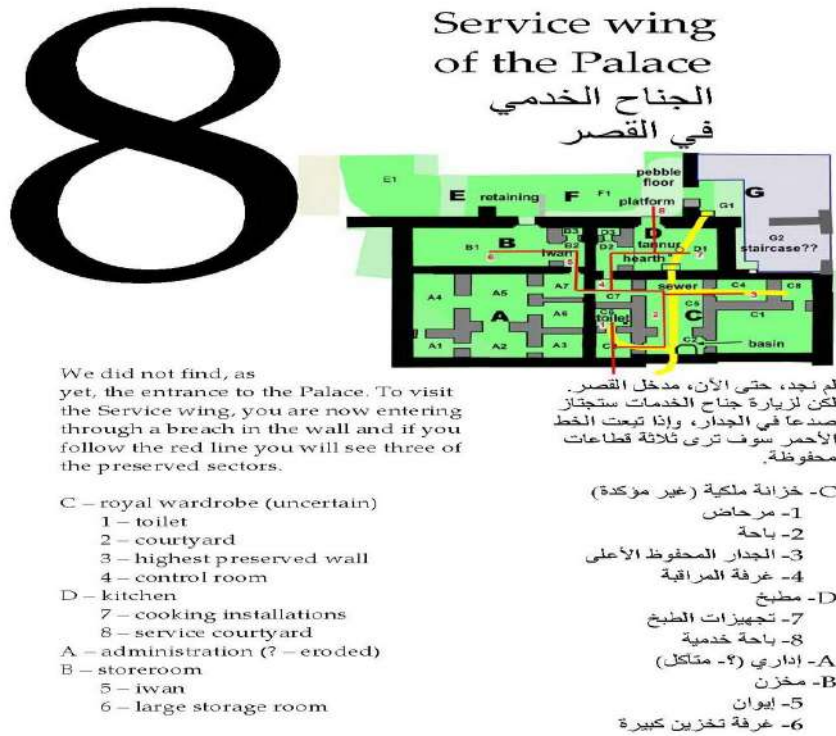
Figure 13

- **The Signpost page** (Fig. 13) is missing:  
<https://urkesh.org/pdf/signposts/08.pdf>  
No images of the corresponding panel are available on the UGR.
- **The Entering through a breach page** (Fig. 14) is missing:  
<https://urkesh.org/pdf/stands/08a.pdf>  
The webpage also requires translation into Arabic.
- **The The Palace Kitchen** (Fig. 15) one page is missing:  
<https://urkesh.org/pdf/stands/08c.pdf>  
The webpage also requires translation into Arabic.
- **The Finding Objects** (Fig. 16) one page is missing:  
<https://urkesh.org/pdf/stands/08e.pdf>  
The webpage also requires translation into Arabic.
- **The Control Room panel** (Fig. 17) is missing:  
<https://urkesh.org/pdf/stands/08f.pdf>
- In addition, no photographs of the panels belonging to this paths are available on UGR.

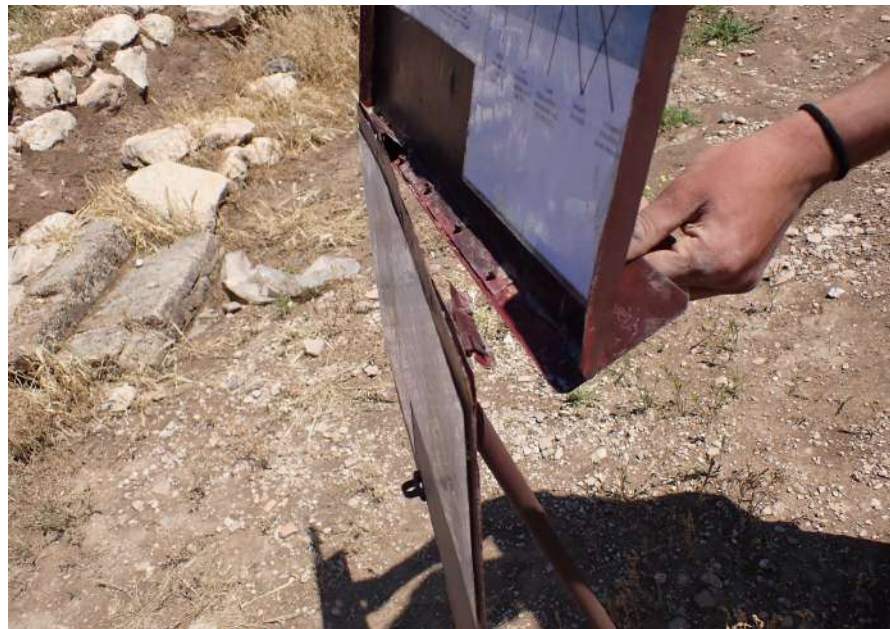
Figure 24

One example is the panel in Area **J5** (Fig. 24), which has suffered damage that makes repair impractical. There are also several panels that tilt excessively backward when opened, making them difficult to read and reducing their effectiveness as interpretive displays (Fig. 25). These panels should likewise be replaced.

therefore recommend replacing these display boards with new ones made from a stronger material that can be welded and repaired in the future if necessary.

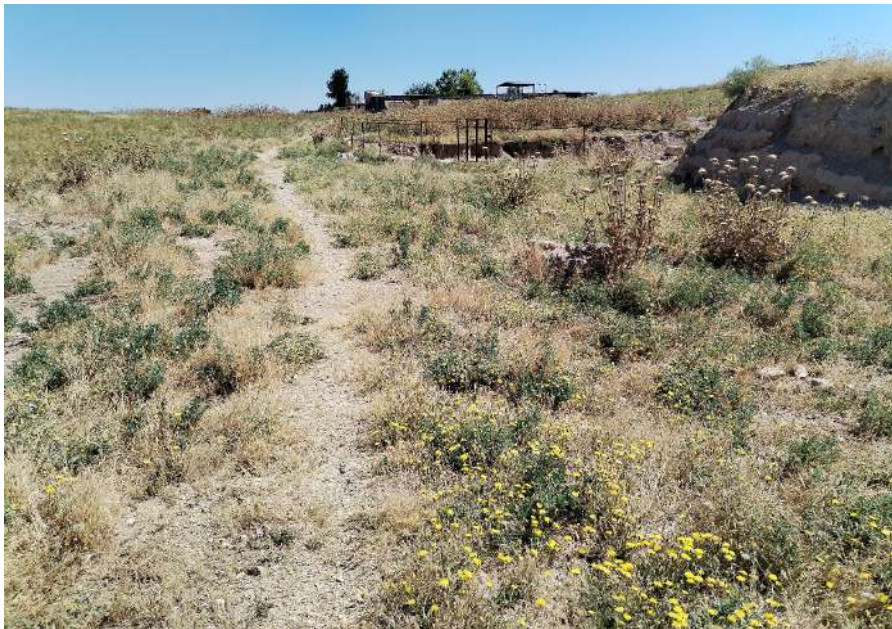
*Figure 26*

Some visitor paths have become less visible due to the loss of part of the crushed-stone surface that originally covered them, as well as the accumulation of vegetation (Fig. 26). The current plan is to remove weeds, soil, and debris from these paths and then redistribute and level the crushed stone. If it becomes apparent that additional material is required, we may need to bring more crushed stone to the site. I do not expect the quantity needed to exceed approximately two cubic meters.

- If additional crushed stone is required, approximately **2 cubic meters** may be needed. At **\$25 per cubic meter**, including transportation, the estimated total cost would be **\$50**.

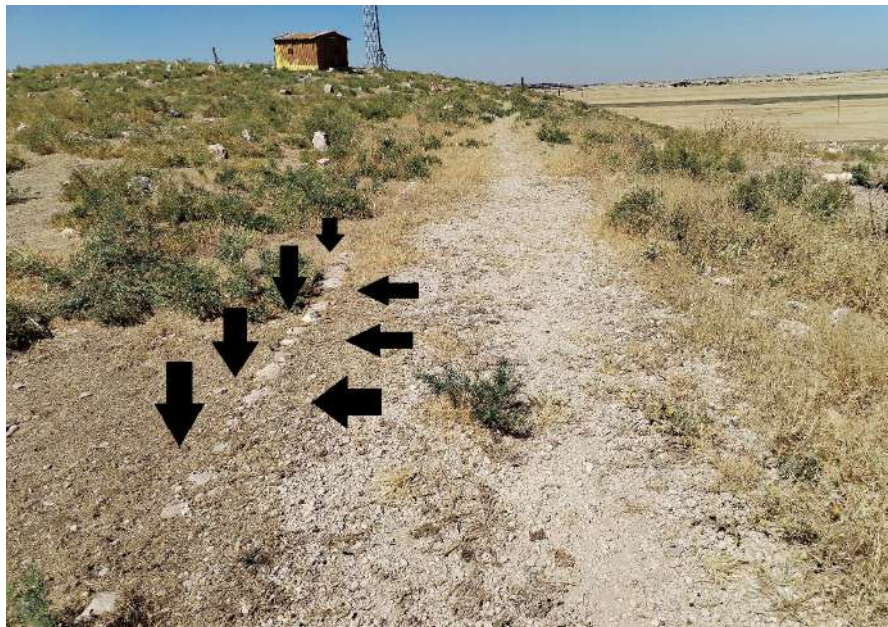
*Figure 27*

After cleaning and resurfacing the paths, small stones will be placed along both sides of the paths (Fig. 27), as was done previously, and secured with mud to prevent the

crushed stone from spreading beyond the path boundaries. However, this treatment will require periodic maintenance, as weather conditions and visitor traffic may necessitate the repositioning of stones and repair of damaged mud sections.

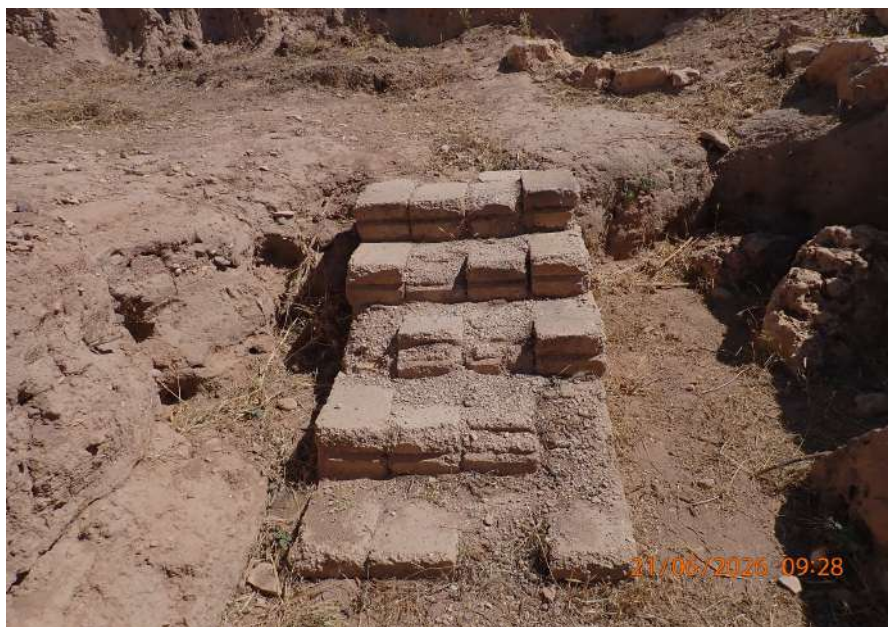
*Figure 28*

As noted in previous monthly reports, several of the cement blocks used as steps within excavation areas have deteriorated significantly and, in some cases, have become almost unusable (Fig. 28). These damaged blocks should therefore be replaced. It may be possible to reuse some blocks currently scattered around the site, particularly those located near the mission house (Fig. 29). According to preliminary estimates, no more than 25 cement blocks should be required.

- Approximately **25 cement blocks** may be required. At a cost of **\$0.65 per block**, including transportation to the mound, the estimated total cost would be **\$16.25**.

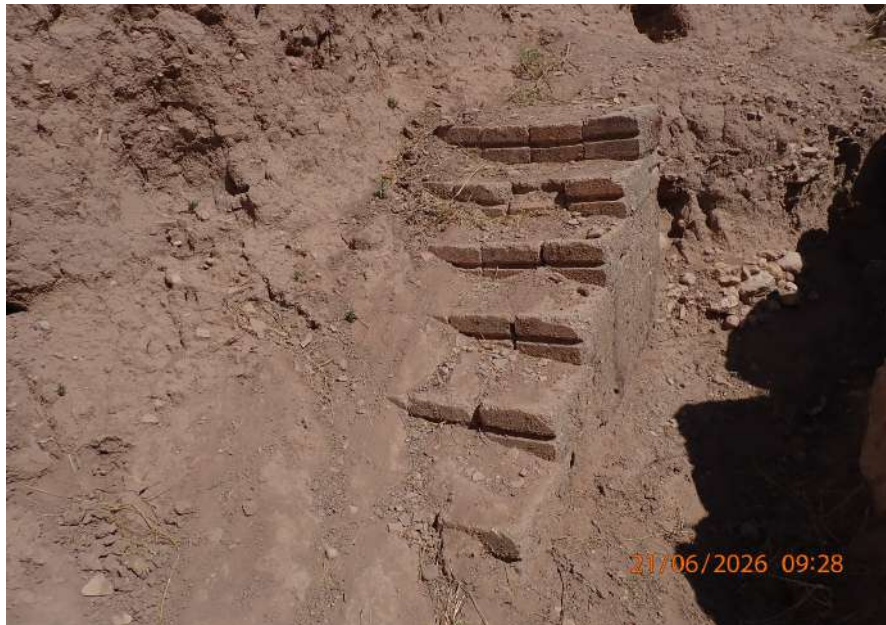
*Figure 30*

The staircase in Area **J5**, which has been buried by soil due to the collapse of the section opposite the retaining wall (Fig. 30), will be cleaned, rehabilitated, and repaired where necessary. The main issue, however, is the accumulation of soil resulting from previous collapses. In my opinion, this soil could be placed in burlap bags and used as additional support for the section. This approach may help stabilize the area and reduce the likelihood of future collapses. I would be interested in hearing your opinion on this proposal.

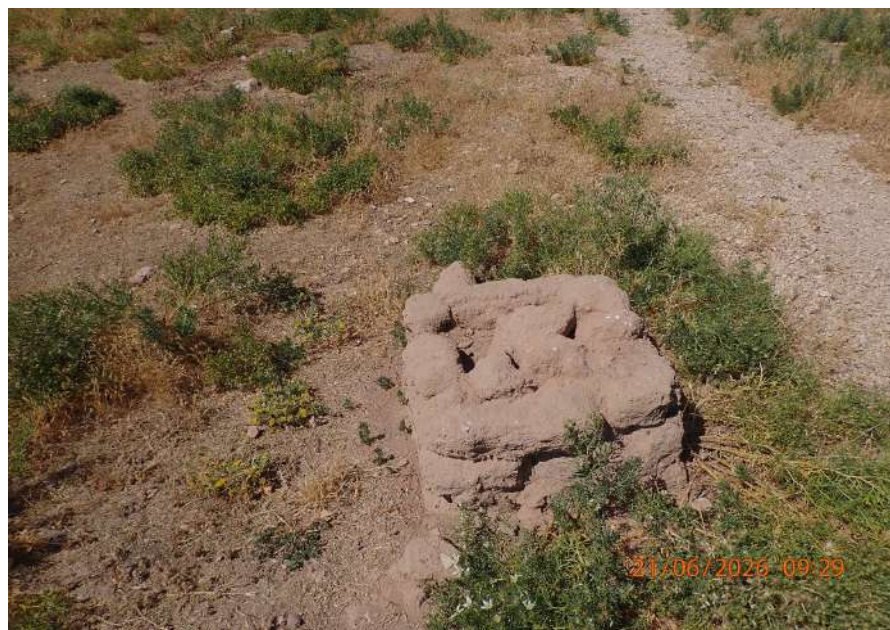
*Figure 31*

I previously constructed four mud-brick waste containers for visitors (Fig. 31), three of them along the upper path near the temple and plaza, and one near the palace. Over time, however, they deteriorated and partially collapsed due to weather conditions and the absence of regular maintenance.

The current plan is to restore these containers by repairing the existing mud-brick structures and equipping them with metal cans (Fig. 32) of the type commonly used for food products or oils. Plastic containers were previously used inside the mud structures

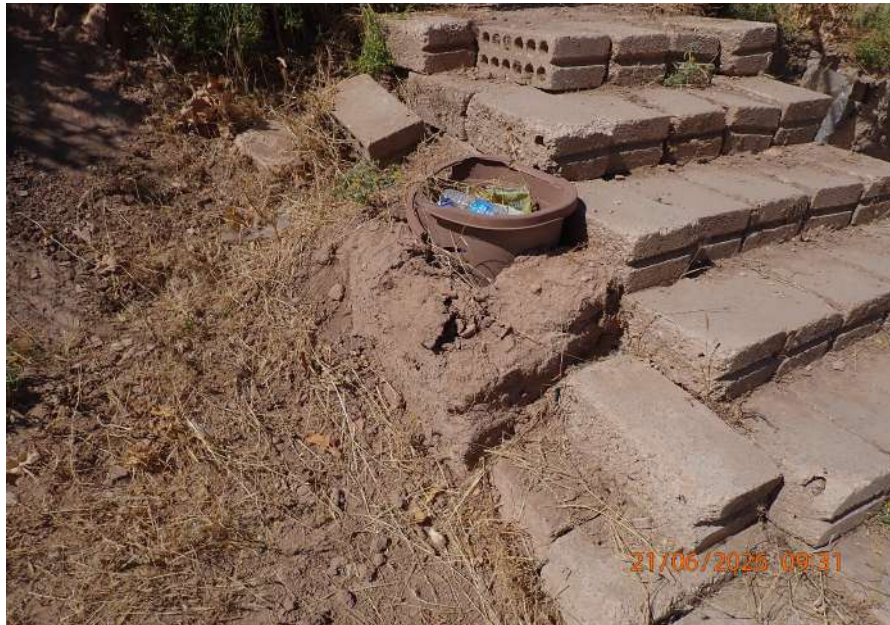
*Figure 33*

(Fig. 33), but experience has shown that they are not suitable for the site's climatic conditions, particularly high temperatures and exposure to rain.
