To cite this article: Neville Agnew (2002) Methodology, conservation criteria and performance evaluation for archaeological site shelters, *Conservation and Management of Archaeological Sites*, 5:1-2, 7-18, DOI: [10.1179/cma.2002.5.1-2.7](https://doi.org/10.1179/cma.2002.5.1-2.7)

Methodology, conservation criteria and performance evaluation for archaeological site shelters

NEVILLE AGNEW

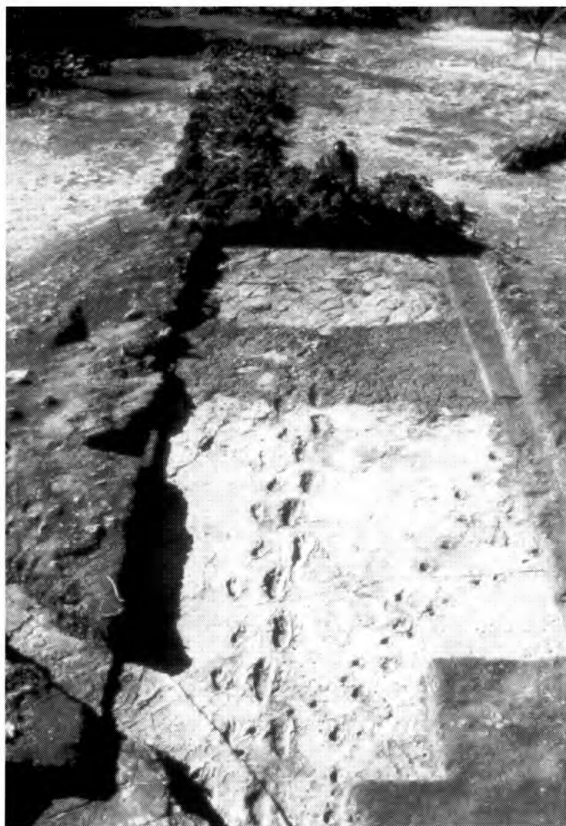
Figure 1. Re-excavated southern section of the Laetoli hominid trackway, after conservation and documentation in 1995 and prior to reburial (photo: N. Agnew, copyright J. Paul Getty Trust).

Sheltering is sometimes not the best way to preserve a site, however important and worthy of preservation. For example, at the fragile site of the Laetoli hominid trackway (Fig. 1) in a remote part of Tanzania, various groups had proposed a shelter and public access (as well as other options such as lifting the tracks). The condition and management assessments and conservation criteria for sheltering showed very clearly that a shelter could not fulfill its purpose. The strong recommendation not to shelter was based on considerations such as the rapid weathering of the volcanic tuff, its mechanical weakness, remoteness of the site, lack of infrastructure (water, power, access road), lack of trained personnel, security of the site and inadequate maintenance capability, among other considerations. Consequently, the site was reburied (Fig. 2) and as part of the project an interpretive display was created with a replica of the trackway at the existing Olduvai Museum some distance away [3, 4].

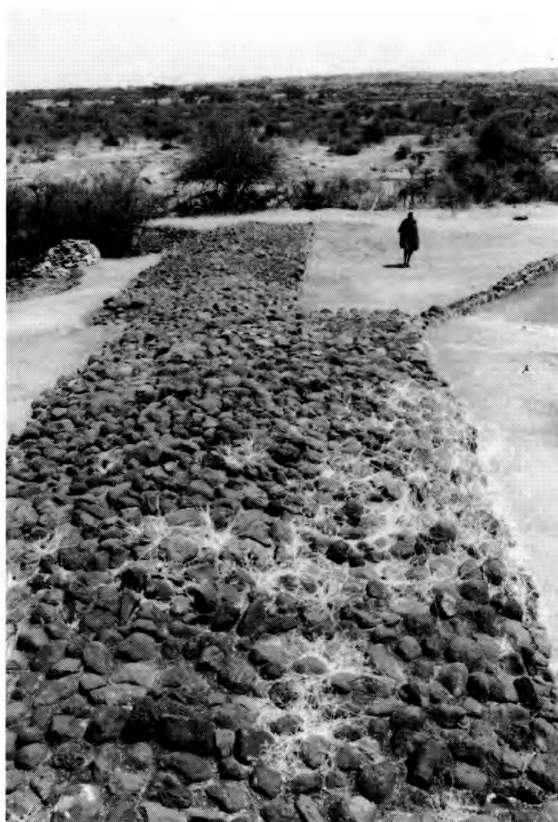
Figure 2. Entire conserved and documented Laetoli trackway after reburial in 1996 (photo: A. Bass, copyright J. Paul Getty Trust).

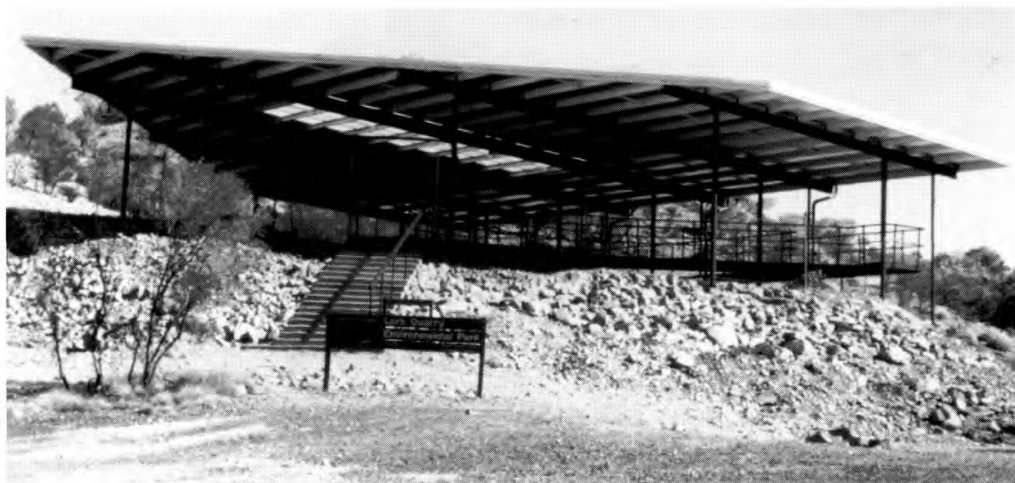
Figure 3. Roof at Lark Quarry in 1981, prior to the erection of a perimeter fence to prevent kangaroos sheltering under the roof. Natural lighting is provided by translucent panels and visitors view the tracks from a raised walkway (photo: N. Agnew).

That being said, the shelter built in 1979 comprised a pentagonal flat roof set on steel posts in concrete footings (Fig. 3). There are a number of cautionary lessons to be learned from both the design and the construction of this shelter. The construction work for the shelter was not supervised and damage occurred where one of the concrete footings destroyed a holotype footprint. The straw and plastic protective covering on the surface was not removed during construction and caught fire during welding. This resulted in darkening and exfoliation of the surface. The shelter roof is open at the sides and does not exclude wind-blown rain and dust. Today we are all aware that the environments created by shelters also attract un-

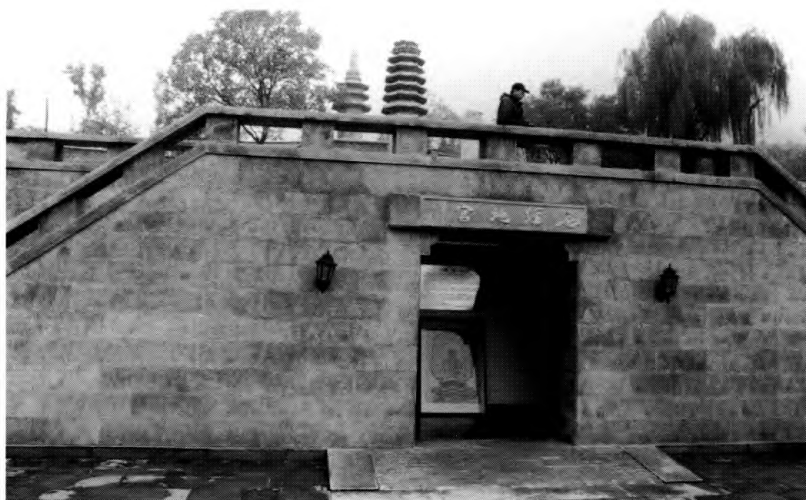
Figure 5. Underground shelter for inscribed stone stele at Yunju Temple near Beijing (photo: N. Agnew, copyright J. Paul Getty Trust).

At Yunju Temple, an ancient Buddhist site near Beijing (not far from the Peking Man fossil site), some 10,000 stone stele inscribed with texts predicting the end of the world, dating from about the 6th century, were excavated and in recent years housed on site in a new underground shelter (Fig. 5). This was done, presumably, to mimic the original deliberate burial of stele. This is an interesting hybrid of sheltering and 'reburial' of which a number of other examples exist, e.g. Tubac in Arizona and Atri [6] in Italy. Visitors view the stele, through glass, in their nitrogen-filled underground gallery. The stele are stacked in rows one behind the other and are inaccessible (Figs 6 and 7).

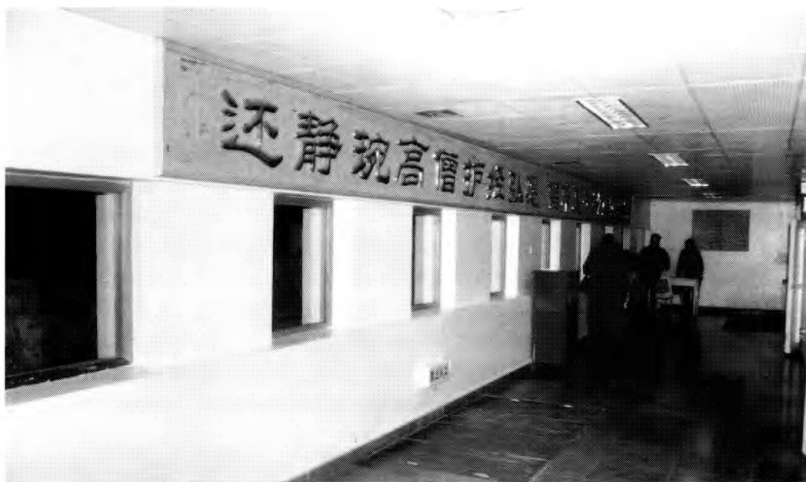
Figure 6. The underground viewing gallery at Yunju Temple (photo: N. Agnew, copyright J. Paul Getty Trust).

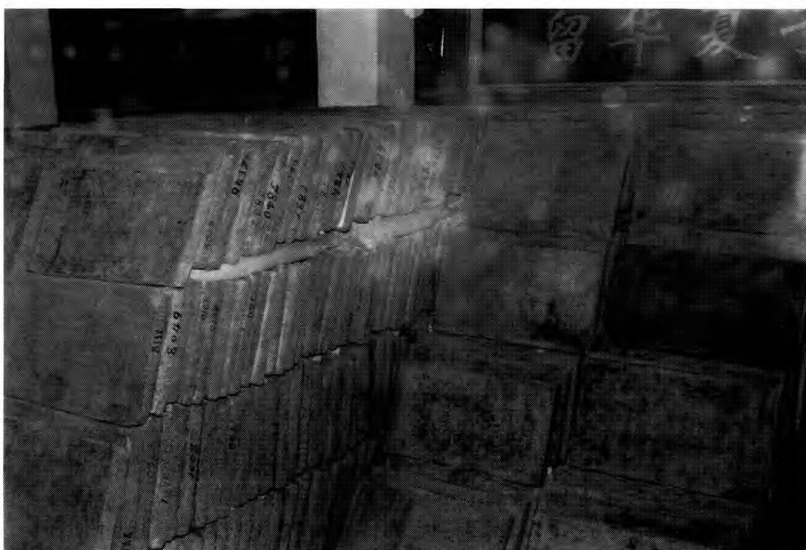
Figure 7. Stacked stele at Yunju Temple. View through the window ports (photo: N. Agnew, copyright J. Paul Getty Trust).

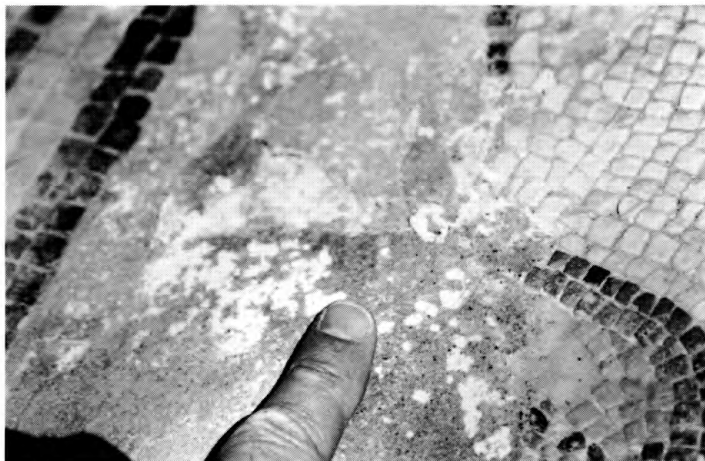
Figure 9. Accumulation of soluble salts by capillarity from the ground. Sheltered mosaic at Paphos, Cyprus (photo: N. Agnew, copyright J. Paul Getty Trust).

Buildup of soluble salts under shelters is often not realized as a consequence of sheltering. Any good shelter will have a rainwater disposal system from the roof and this is obviously an essential requirement, yet capillary rise from soil moisture or ground water, together with lateral migration from the unsheltered surroundings which are wetted by rain, brings soil salts to the surface. Ventilation systems in shelters have the potential to exacerbate this phenomenon by accelerating evaporation from the

sheltered surface. If a capillary supply of moisture is feeding this evaporation, the problem is made all the worse. Of course, under the shelter, the accumulation of salts is not reduced by rainfall as the surface is not wetted. The consequences of accumulation of salts on a fragile surface naturally are often quite destructive (Fig. 9). This may be an intractable problem, but one which is best addressed by ensuring that site drainage is effective, and capillary rise of moisture is minimized.

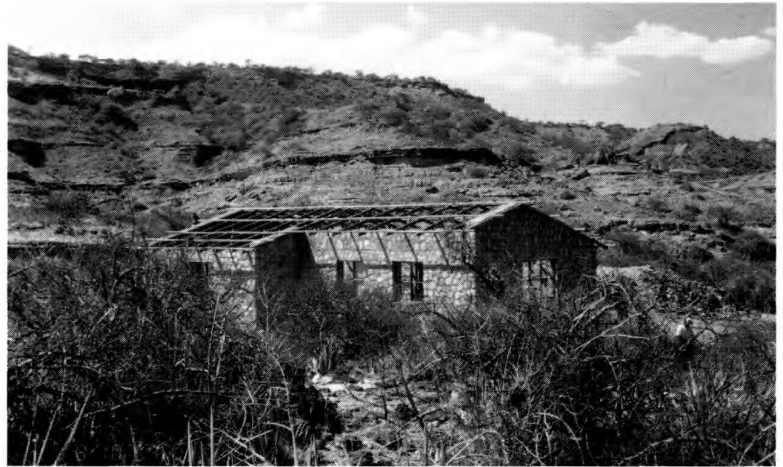
Figure 10. Shelter building over the DK hominid site in Olduvai Gorge, Tanzania (photo: N. Agnew, copyright J. Paul Getty Trust).

In poor countries building materials are a valuable commodity. Where sheltered sites are not staffed the shelter itself may become the target, not of vandals but of local people wanting materials. A shelter may literally disappear overnight. This might seem an obvious risk given foresight, yet it happens. The so-called DK site, a two-million-year old hominid site in the Olduvai Gorge, was sheltered by Mary Leakey in the 1960s or 1970s. Within a short while, the valuable galvanized steel roof was stripped. The shelter has never been repaired and today the site is derelict (Fig. 10). Other sites in the region have experienced a similar fate [7].

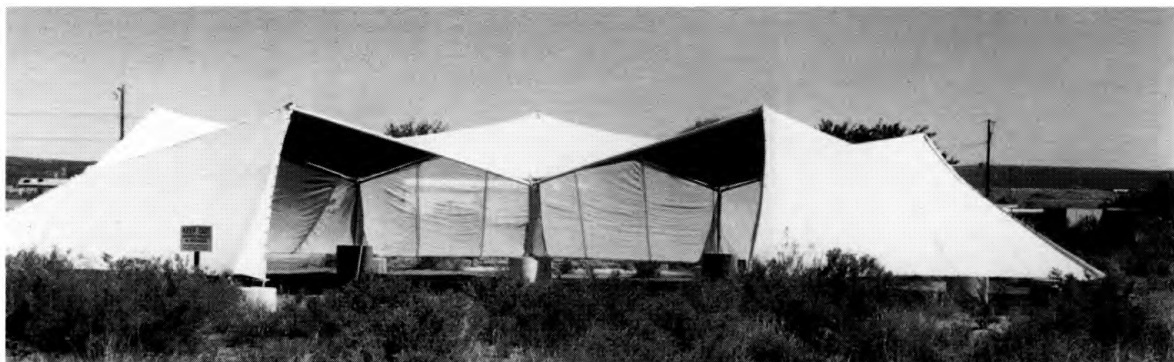
Figure 11. Hexashelter at Fort Selden, New Mexico. The roof is an impervious membrane and the side-panels are a knitted, open-weave synthetic textile (photo: N. Agnew, copyright J. Paul Getty Trust).

In passing, it should be mentioned that 'hexashelter' is a catchword for the hexagonal 'footprint' of each module. This experimental shelter (Fig. 11) was erected specifically to evaluate its effectiveness (or otherwise) in reducing climatic impact. This was
