## Sector A: Foundations

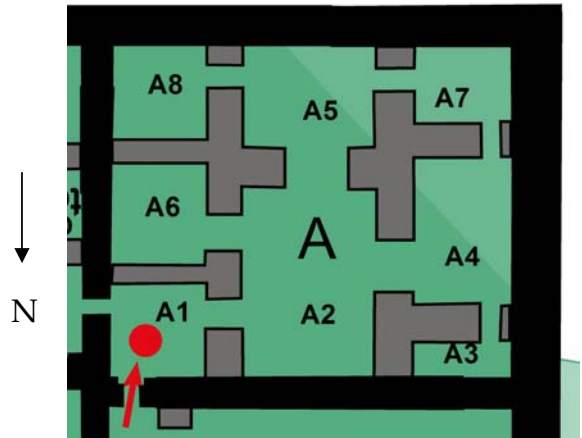
We do not know the function of sector A because all its floors were eroded (you can see how the surface of the tell slopes down sharply in this direction).

But we can still identify patterns of circulation, and we can gain new insights in the construction history of the building by looking at its foundations.

We have protected with iron trellises only the perimetral walls, while we have left exposed the inside partition walls. White rods mark clearly their outline.

By each doorway we have exposed the lowermost course of stones. As you will see, the typology is very varied. In the doorway in front of you (between A1 and A2) the foundation ties the walls across the doorway itself. The doorways between A6-A2 and A2-A4 show a step on the south side.

You can also see how the partition wall between the A and the B sectors is very high founded (we have left a gap between the reconstructed portion to the east, and the original in the west).

The walls sit on a slope which was evened out with compact and clay rich fill (a deep color red known locally as *baqaya*).
