# **Plastering of the Protective System**

**Amer Ahmad**

**18.11.2025**

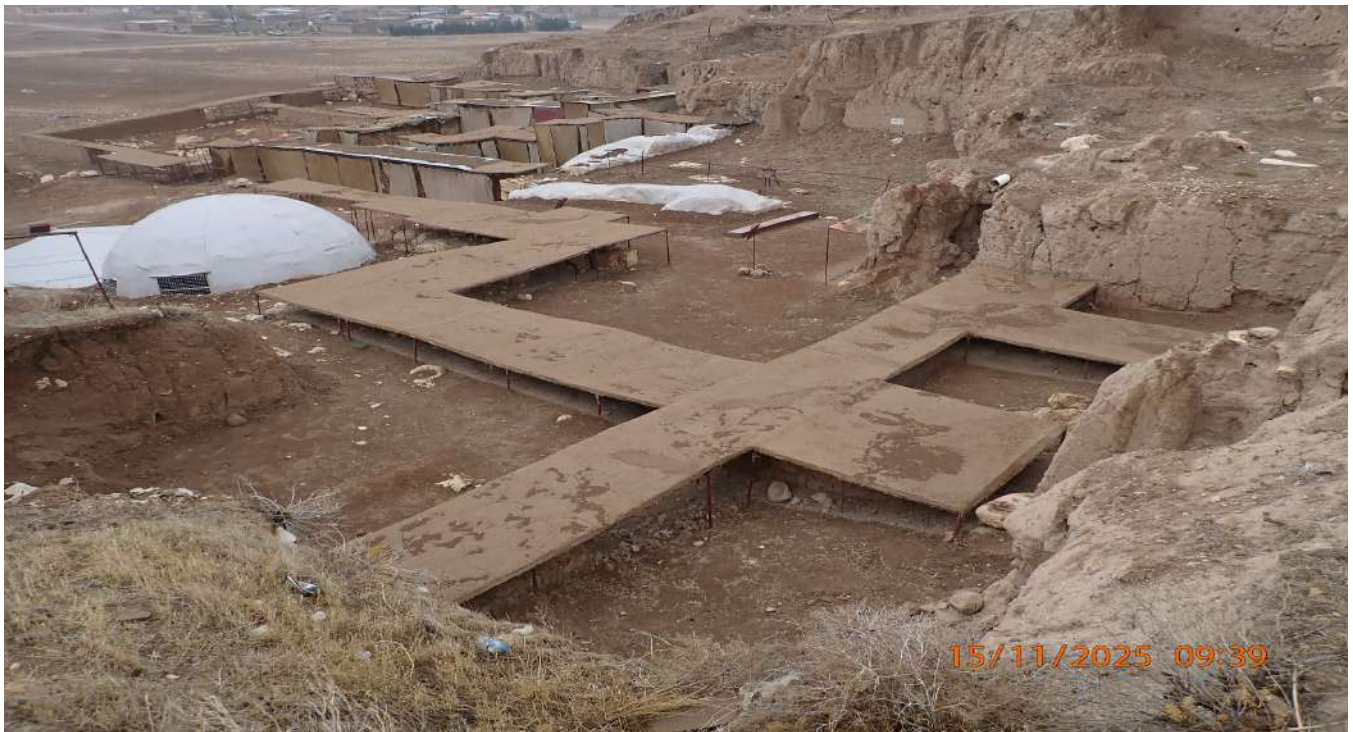
Erosion caused by rain and wind gradually removes the upper layers of soil, leaving the underlying architectural remains increasingly vulnerable to damage (Fig. 1).

*Figure 1: An image illustrating the impacts of weathering on the Tell Khazna excavations*

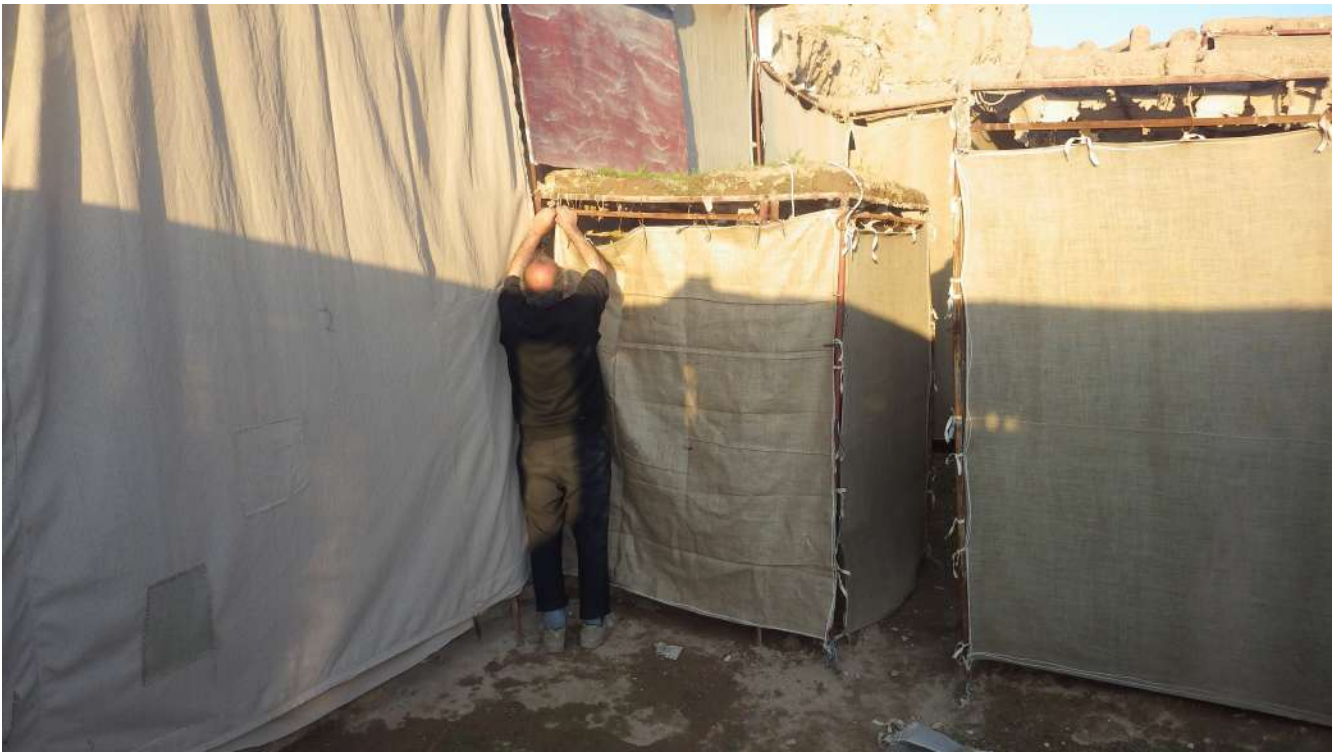
Since 1990, the mission has developed a specialized protective system for the palace walls, which evolved into the current framework consisting of metal rods and structures that follow the contour of the walls, forming a virtual reconstruction of the building (Fig. 2). Brown burlap is attached to the structure to shield the walls from rainfall. This system is simple and efficient, allowing easy inspection of the walls (Fig. 3).

*Figure 2: The protective system as a virtual reconstruction of the palace building*

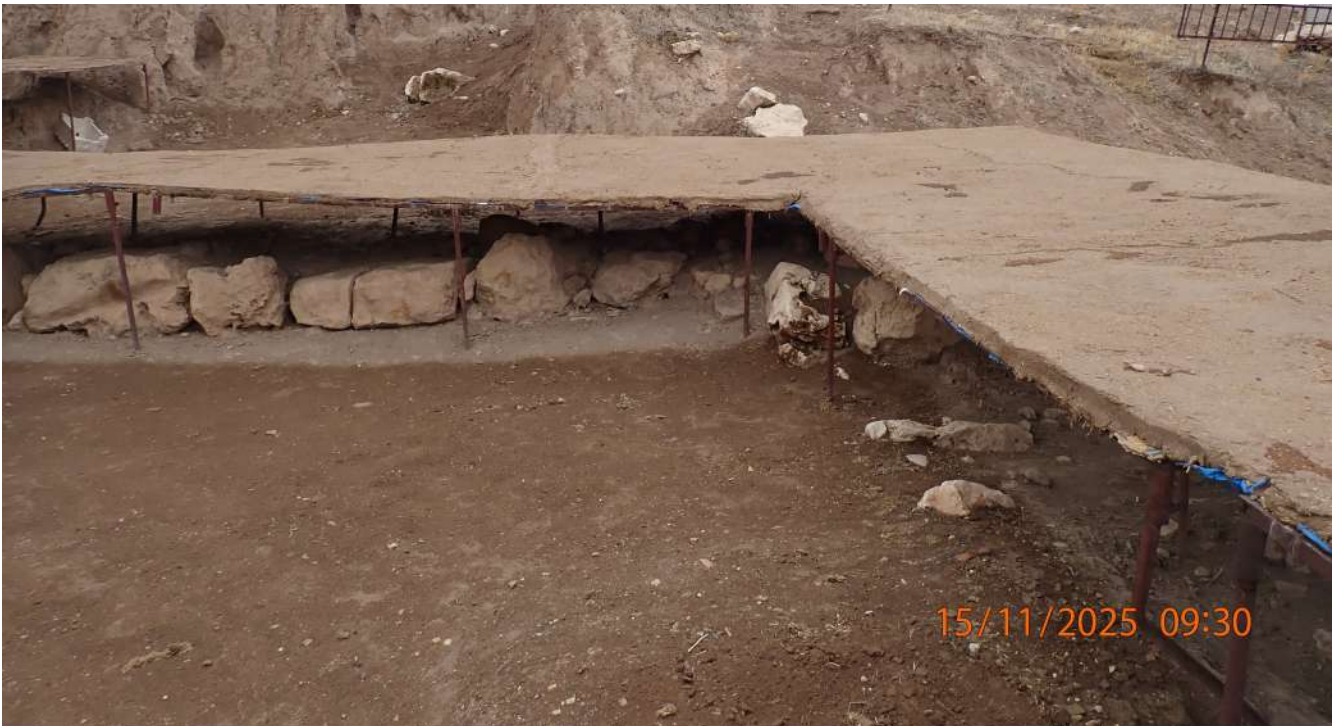
*Figure 3: The simplicity of the protective system and the brown-colored burlap*

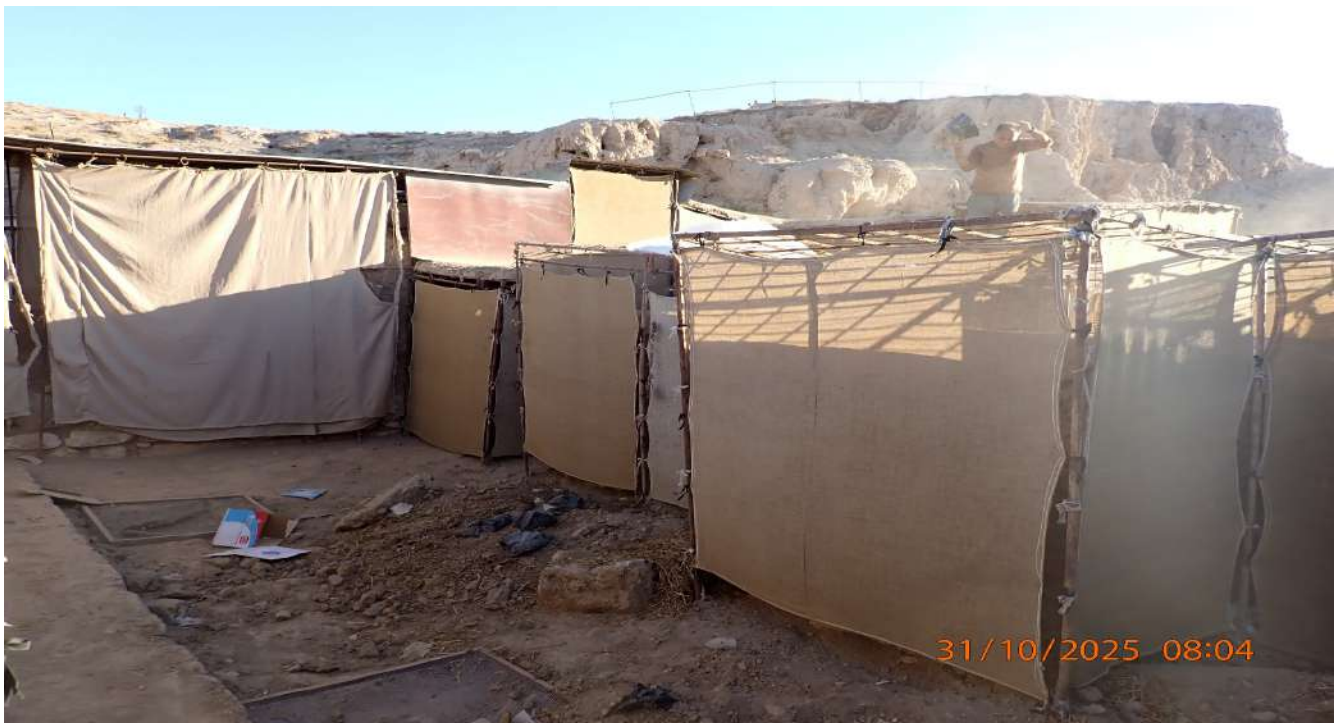
*Figure 11: Removal of the fragile and deteriorated mud plaster*

The work area consisted of two main sections: Sector H and the service wing sectors. Work began in Sector H before progressing to the other sectors. The process involved the removal of all fragile and deteriorated mud plaster (Fig. 11), which resulted in debris accumulating at the base of the walls and on the room floors (Fig. 12). The debris was collected (Fig. 13) and transported away from the excavation areas (Fig. 14) for disposal at a more distant location later.

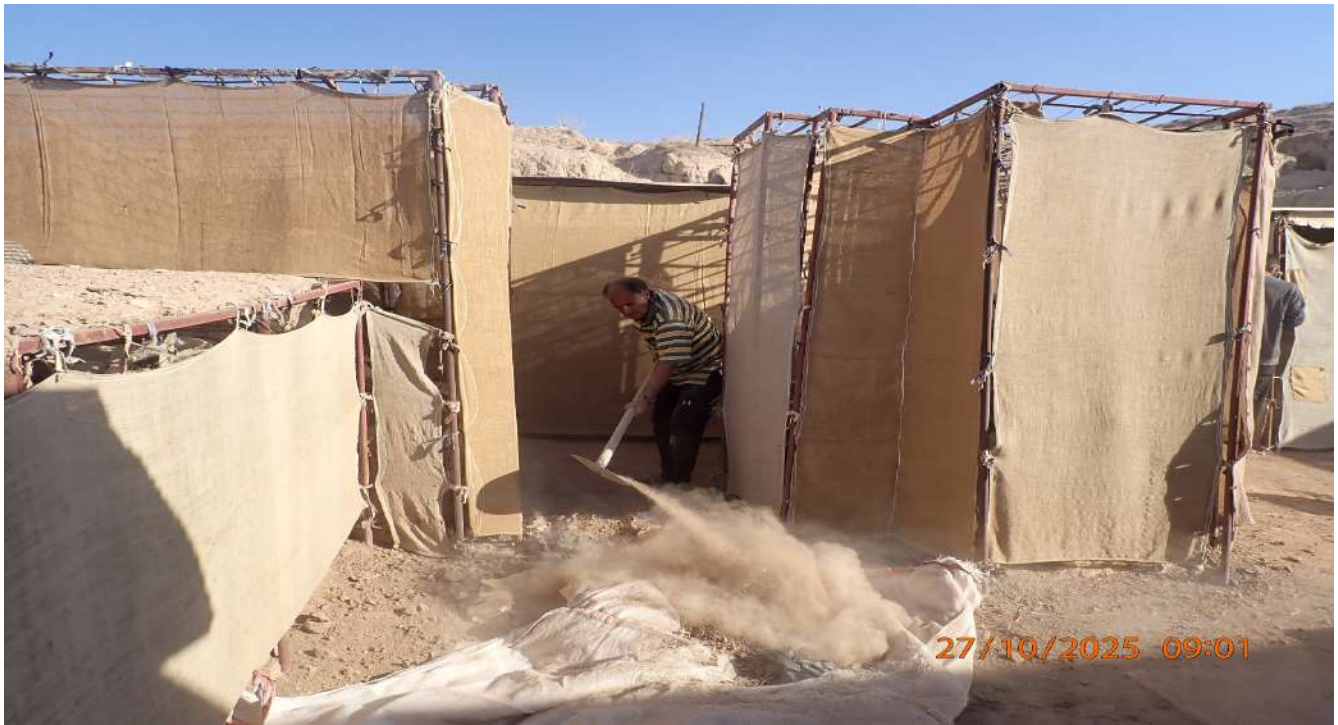
*Figure 12: Debris accumulated at the base of the walls and on the room floors*

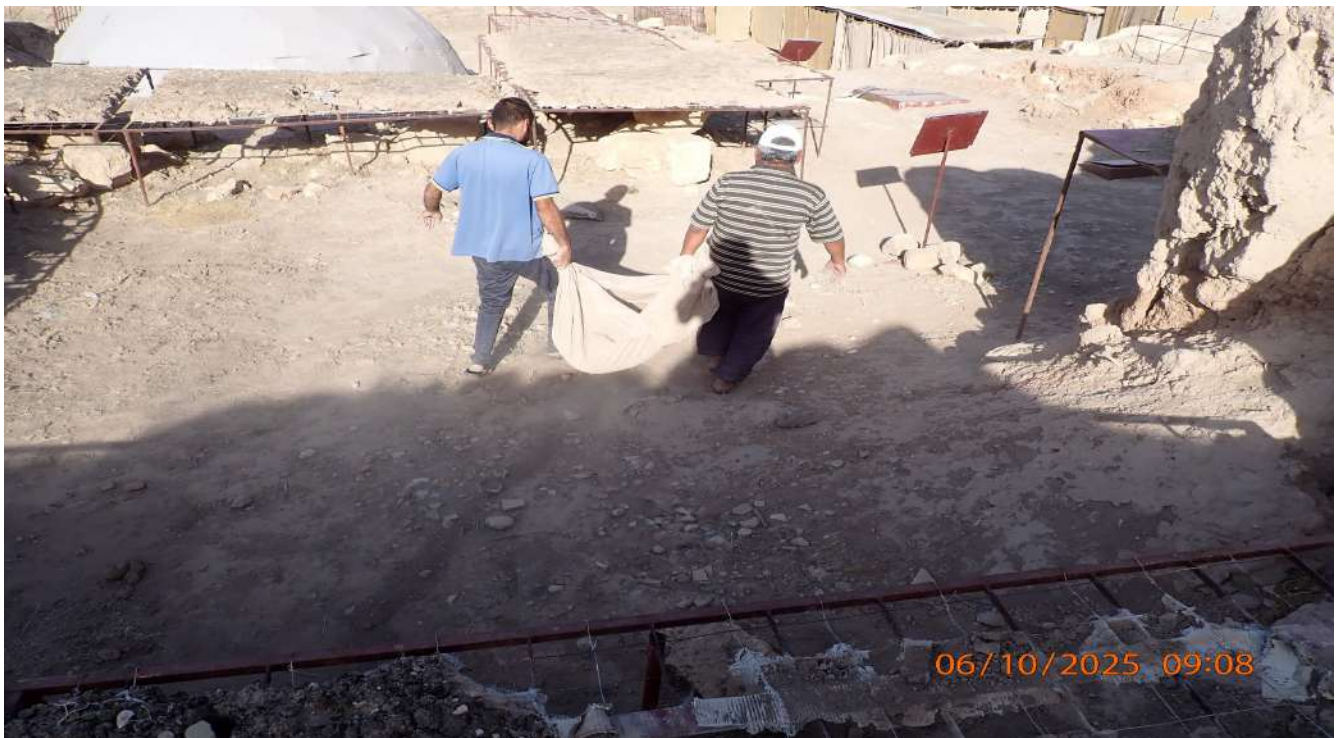
*Figure 13: Collection of the debris*

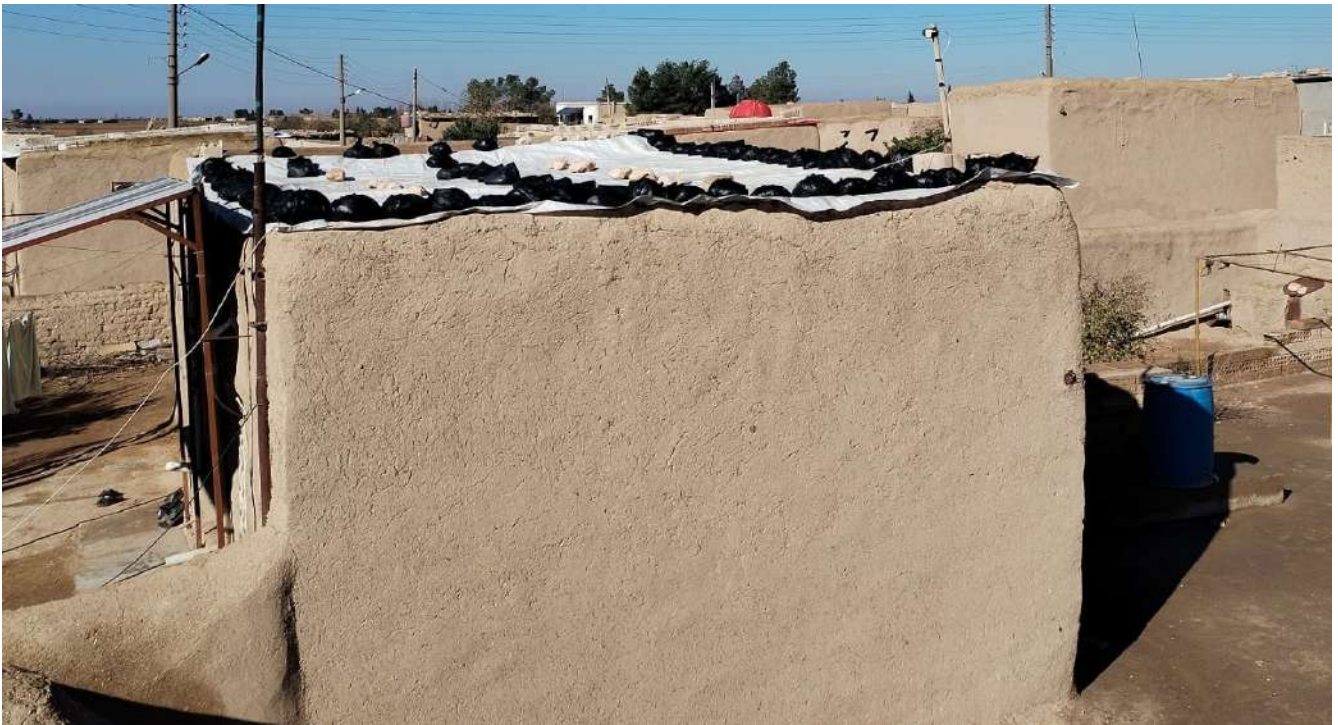
*Figure 16: Placement of plastic sheet*

Additional metal wires were installed in areas requiring reinforcement (Fig. 15), followed by the placement of plastic sheet (Fig. 16) of the type commonly used locally to cover mud-brick houses (Fig. 17). A layer of cardboard was then added to reduce pressure on the plastic sheet and wires (Fig. 18) and to prevent clay blocks from slipping through lower openings.

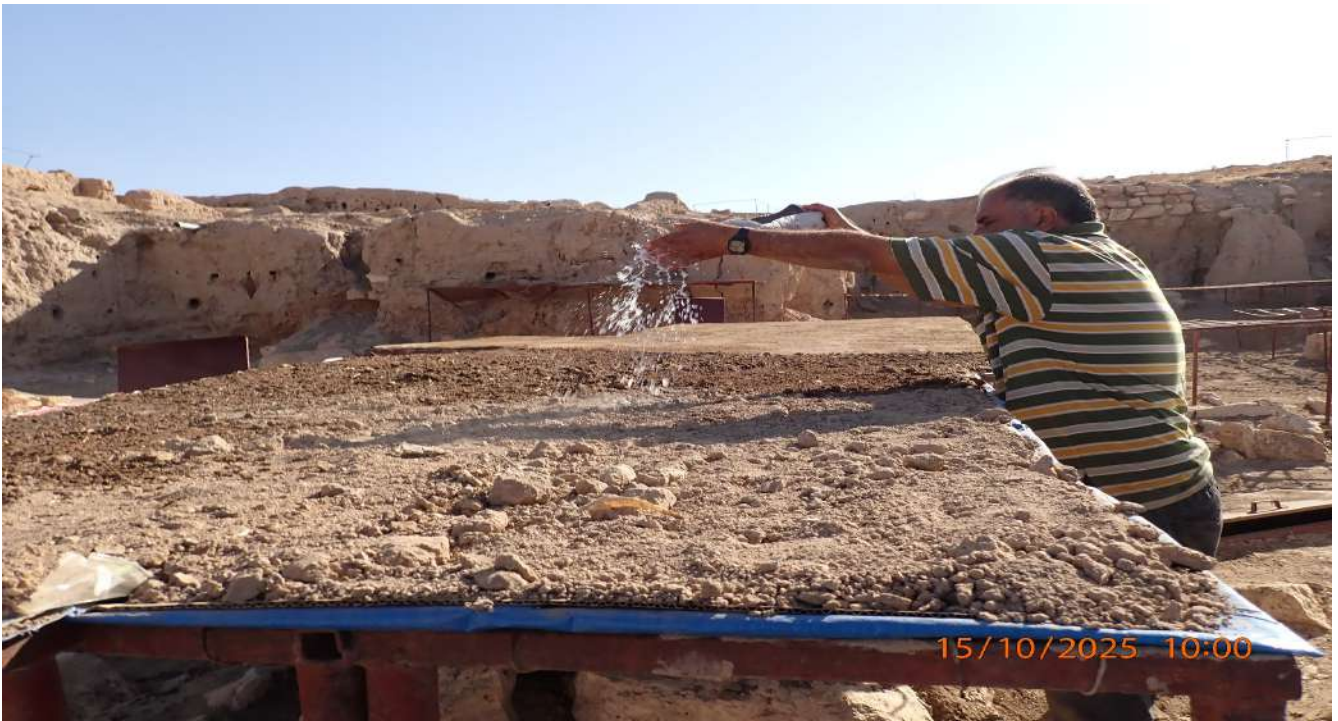
Subsequently, a layer of soil from the old mud plaster was applied (Fig. 19). Due to the fragility and deterioration of the old plaster, it was not used in its entirety. Additionally, excessive weight on the surfaces could cause the metal rods to bend, as observed in one of the rods at the opening of the south wall of Room C3 (Fig. 20), or lead to the lowering of the sheet metal (*tutiya*), which came into direct contact with the wall, as seen in Wall F1-4 (center) (Fig. 21). Although a blacksmith had previously been present on-site, the rods were not adjusted in order to avoid any unintended damage to the protective structure.

*Figure 21: Contact of the sheet metal (tutiya) surface with the top of Wall F1-4 (center)*

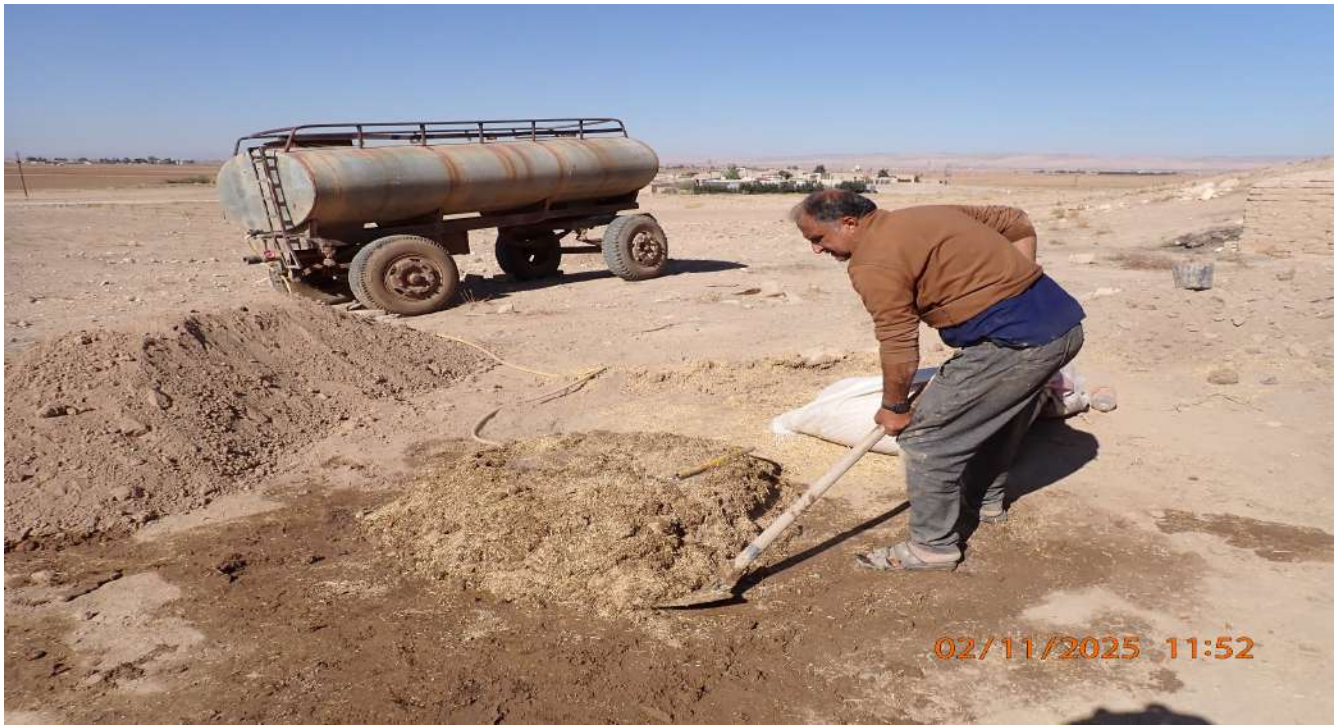
*Figure 22: Soil moistening*

Once the surfaces were prepared, the soil was moistened to ensure adhesion with the new mud plaster (Fig. 22). The mud plaster was then prepared (Fig. 23), and a thicker-than-usual plaster layer was applied (Fig. 24), as traditional plaster layer is typically thin.

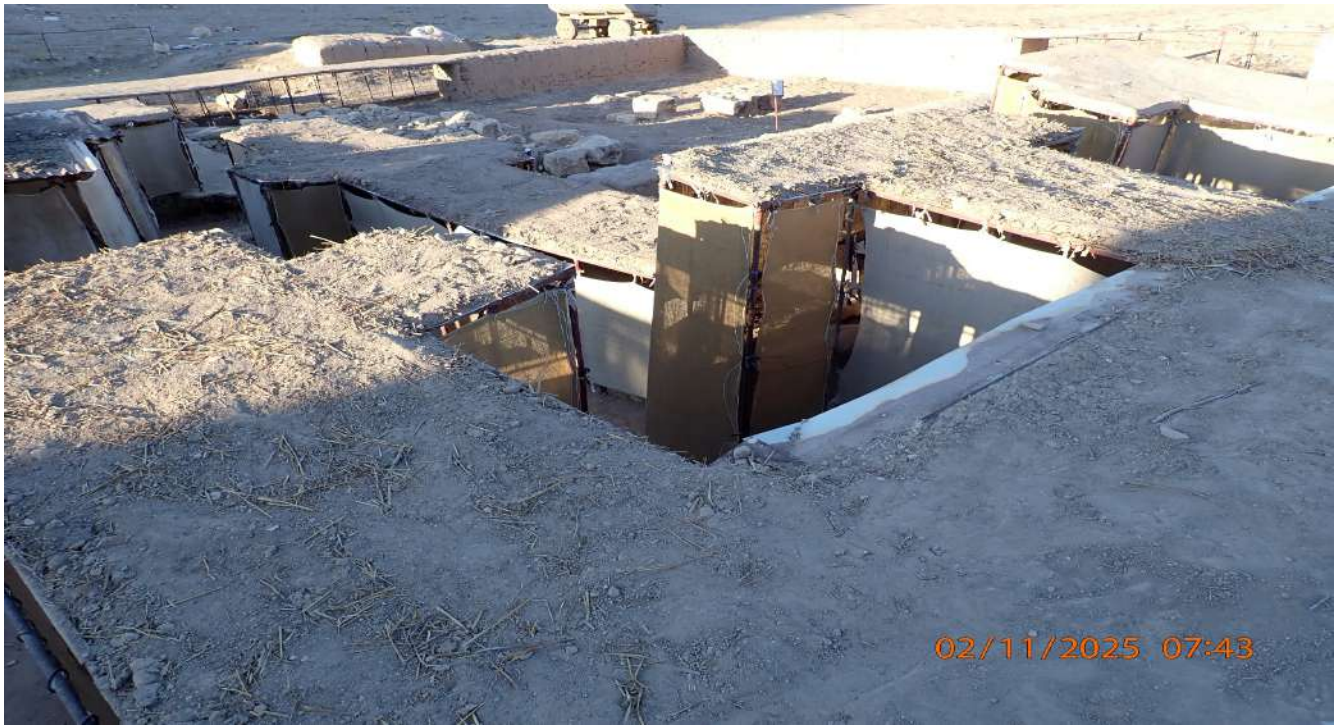
*Figure 24: Application of a thick plaster layer*

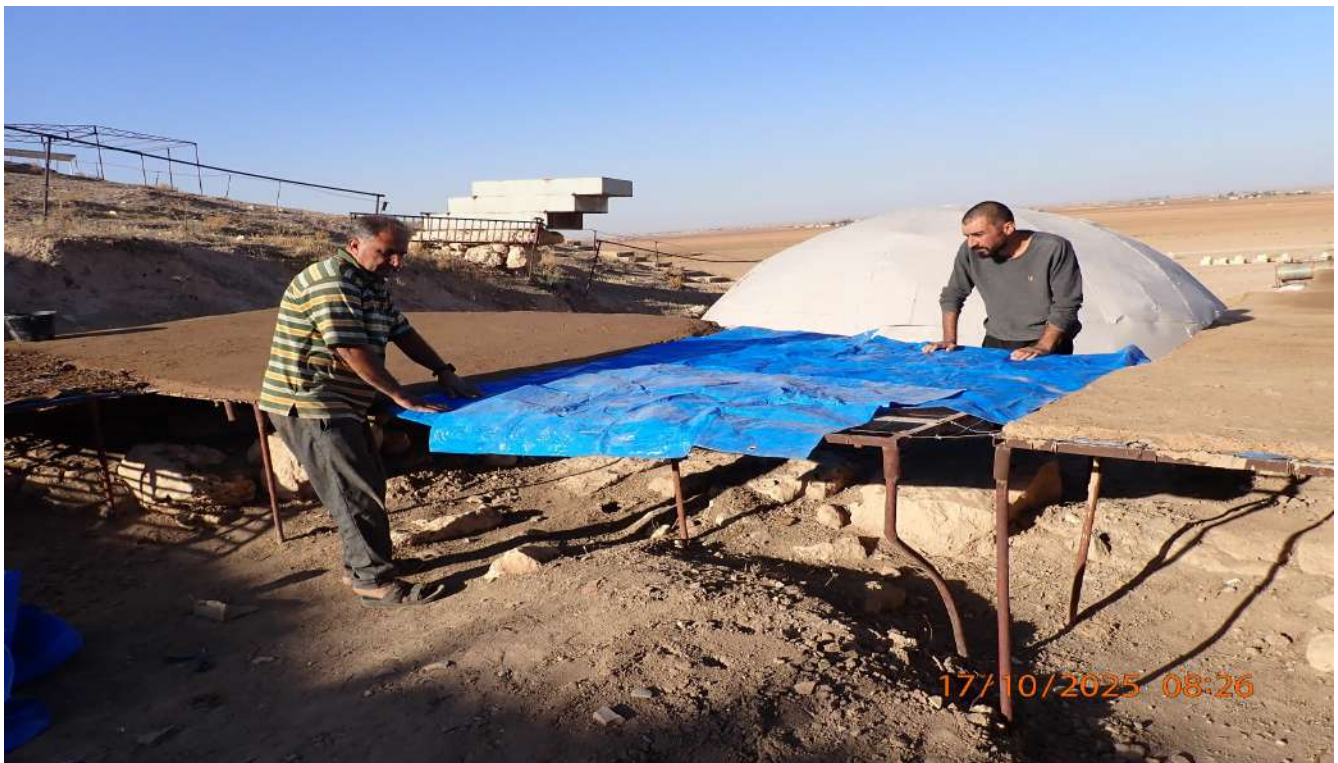
*Figure 25: Preparation of service wing surfaces*

In the service wing sectors, the surfaces were prepared all at once (Fig. 25), unlike in sector H, where each section was prepared and plastered before moving to the next (Fig. 26). This sequential method increased the duration of work and the cost of water supply. Work in sector H took 13 days, while plastering in the service wing required only 5 days, bringing the total effective working time to 18 days.
