MZ23  
U904  
ed1 (Elizabeth Drolet)

## Wall Conservation Lexicon

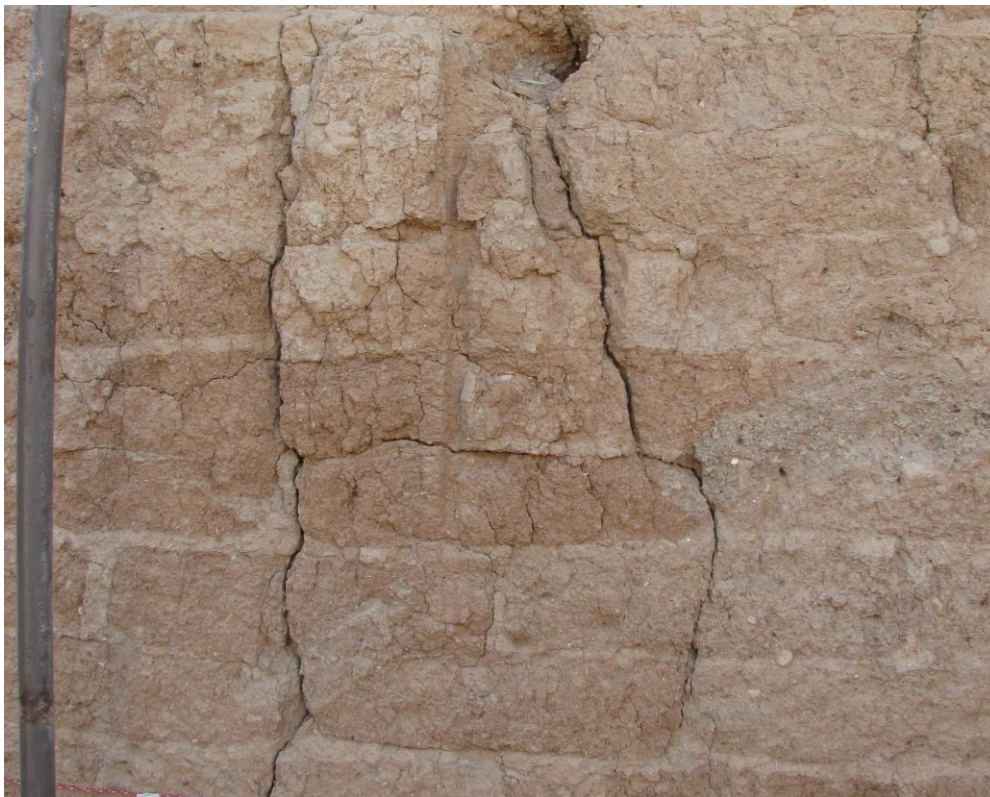
#### **Cracks:**

Fissures in the structure of the wall. These can be vertical or horizontal. The severity of the cracks can be determined by noting the overall length of the crack, and whether or not it is gapped (has space in between). Thin cracks with little or no space in between are fairly minor,

while long cracks with  $\frac{1}{2}$  cm of space or more are severe and should be carefully monitored.

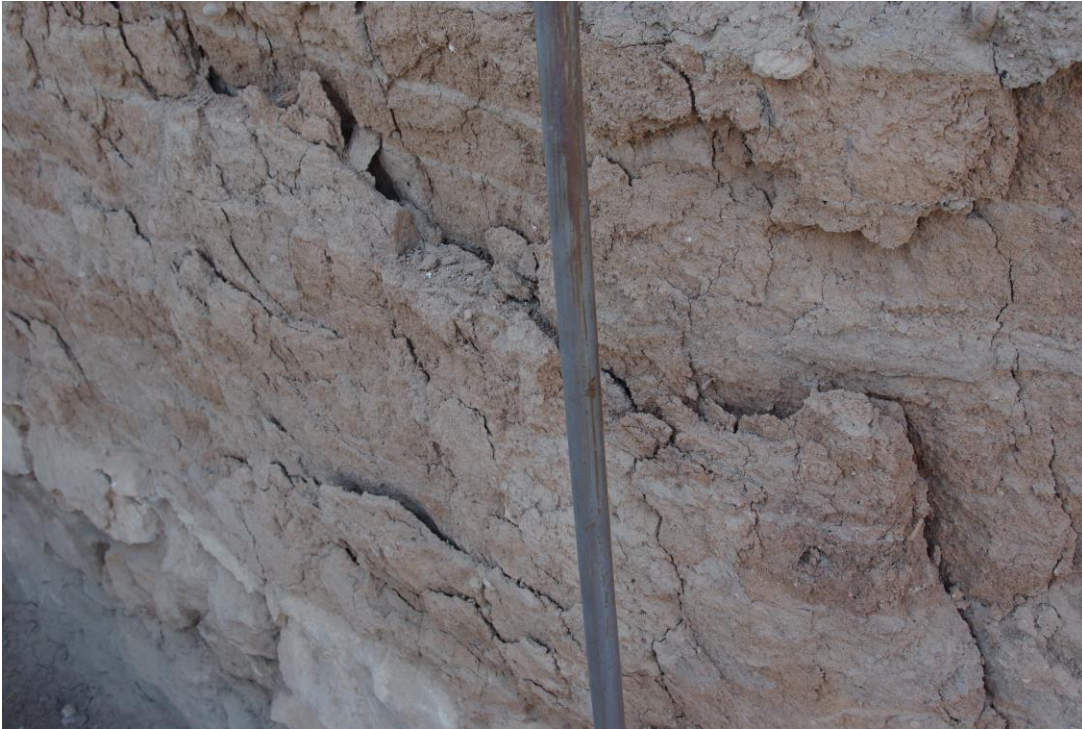
**Delamination:**

Partial splitting of the outer surface of the wall, causing sections to separate from the wall

surface parallel to the face of the wall.

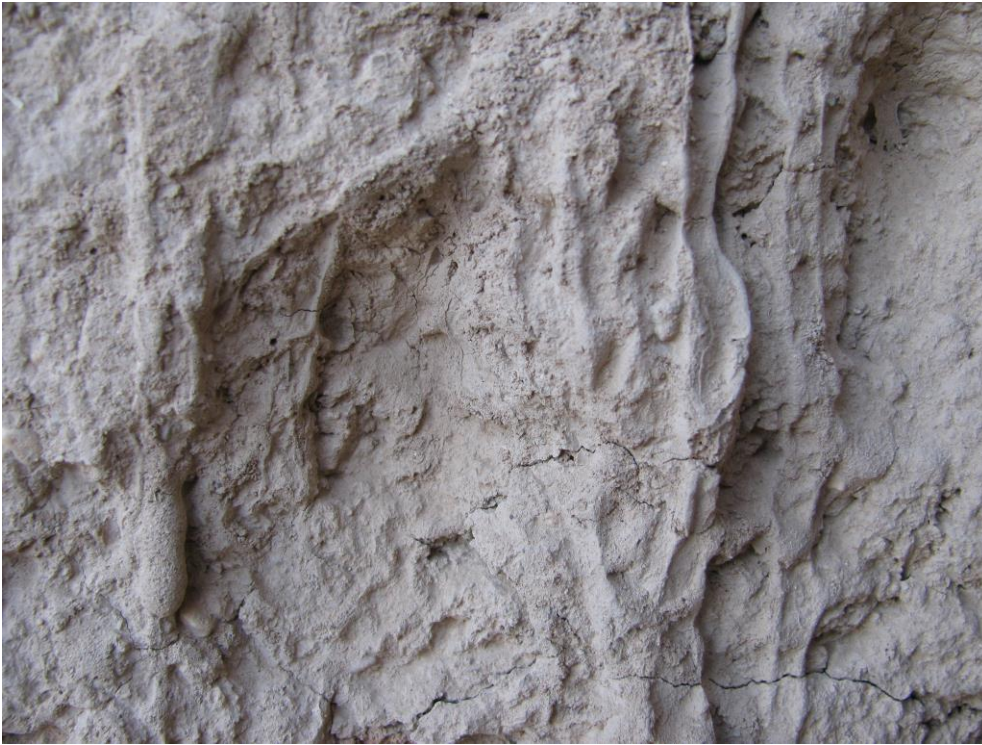
**Erosion:**

The loss of the outer surface of the bricks due to contact with water. This is the result of dripping water or contact with rain, and sometimes results in smooth eroded areas of loss, or in severe cases melting of the bricks. On some walls the individual drip lines can be seen on the wall face.

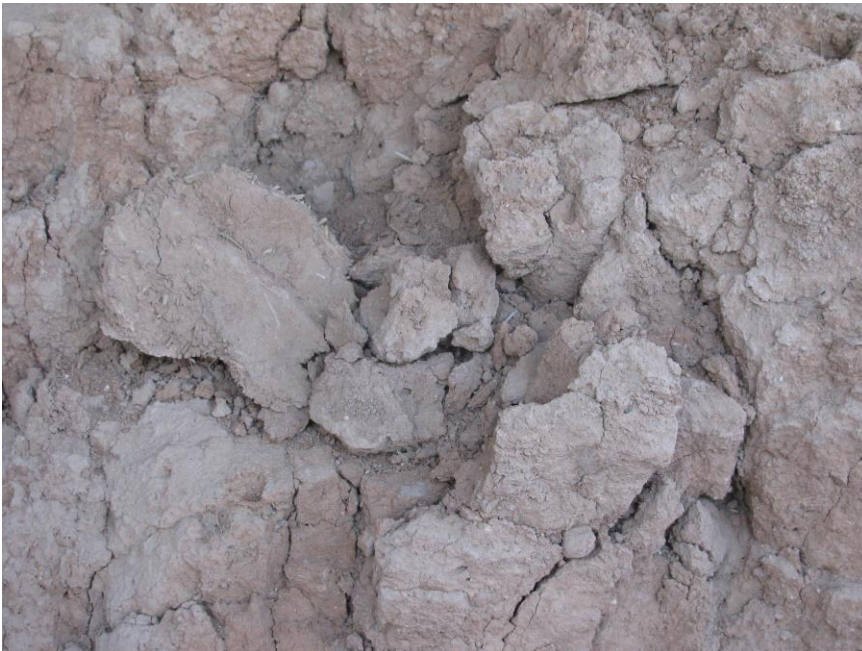
**Crumbling:**

Loss of cohesion within the structure of the bricks and mortar. Results in small pieces of detached material which often falls onto lower surfaces.

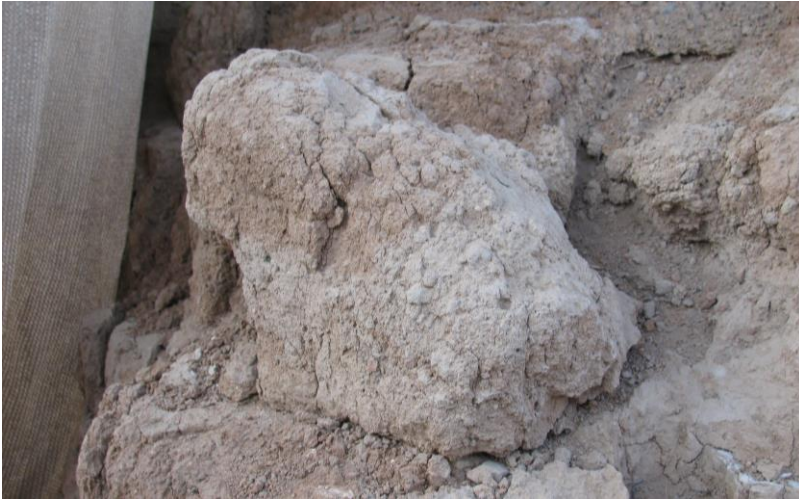
**Separation:**

Areas where a section has completely detached from the wall, but still remains in place. This is generally either a result of cracks becoming very wide and gapped, or occurs along lines where two different types of soil meet. Often separation occurs at the line between the bricks and mortar.

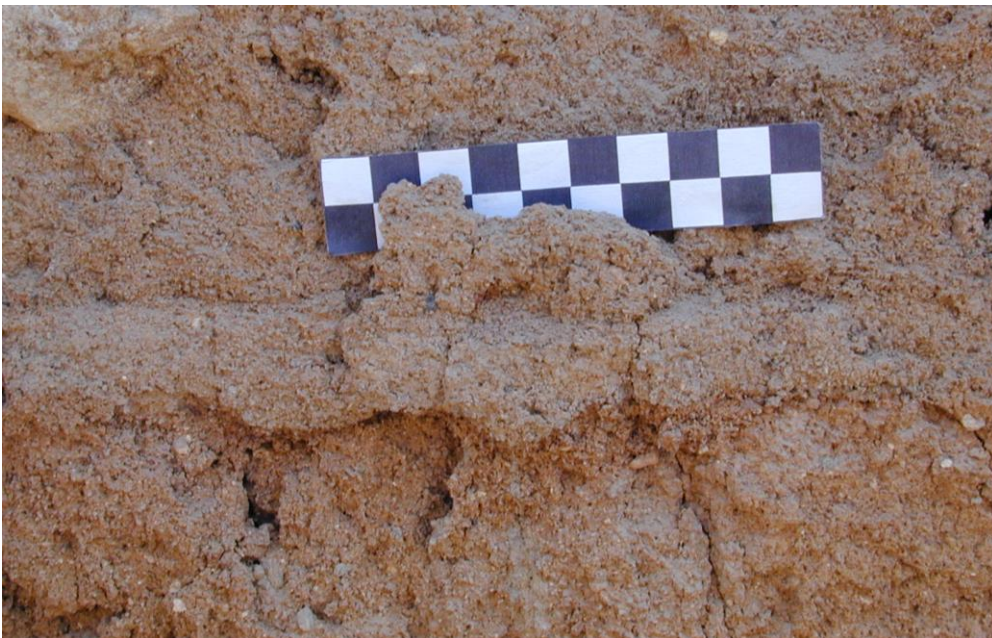
**Salt Damage:**

Spalling and a powdery surface caused by salts in the body of the bricks. In dry conditions, this damage can often be accompanied by the appearance of salt crystals on the surface, but this is not always the case (see below).

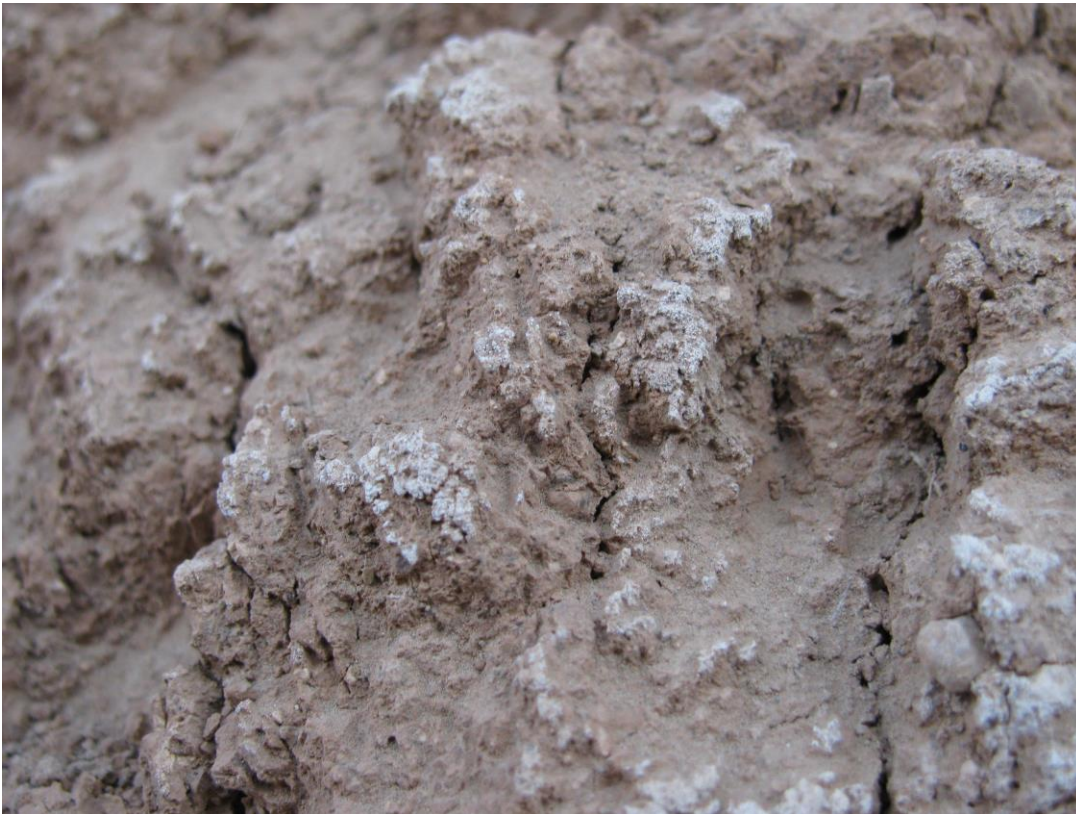
**Salt efflorescence:**

The presence of a whitish haze or visible salt crystals on the surface of the wall. Appears in distinct areas, and are often not easily brushed from the surface.

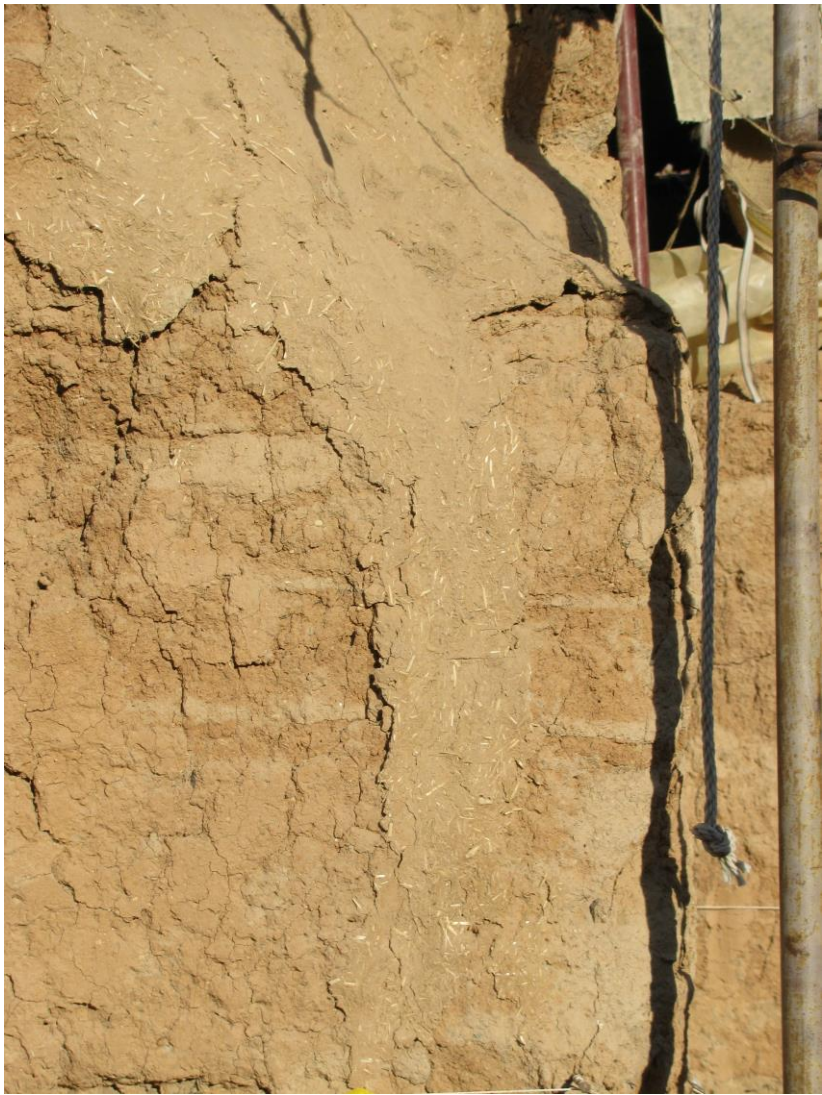
**Previous repairs:**

Modern mud plaster, applied as repairs in previous seasons. Filled with straw, and slightly more gray than the original surface of the walls.
